## Wind Turbine Blade Inspection Report

### T02

**Report Number:** MECHV-REP-XXX-XXX

**Asset:** T02 - 25035 - Vestas V66

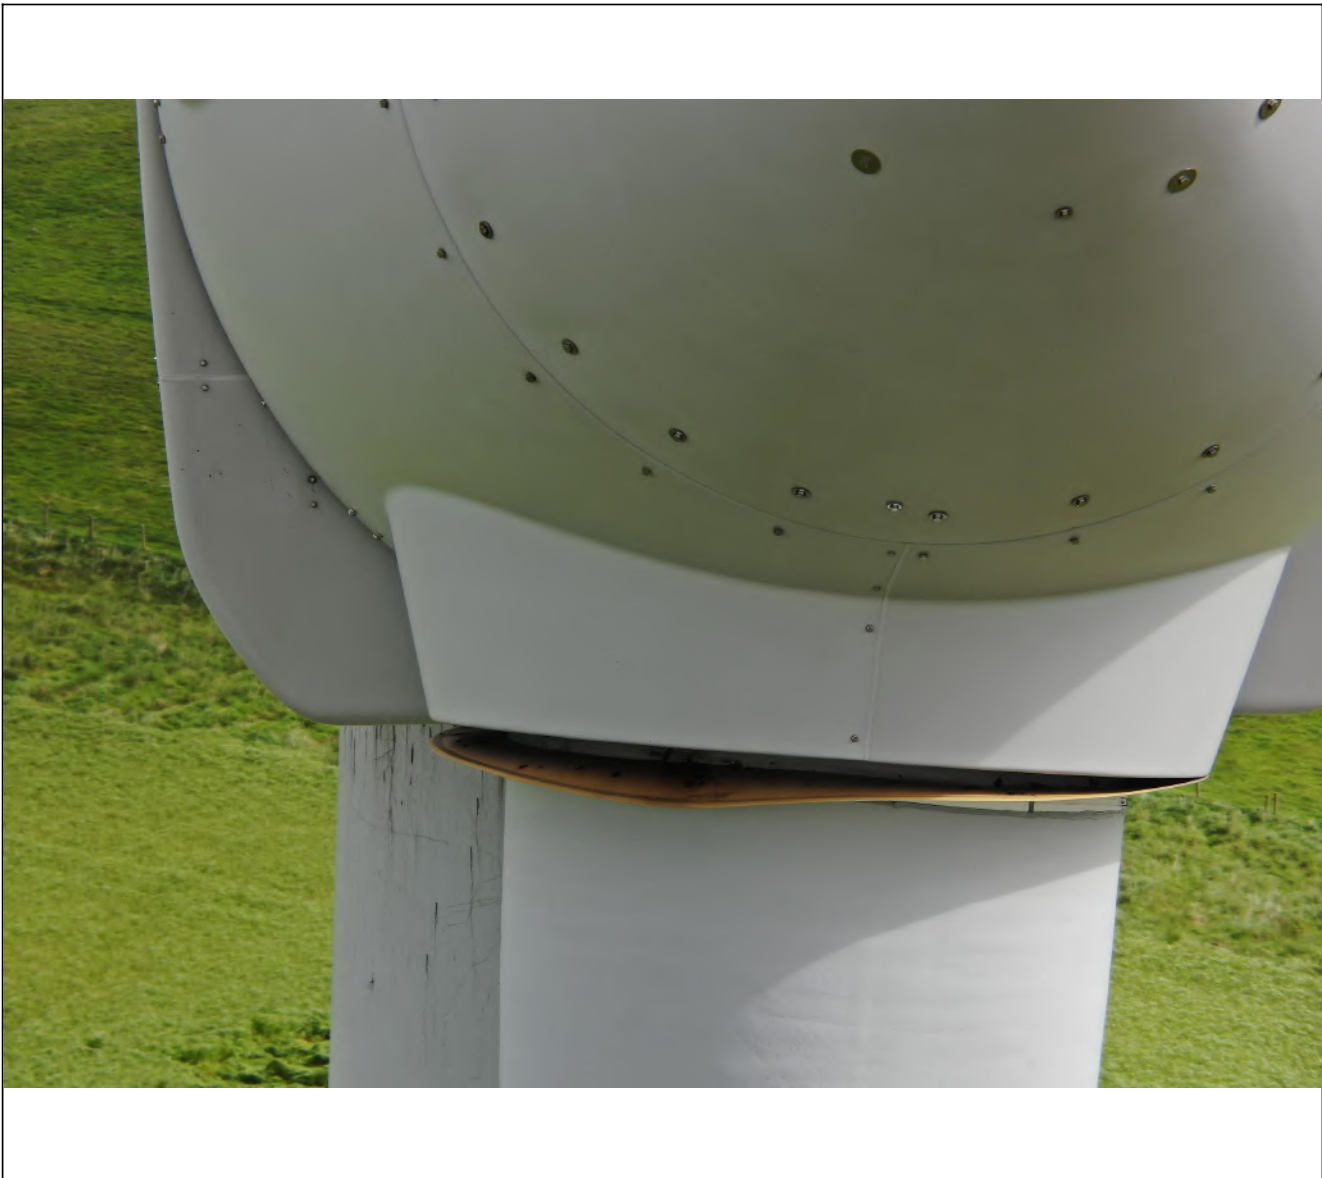
Damage Reference	DN-01	
Damage Category	CAT 2	
Damage Type	Out of alignment	
Distance From Root (m)	0	
Blade Surface	Leading Edge	
Blade Letter/Number	A	
Blade SN		
Image Ref.		
Description	Rain deflector not flush with spinner

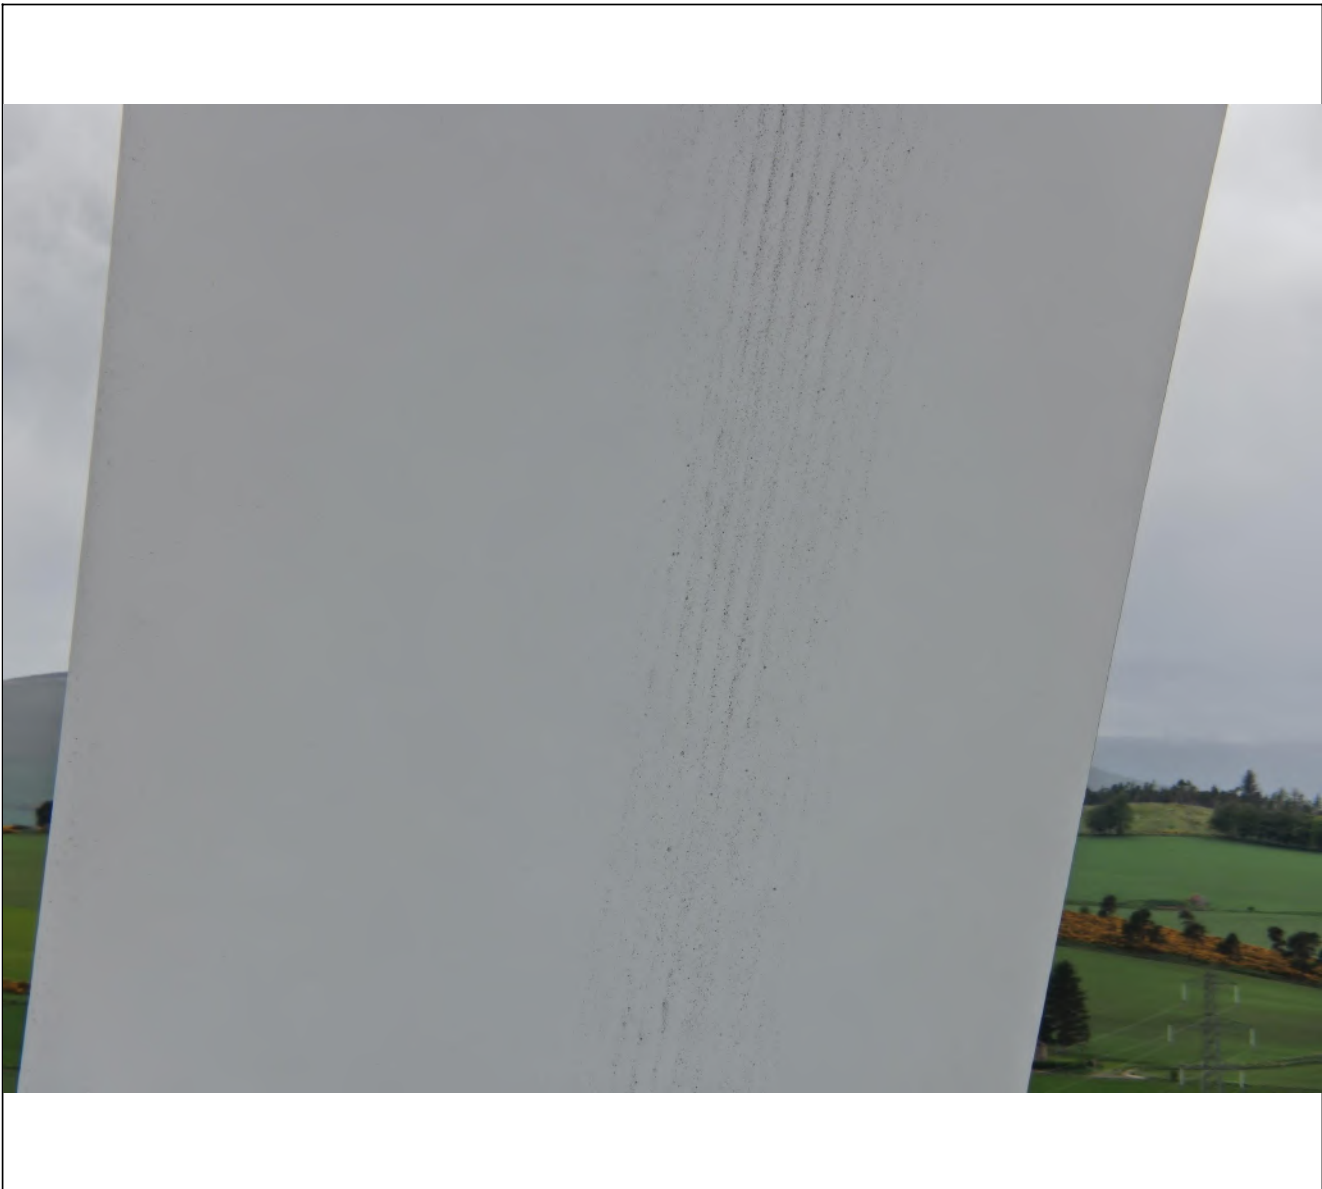
Damage Reference	DN-02	
Damage Category	CAT 1	
Damage Type	Contamination	
Distance From Root (m)	17	
Blade Surface	Pressure Side	
Blade Letter/Number	A	
Blade SN		
Image Ref.		
Description	Small bit of dirt contamination on blade

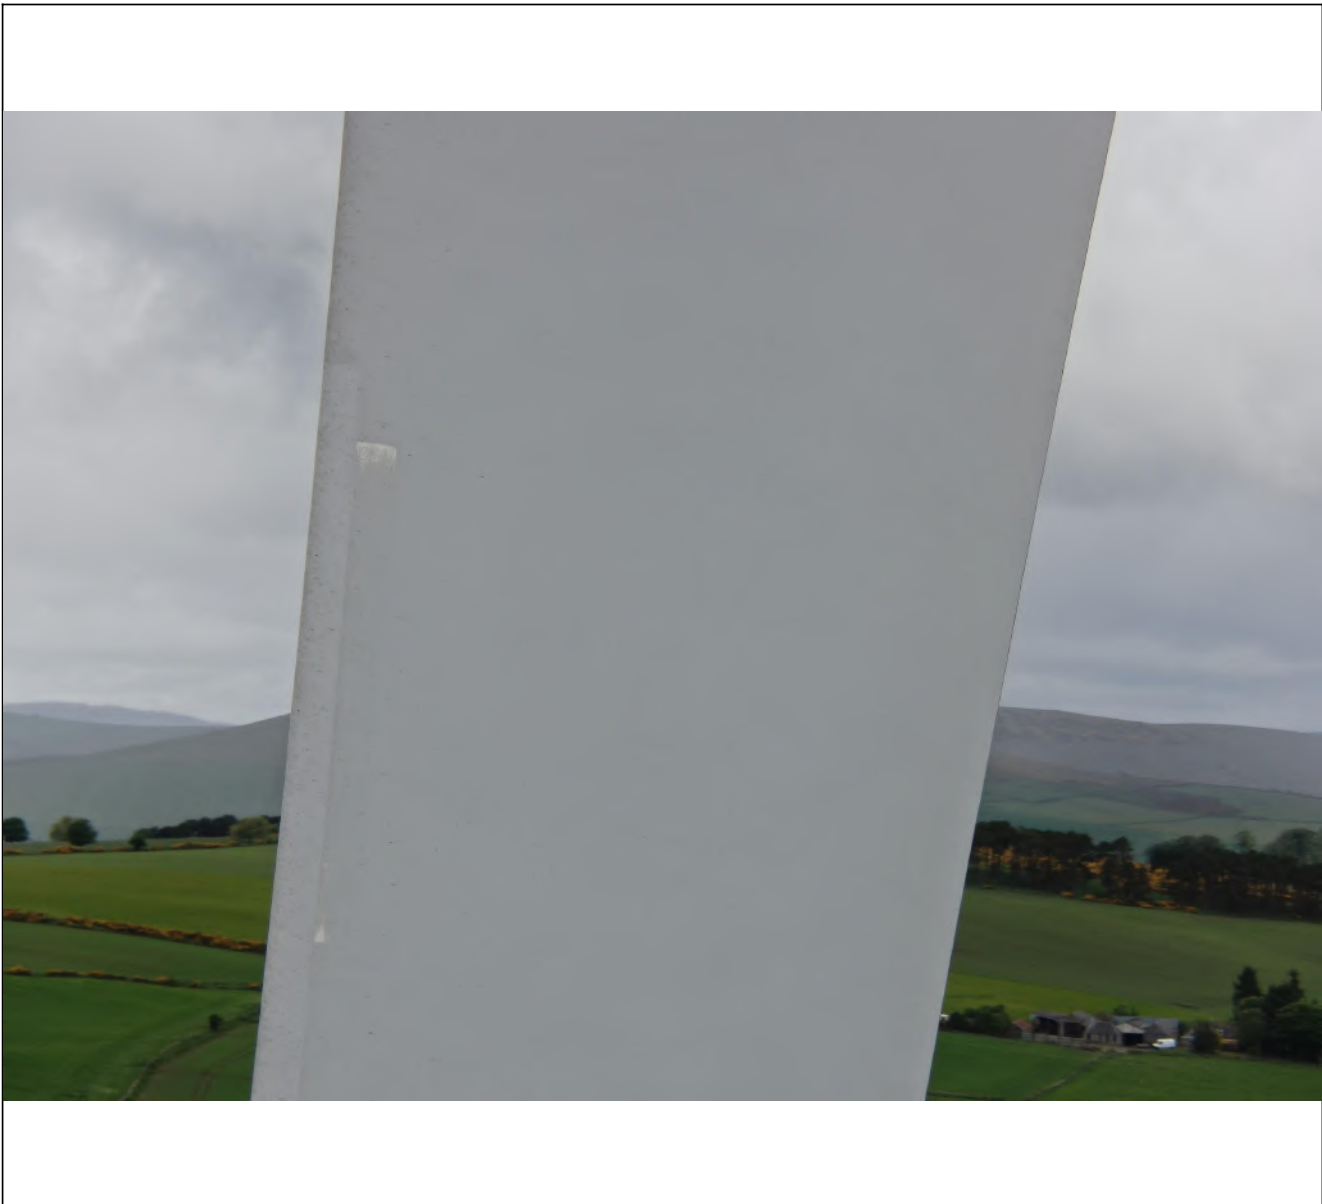
Damage Reference	DN-03	<p>The diagram shows two cross-sections of a wind turbine blade. The top section is labeled 'Pressure Side' and the bottom section is labeled 'Suction Side'. Both sections show the 'Leading Edge' on the left and the 'Trailing Edge' on the right. A red circle is drawn on the upper surface of the pressure side, indicating the location of the damage.</p>
Damage Category	CAT 1	
Damage Type	General observation	
Distance From Root (m)	24	
Blade Surface	Pressure Side	
Blade Letter/Number	A	
Blade SN		
Image Ref.		
Description	Previous repair, all satisfactory

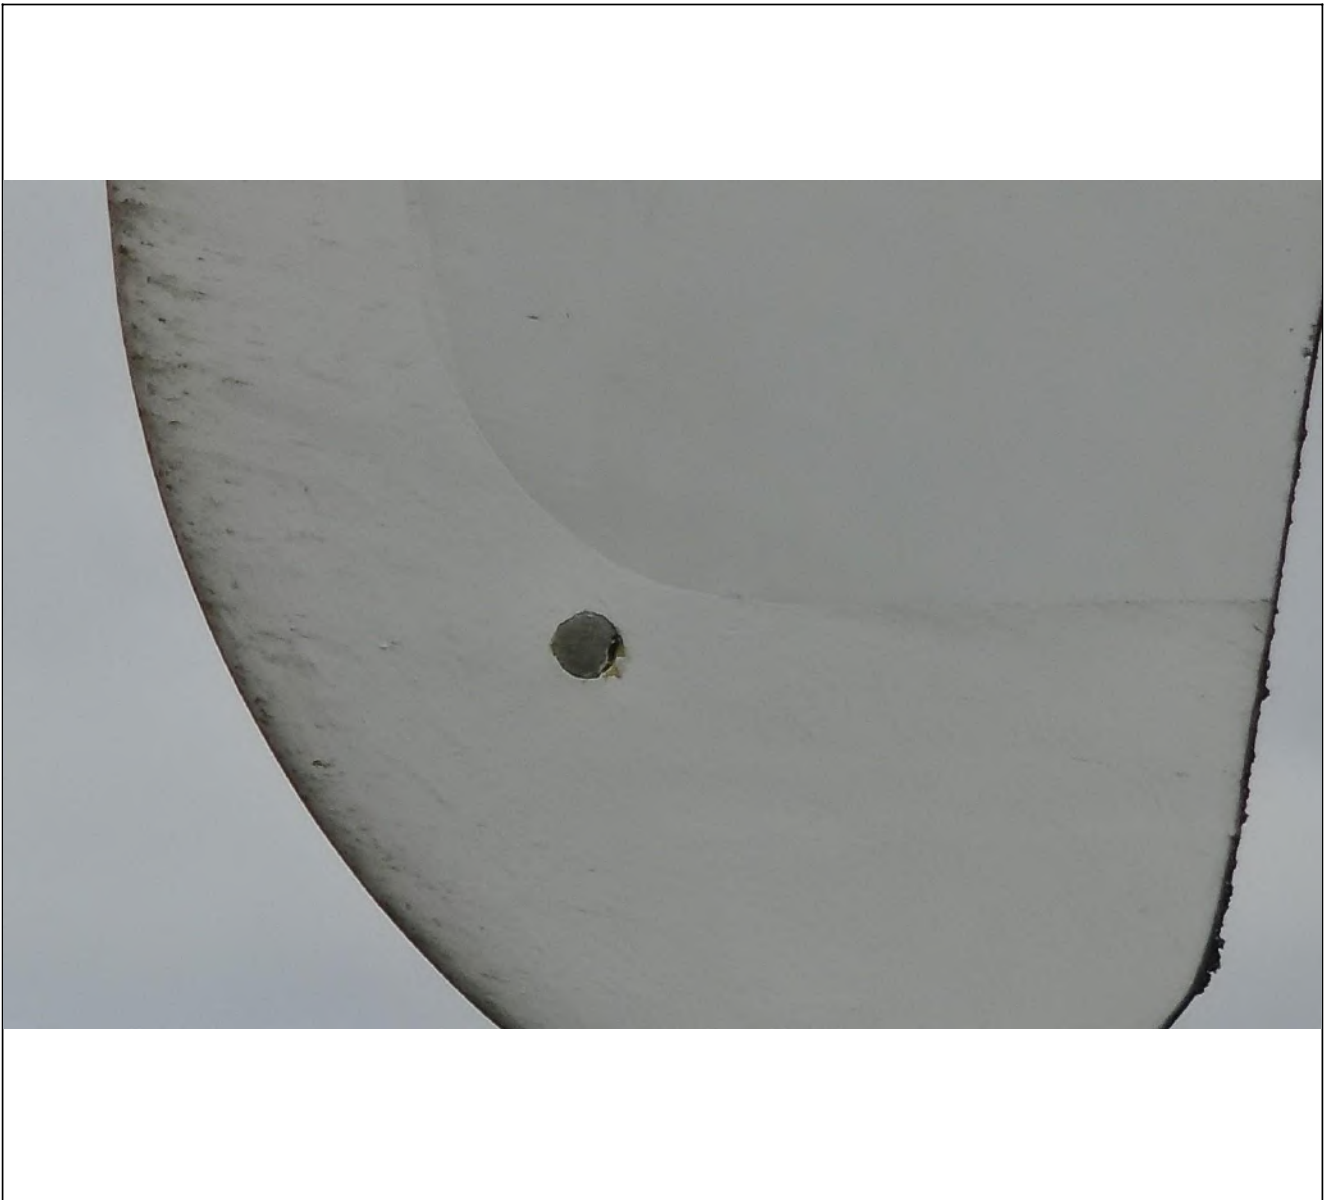
Damage Reference	DN-04	
Damage Category	CAT 2	
Damage Type	Lightning Damage	
Distance From Root (m)	32	
Blade Surface	Pressure Side	
Blade Letter/Number	A	
Blade SN		
Image Ref.		
Description	Lightning receptor partially melted due to lightning strike. Dirt on trailing edge of blade

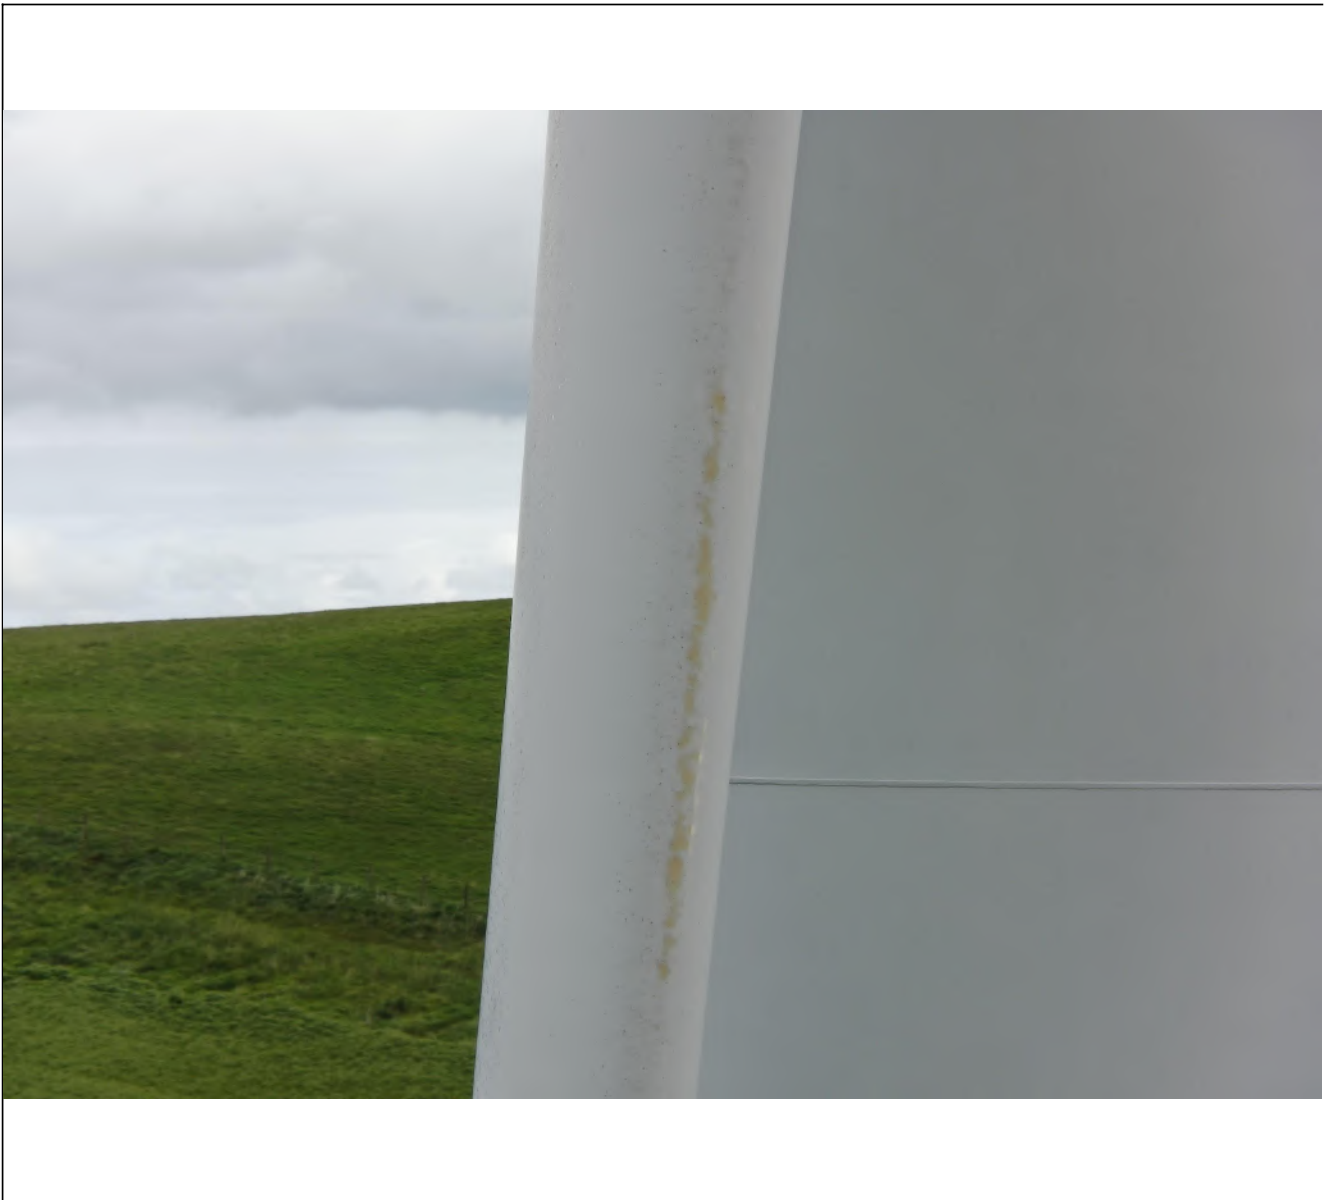
Damage Reference	DN-05	
Damage Category	CAT 2	
Damage Type	Erosion	
Distance From Root (m)	17	
Blade Surface	Leading Edge	
Blade Letter/Number	B	
Blade SN		
Image Ref.		
Description	Top coat eroded and some pitting in the same area

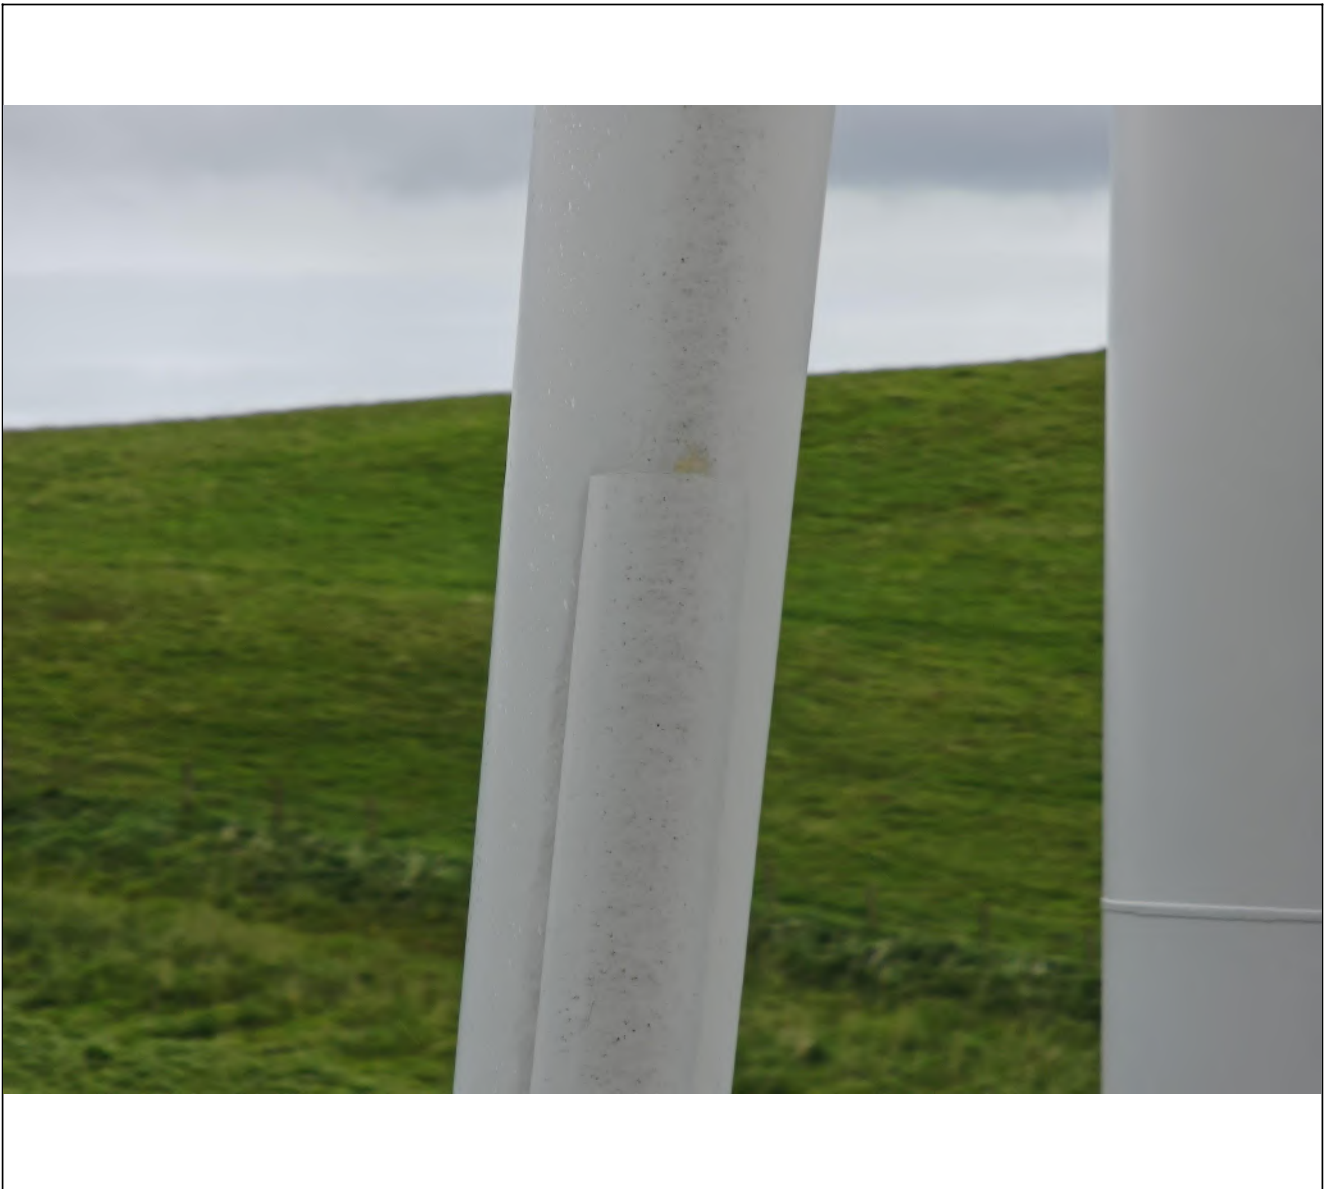
Damage Reference	DN-06	
Damage Category	CAT 1	
Damage Type	General observation	
Distance From Root (m)	23	
Blade Surface	Leading Edge	
Blade Letter/Number	B	
Blade SN		
Image Ref.		
Description	Previous repair, minor area of top coat eroded above repair

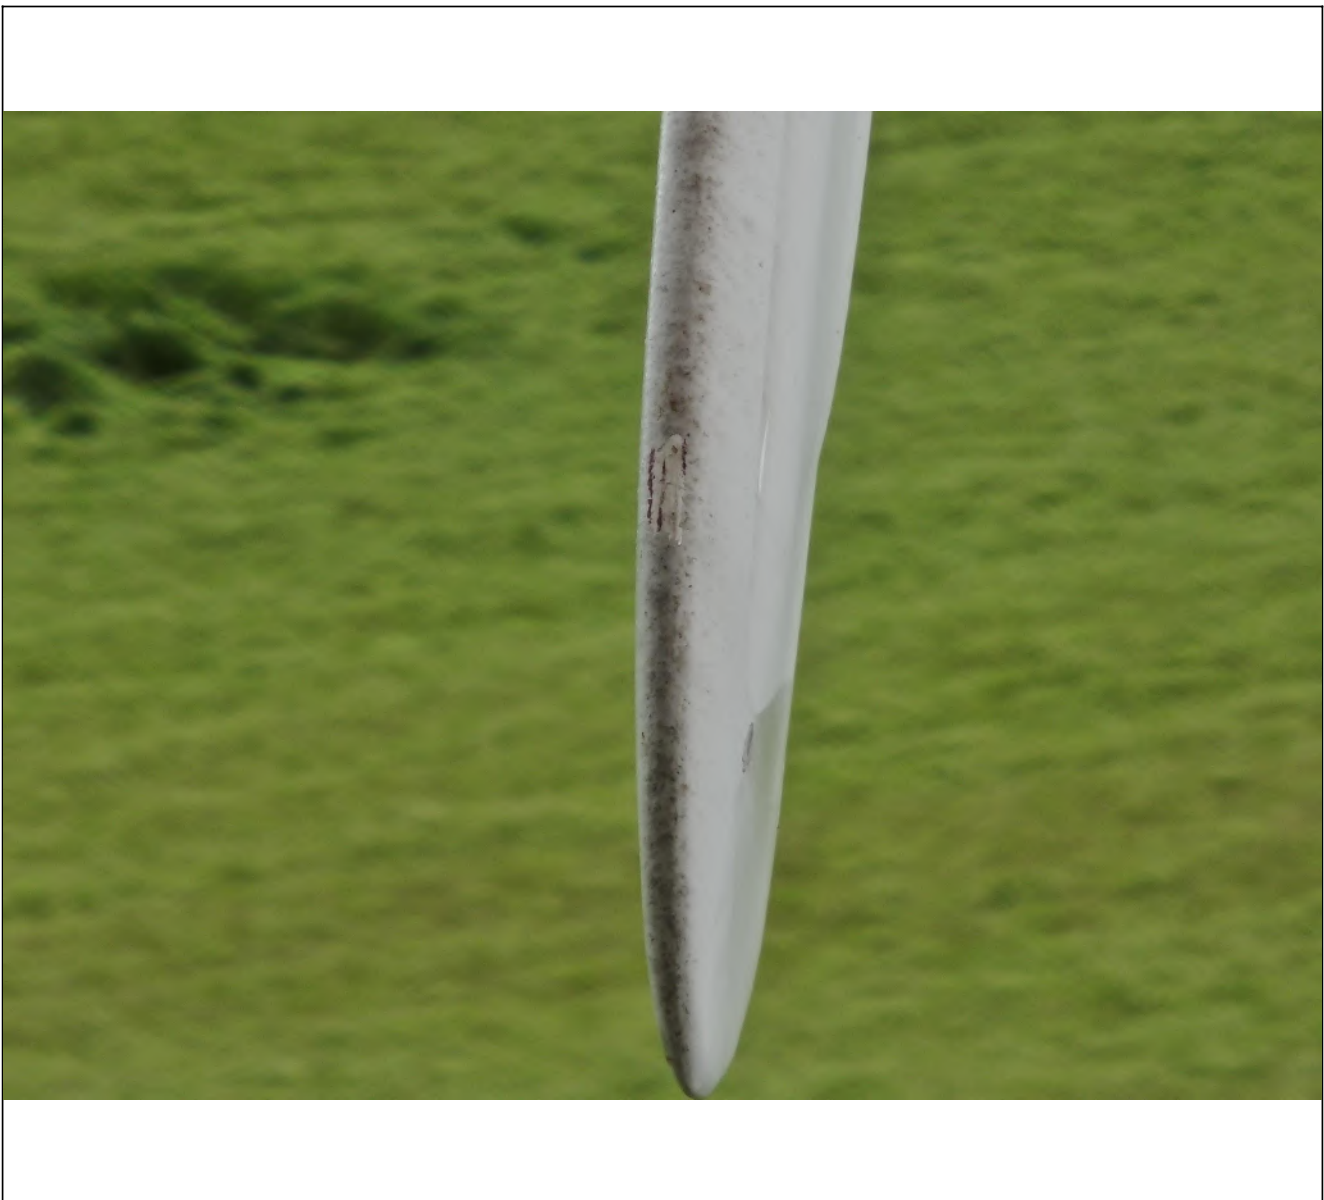
Damage Reference	DN-07	
Damage Category	CAT 2	
Damage Type	Erosion	
Distance From Root (m)	32	
Blade Surface	Leading Edge	
Blade Letter/Number	B	
Blade SN		
Image Ref.		
Description	Top coat eroded. Gelcoat showing

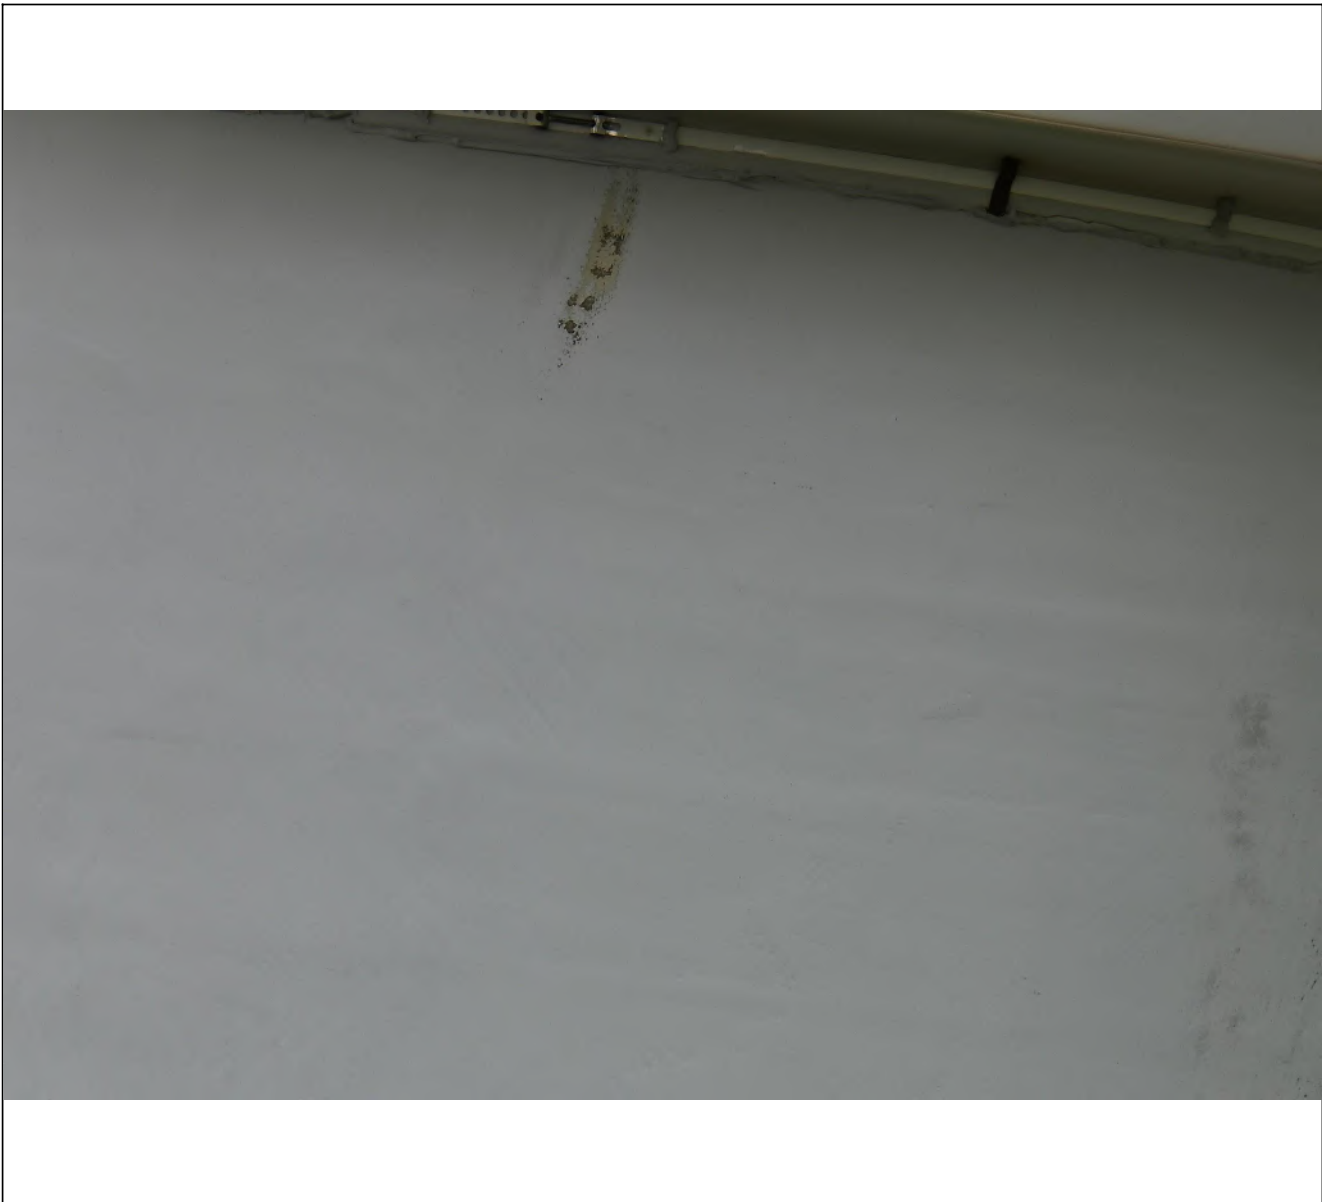
Damage Reference	DN-08	
Damage Category	CAT 2	
Damage Type	Scratch	
Distance From Root (m)	0	
Blade Surface	Pressure Side	
Blade Letter/Number	B	
Blade SN		
Image Ref.		
Description	Top coat scratched under rain deflector

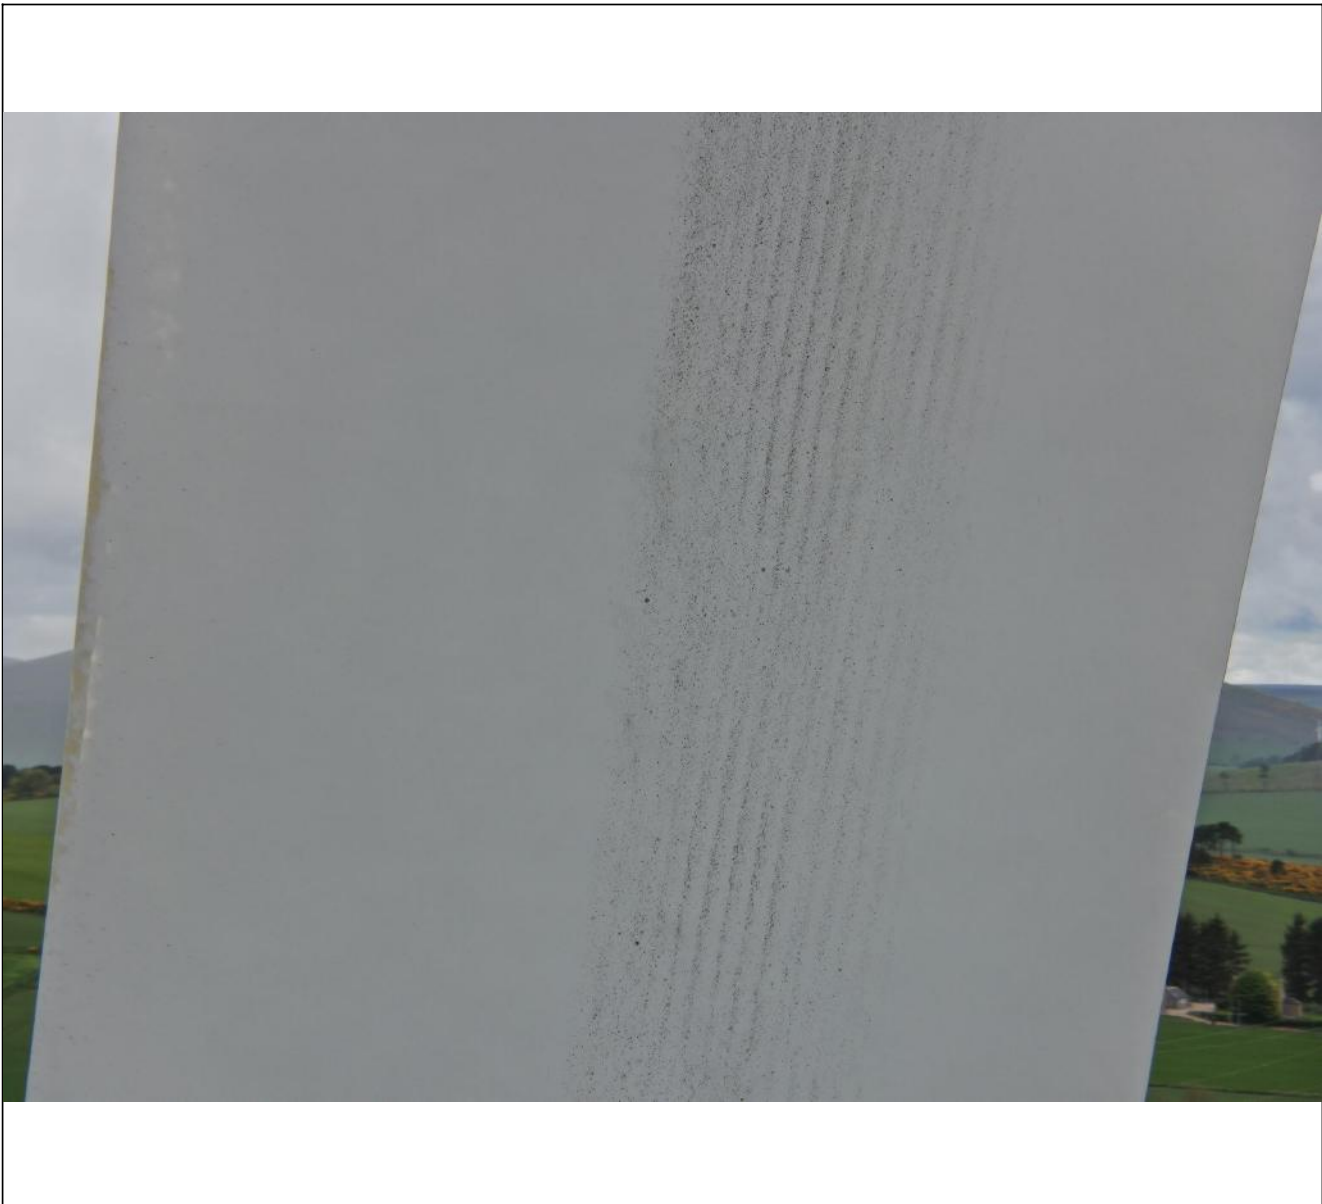
Damage Reference	DN-09	
Damage Category	CAT 1	
Damage Type	Contamination	
Distance From Root (m)	15	
Blade Surface	Pressure Side	
Blade Letter/Number	B	
Blade SN		
Image Ref.		
Description	Mild dirt contamination on blade

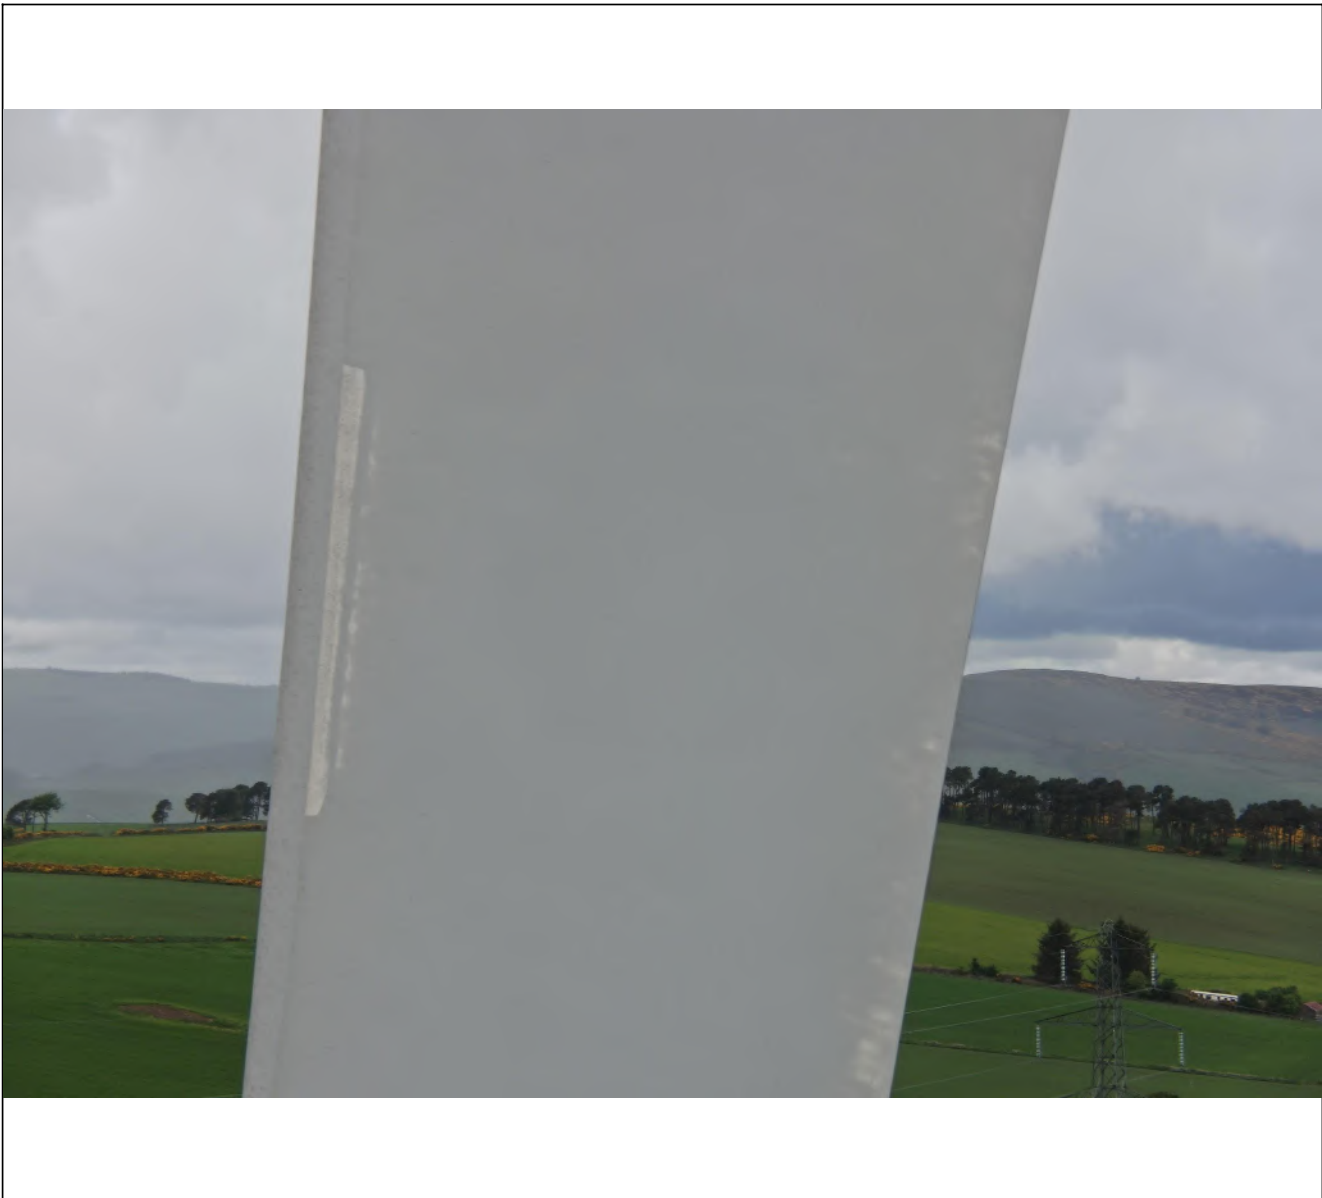
Damage Reference	DN-10	<p>The diagram shows two views of a wind turbine blade. The top view is labeled 'Pressure Side' and the bottom view is labeled 'Suction Side'. Both views show the 'Leading Edge' and 'Trailing Edge'. A red circle is drawn on the leading edge of the pressure side, indicating the location of the damage.</p>
Damage Category	CAT 1	
Damage Type	General observation	
Distance From Root (m)	23	
Blade Surface	Leading Edge	
Blade Letter/Number	B	
Blade SN		
Image Ref.		
Description	Previous repair, All satisfactory

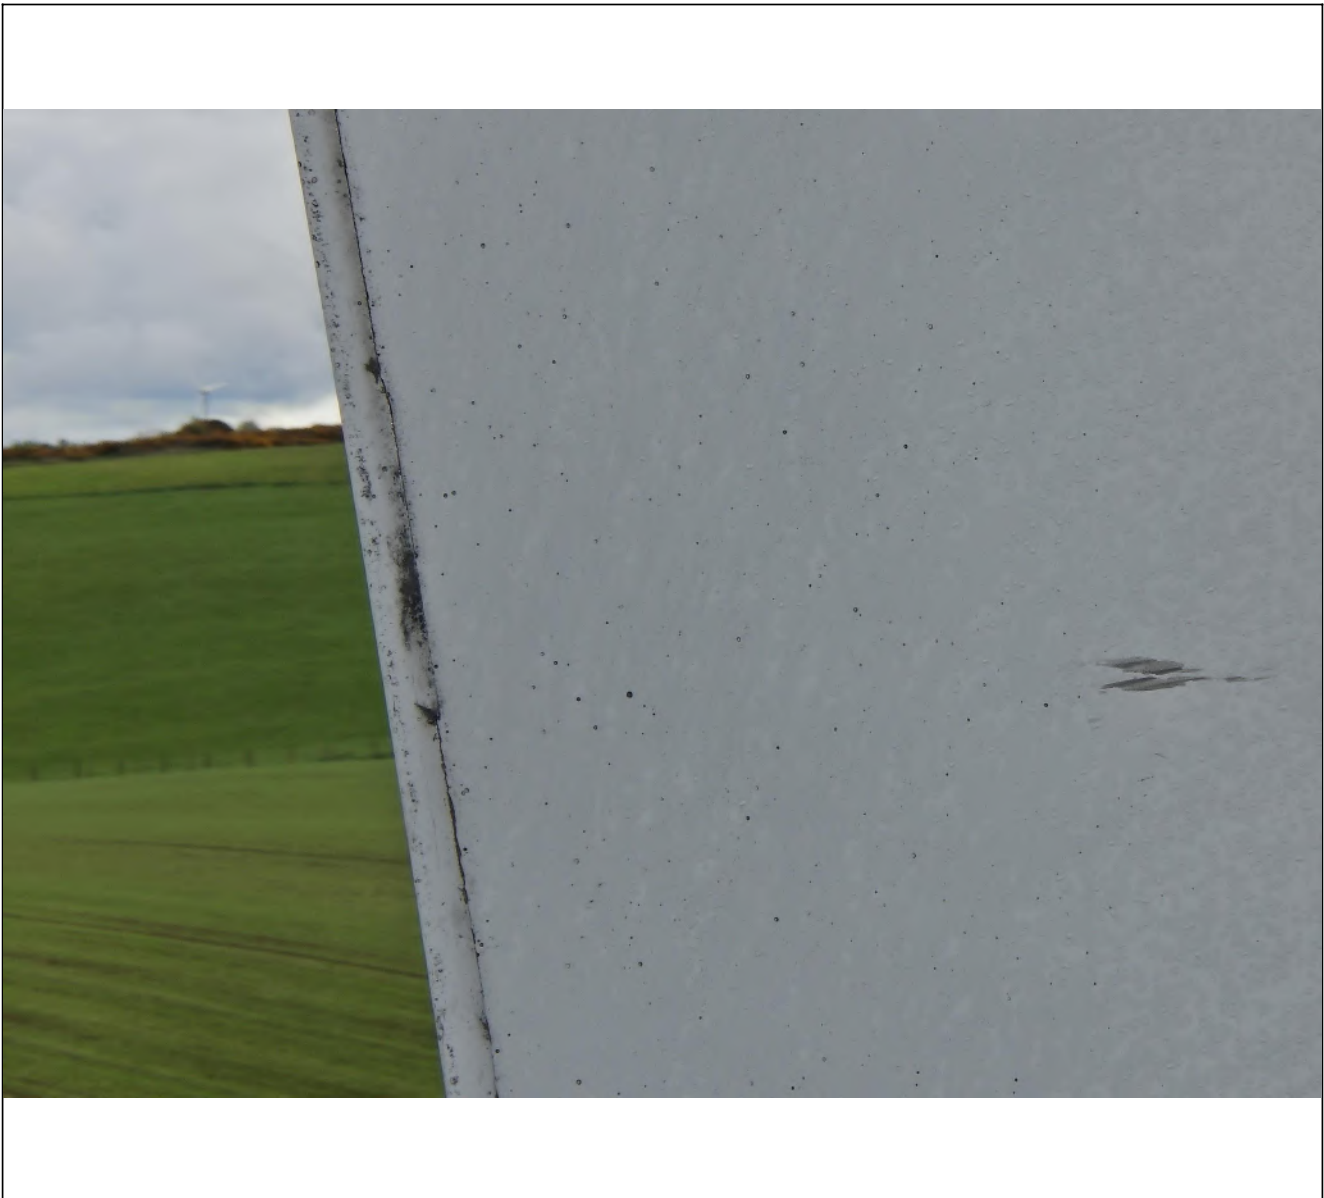
DN-11 : Significant longitudinal crack on suction side near trailing edge of blade. Please consult with Vestas on further action.

Damage Reference	DN-11	
Damage Category	CAT 4	
Damage Type	Cracking	
Distance From Root (m)	26	
Blade Surface	Suction Side	
Blade Letter/Number	B	
Blade SN		
Image Ref.		
Description	Significant longitudinal crack on suction side near trailing edge of blade

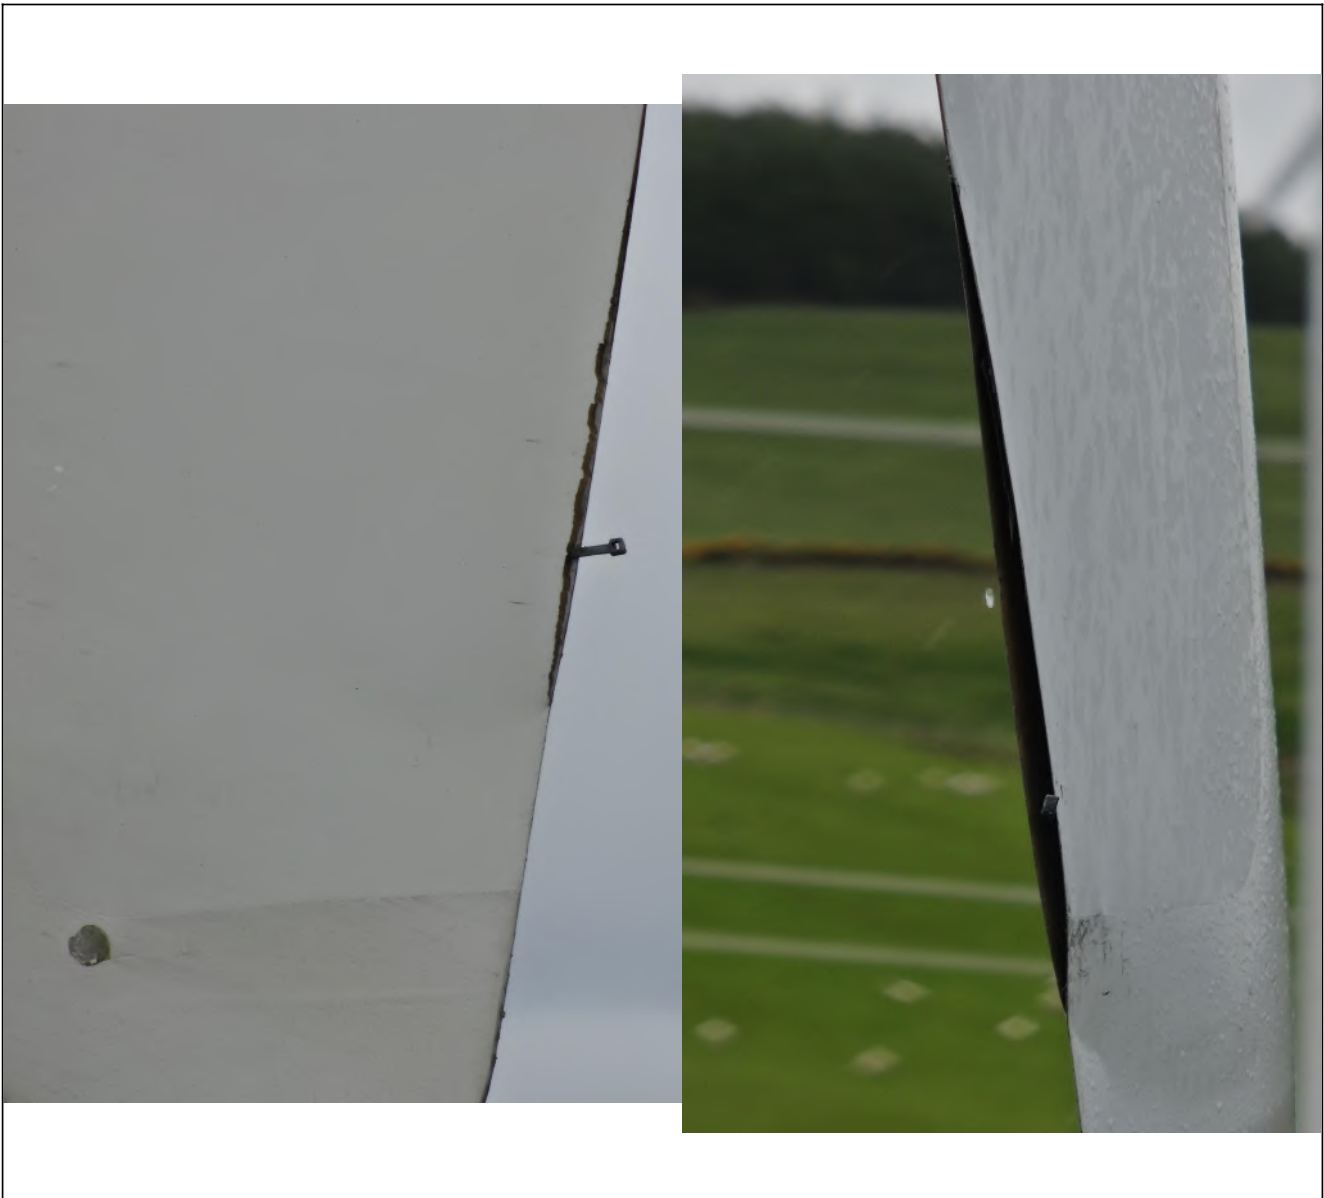
DN-12 : Blade B has an open trailing edge near the tip. Example Client informed of this at time of inspection. Please consult with Vestas on further action.

Damage Reference	DN-12	
Damage Category	CAT 5	
Damage Type	Debonding	
Distance From Root (m)	32	
Blade Surface	Trailing Edge	
Blade Letter/Number	B	
Blade SN		
Image Ref.		
Description	Trailing edge separation near blade tip

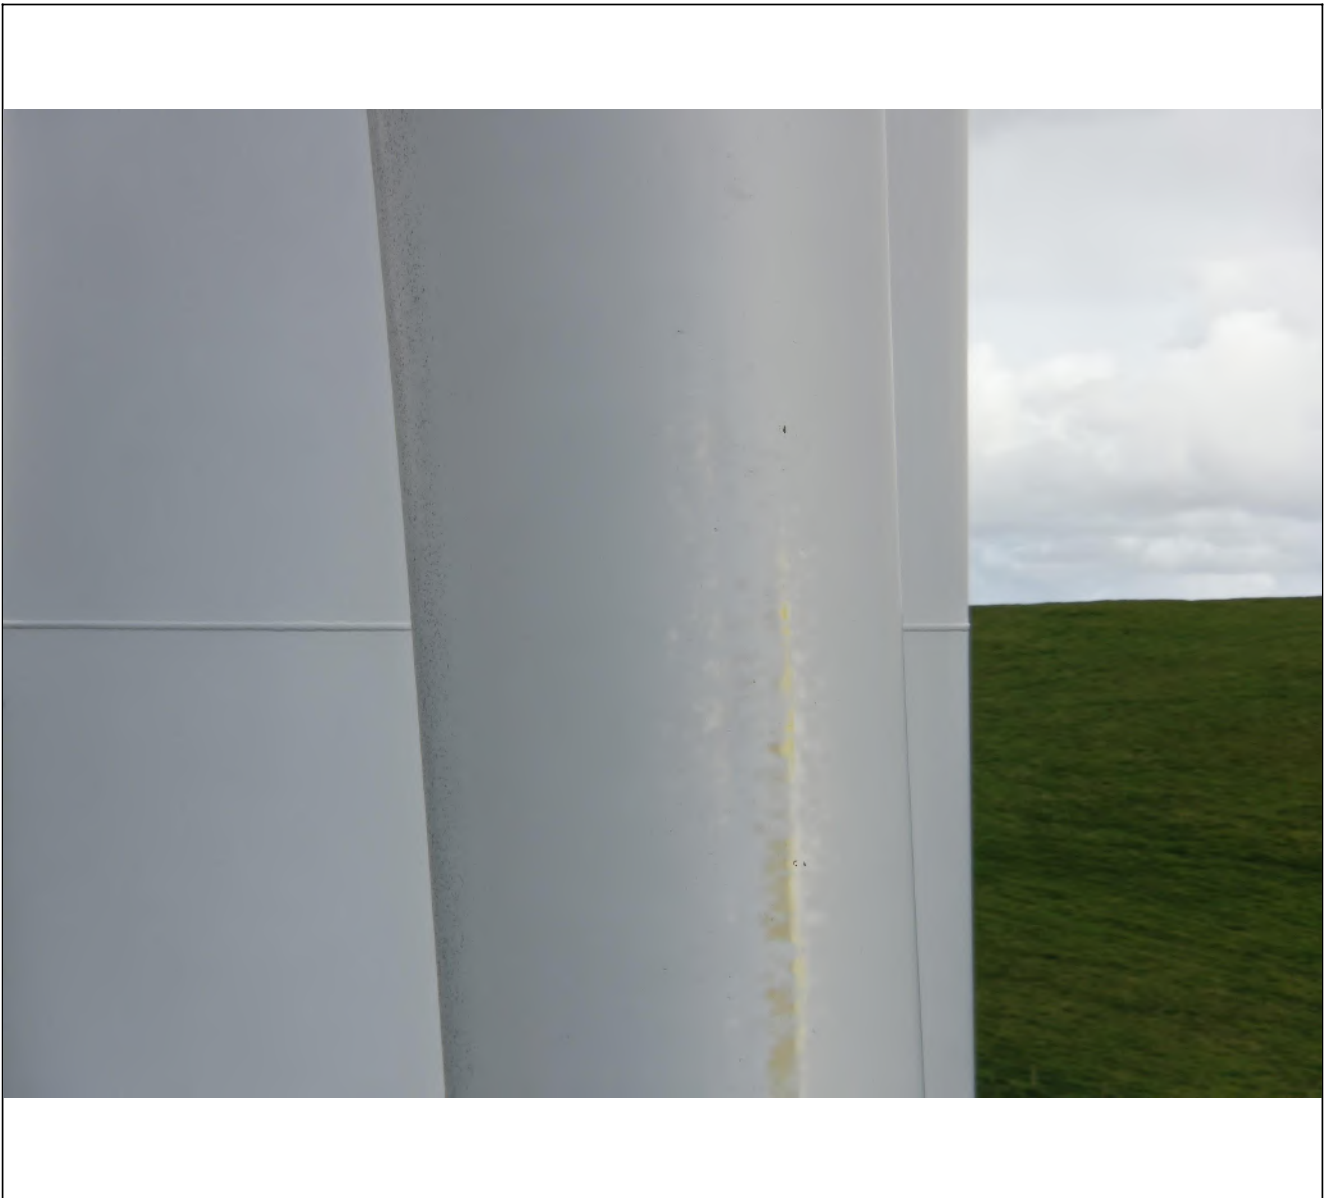
Damage Reference	DN-13	
Damage Category	CAT 2	
Damage Type	Erosion	
Distance From Root (m)	6	
Blade Surface	Leading Edge	
Blade Letter/Number	C	
Blade SN		
Image Ref.		
Description	Gelcoat eroded
