## Wind Turbine Blade Inspection Report

### T02

**Report Number:** MECHV-REP-XXX-XXX

**Asset:** T02 - 25035 - Vestas V66

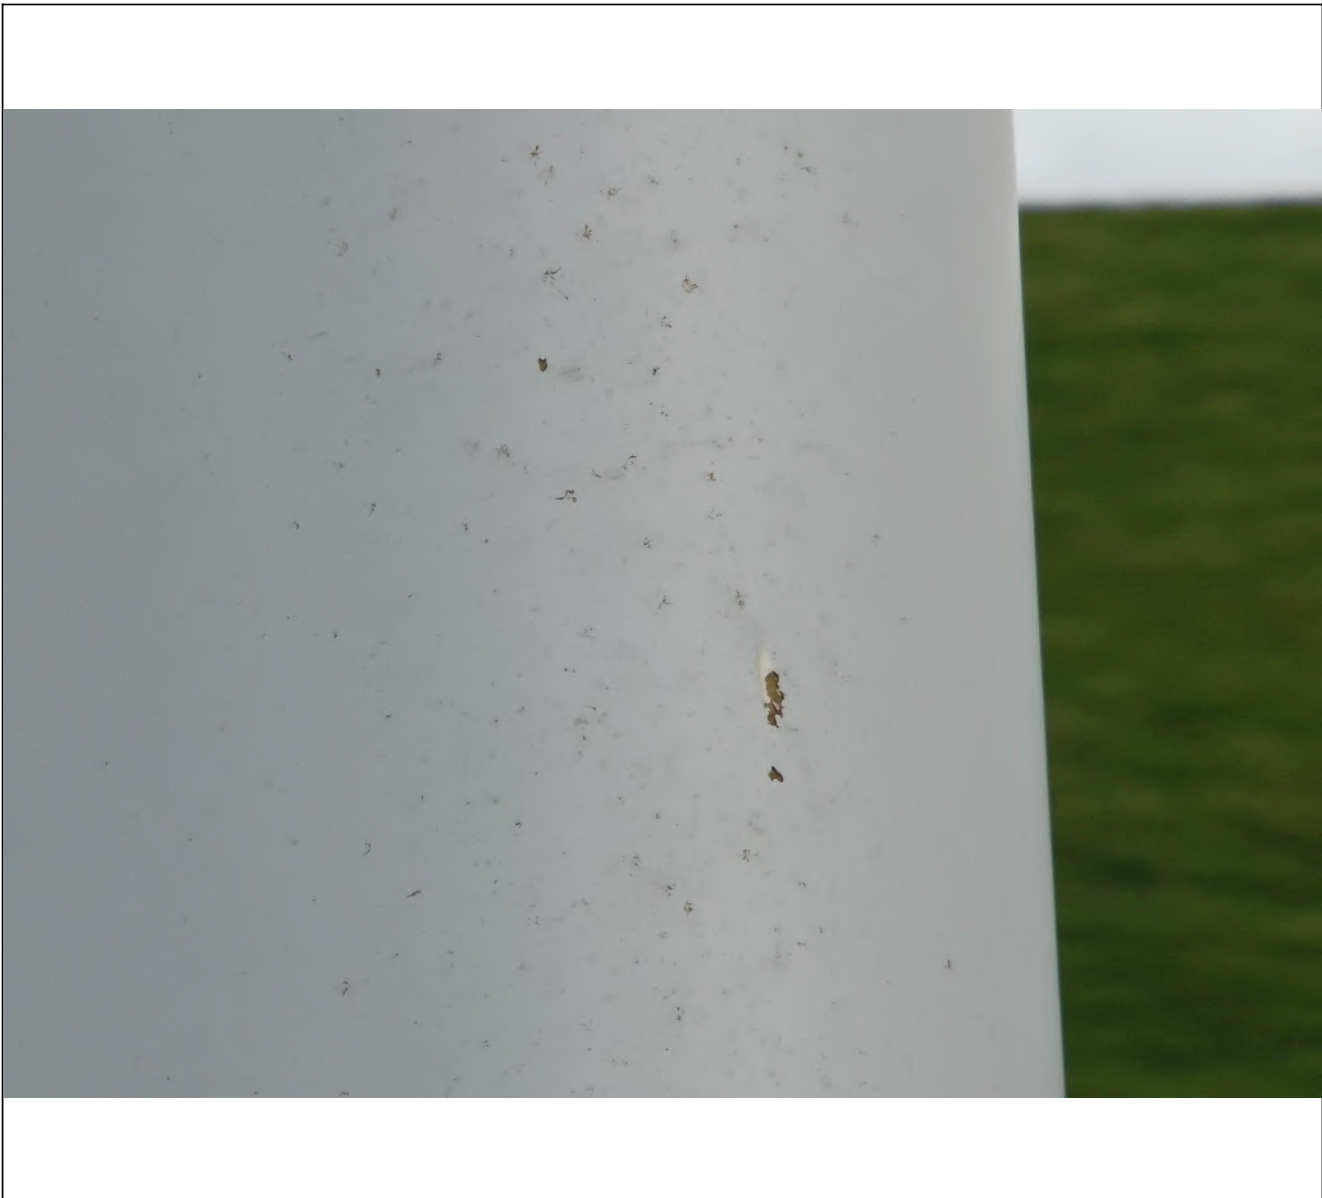
Damage Reference	DN-14	
Damage Category	CAT 2	
Damage Type	Chipping	
Distance From Root (m)	16	
Blade Surface	Leading Edge	
Blade Letter/Number	C	
Blade SN		
Image Ref.		
Description	Small chip in gelcoat on leading edge. No underlying laminate damage.

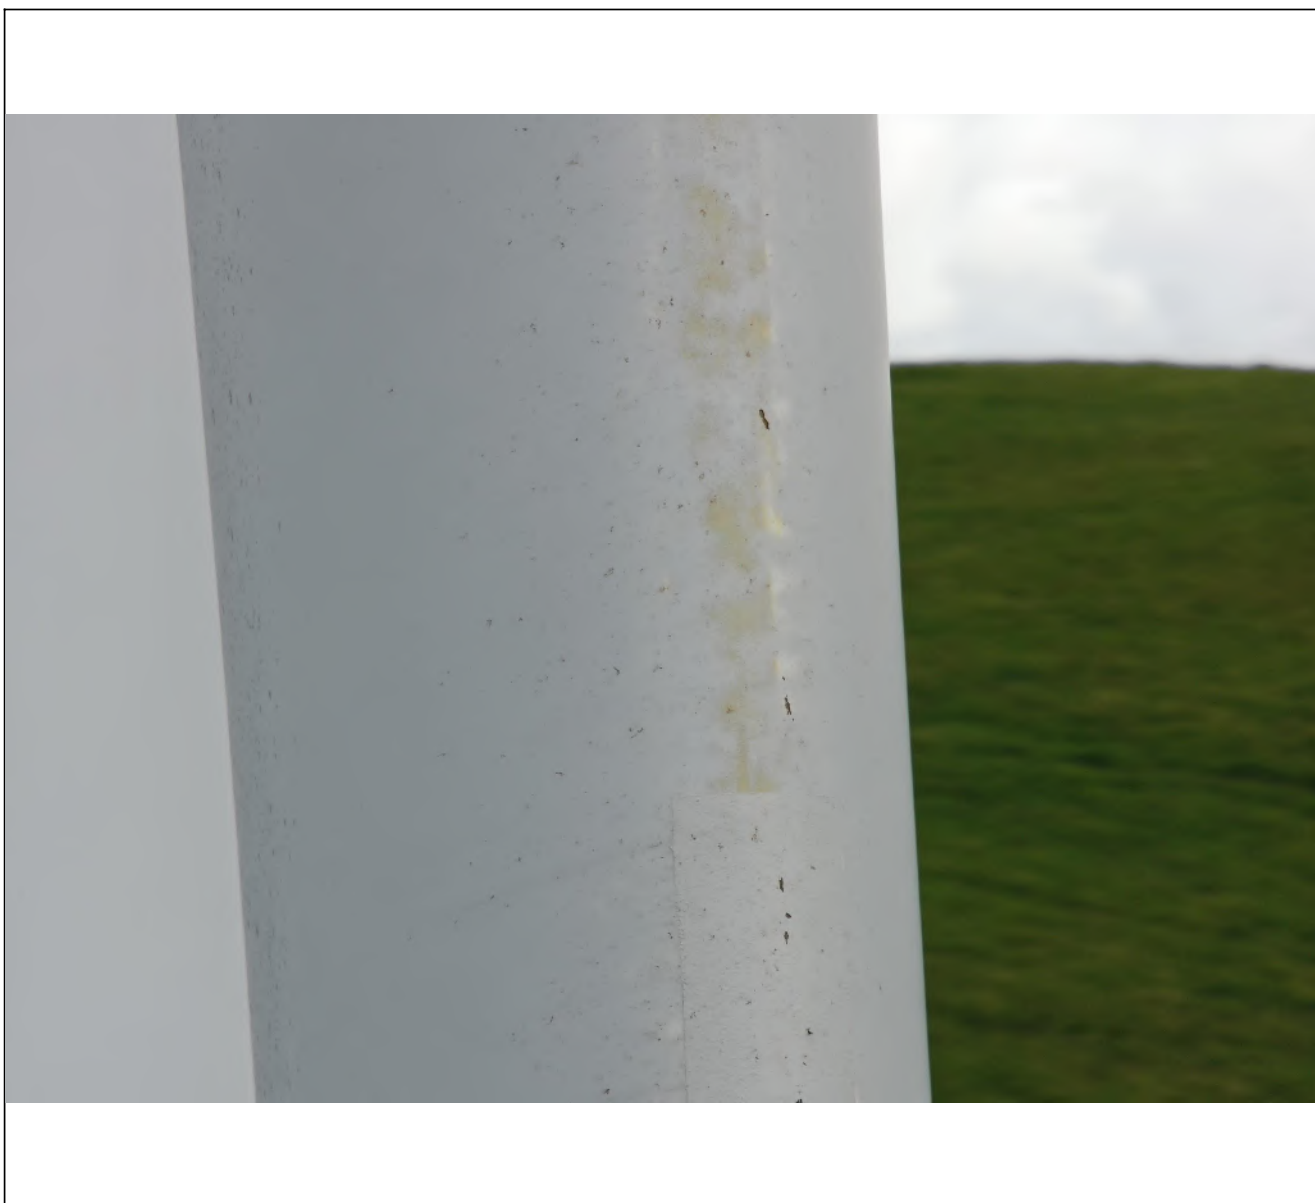
Damage Reference	DN-15	
Damage Category	CAT 2	
Damage Type	Erosion	
Distance From Root (m)	16	
Blade Surface	Leading Edge	
Blade Letter/Number	C	
Blade SN		
Image Ref.		
Description	Top coat eroded. Several chips in gelcoat.

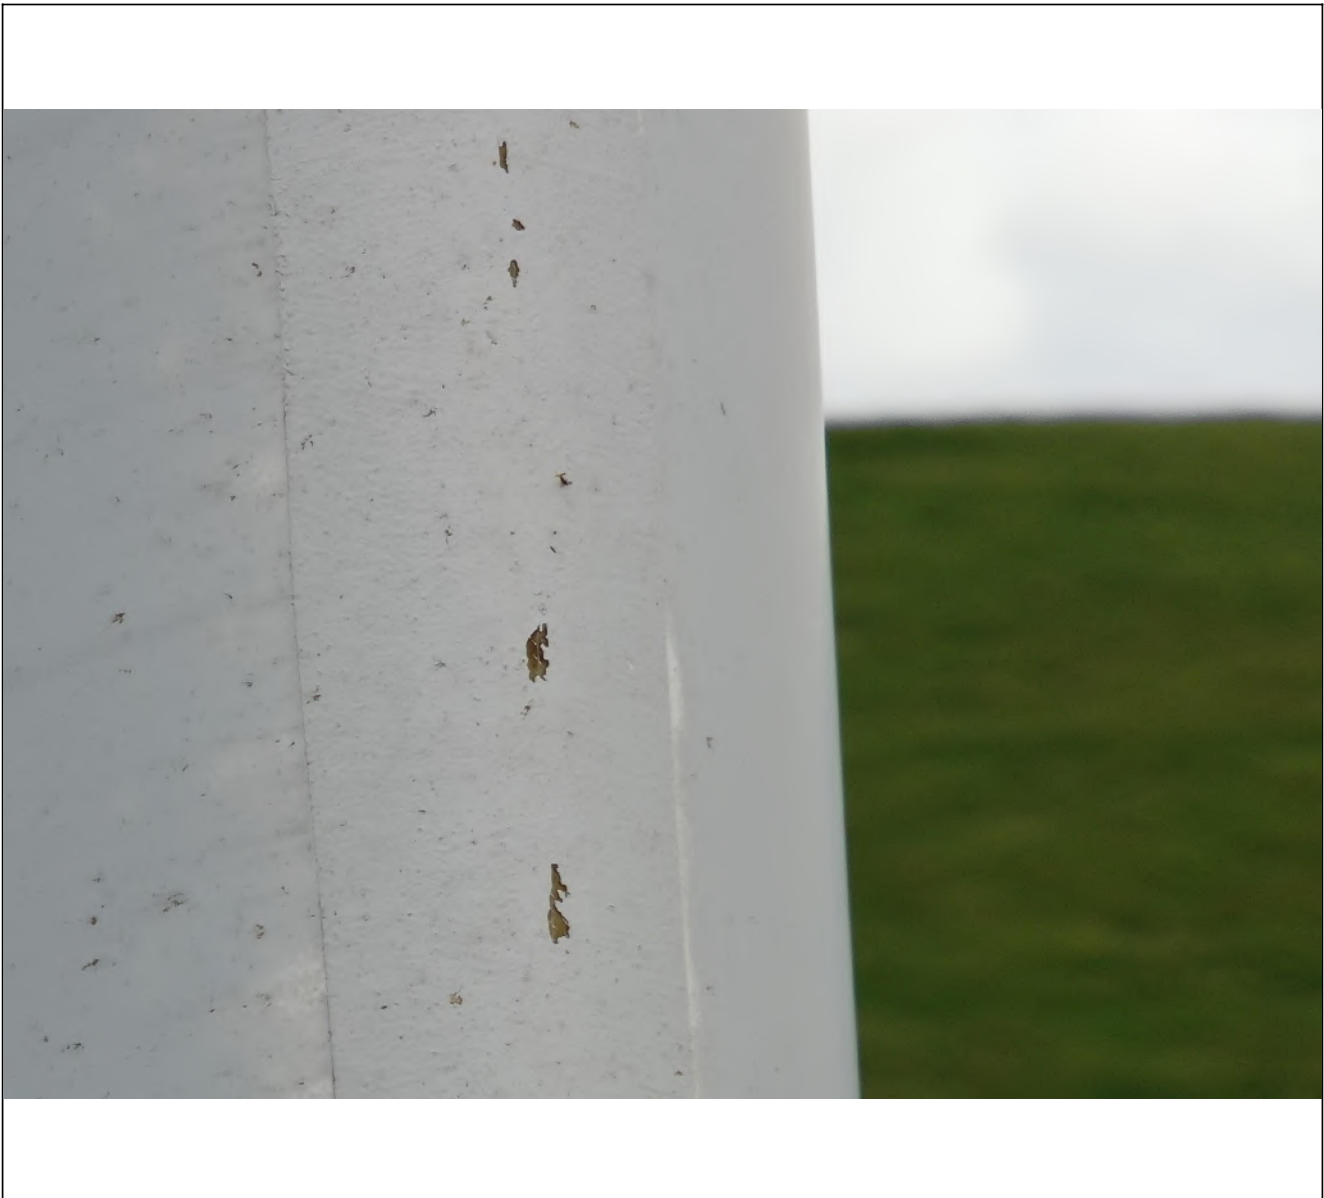
Damage Reference	DN-16	
Damage Category	CAT 2	
Damage Type	Erosion	
Distance From Root (m)	17	
Blade Surface	Leading Edge	
Blade Letter/Number	C	
Blade SN		
Image Ref.		
Description	Gelcoat chipped and laminate exposed

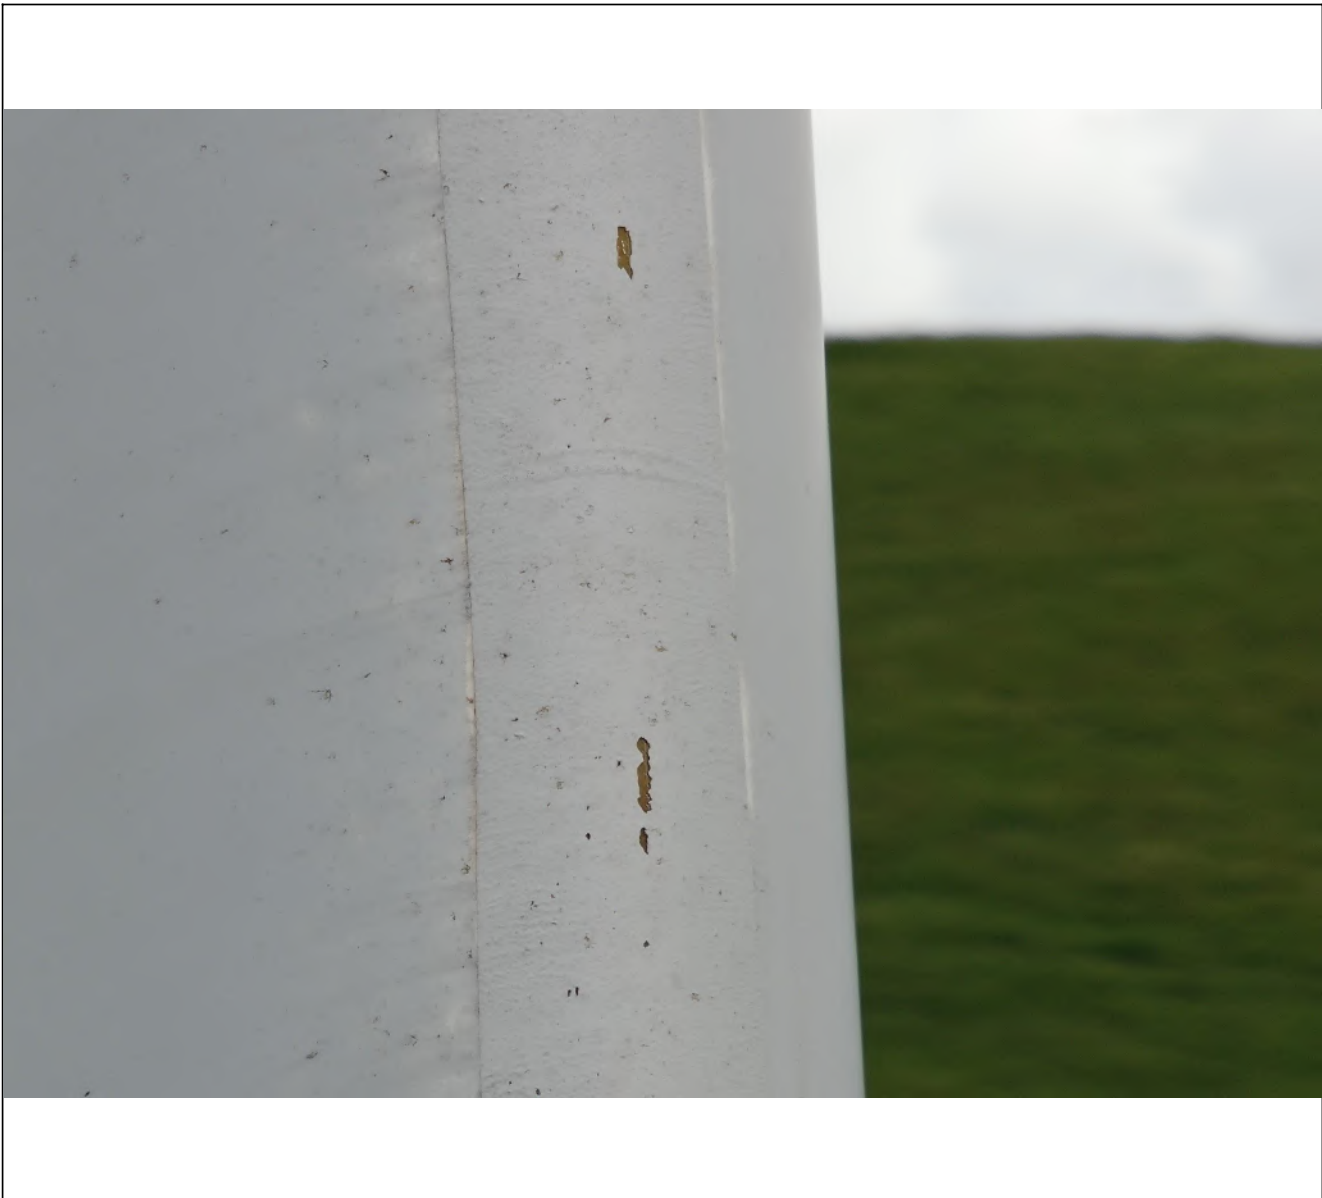
Damage Reference	DN-17	
Damage Category	CAT 2	
Damage Type	Erosion	
Distance From Root (m)	17	
Blade Surface	Leading Edge	
Blade Letter/Number	C	
Blade SN		
Image Ref.		
Description	Gelcoat chipped and laminate exposed

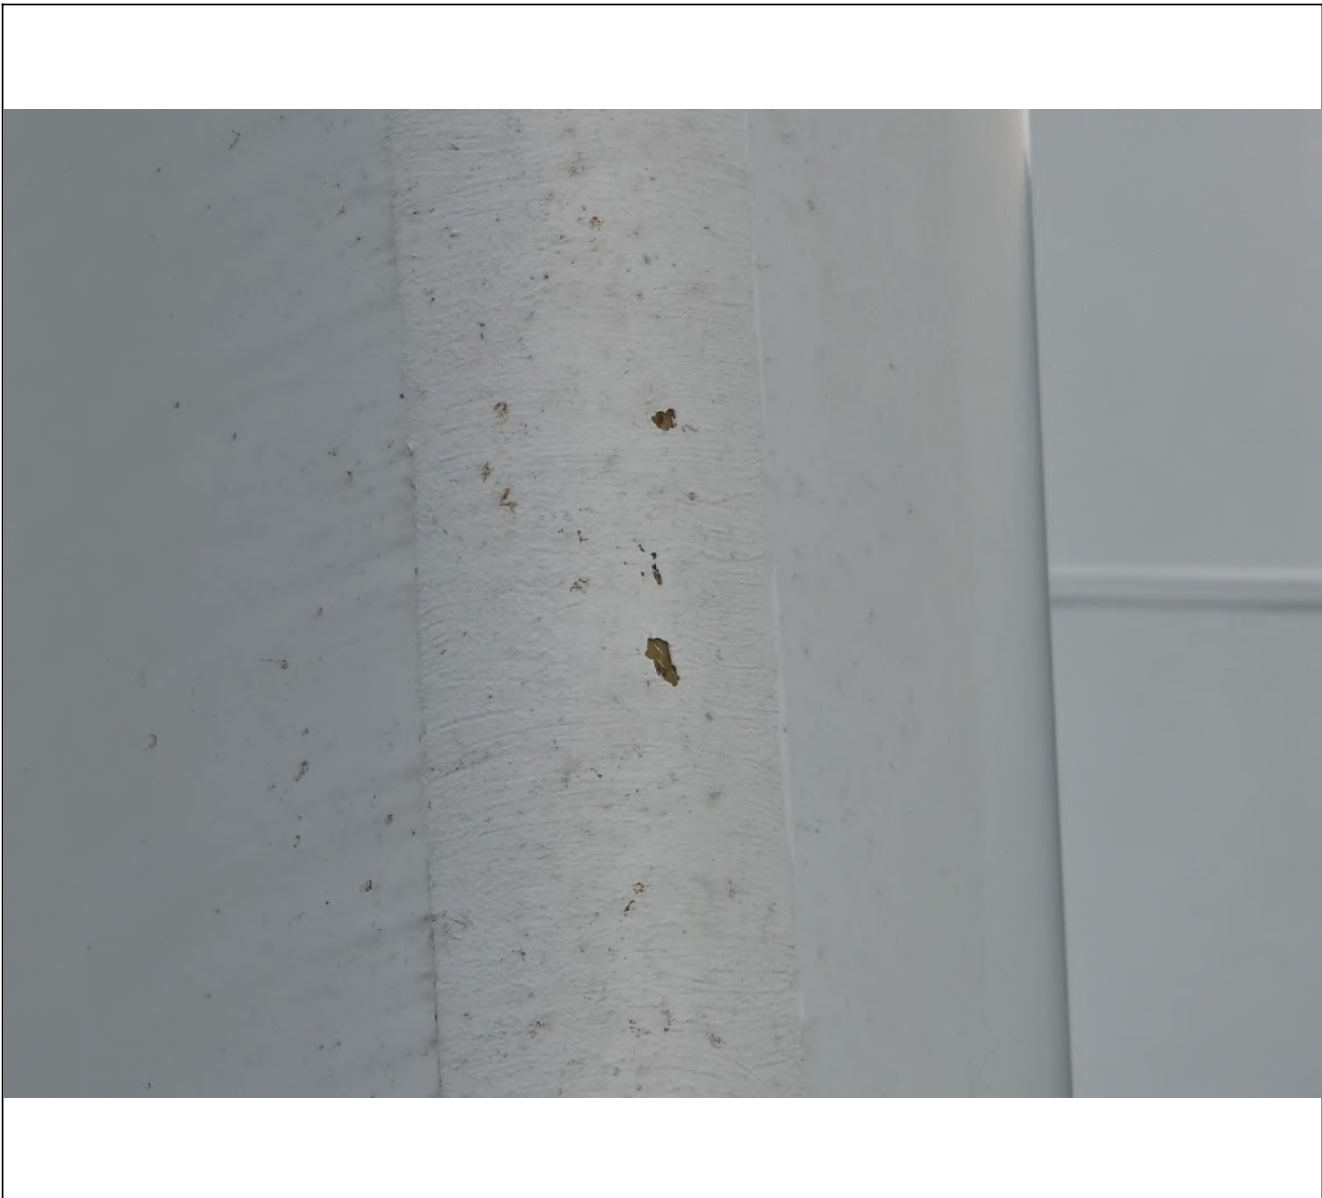
Damage Reference	DN-18	
Damage Category	CAT 2	
Damage Type	Erosion	
Distance From Root (m)	18	
Blade Surface	Leading Edge	
Blade Letter/Number	C	
Blade SN		
Image Ref.		
Description	Gelcoat chipped and laminate exposed

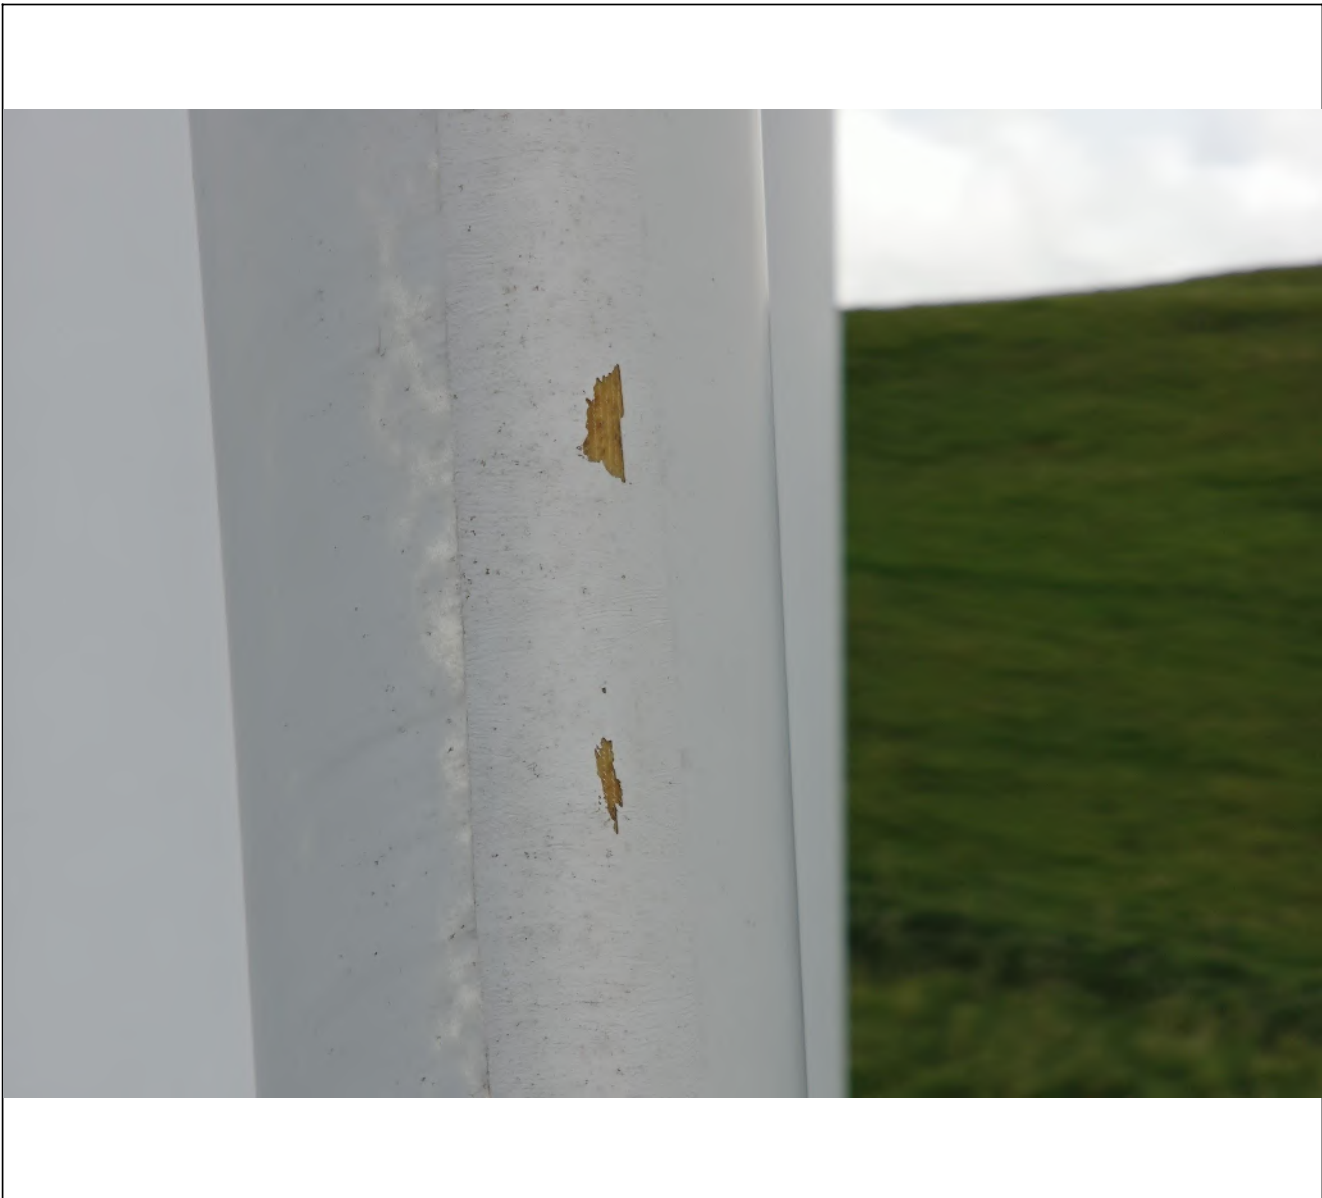
Damage Reference	DN-19	
Damage Category	CAT 2	
Damage Type	Erosion	
Distance From Root (m)	19	
Blade Surface	Leading Edge	
Blade Letter/Number	C	
Blade SN		
Image Ref.		
Description	Gelcoat eroded and laminate exposed

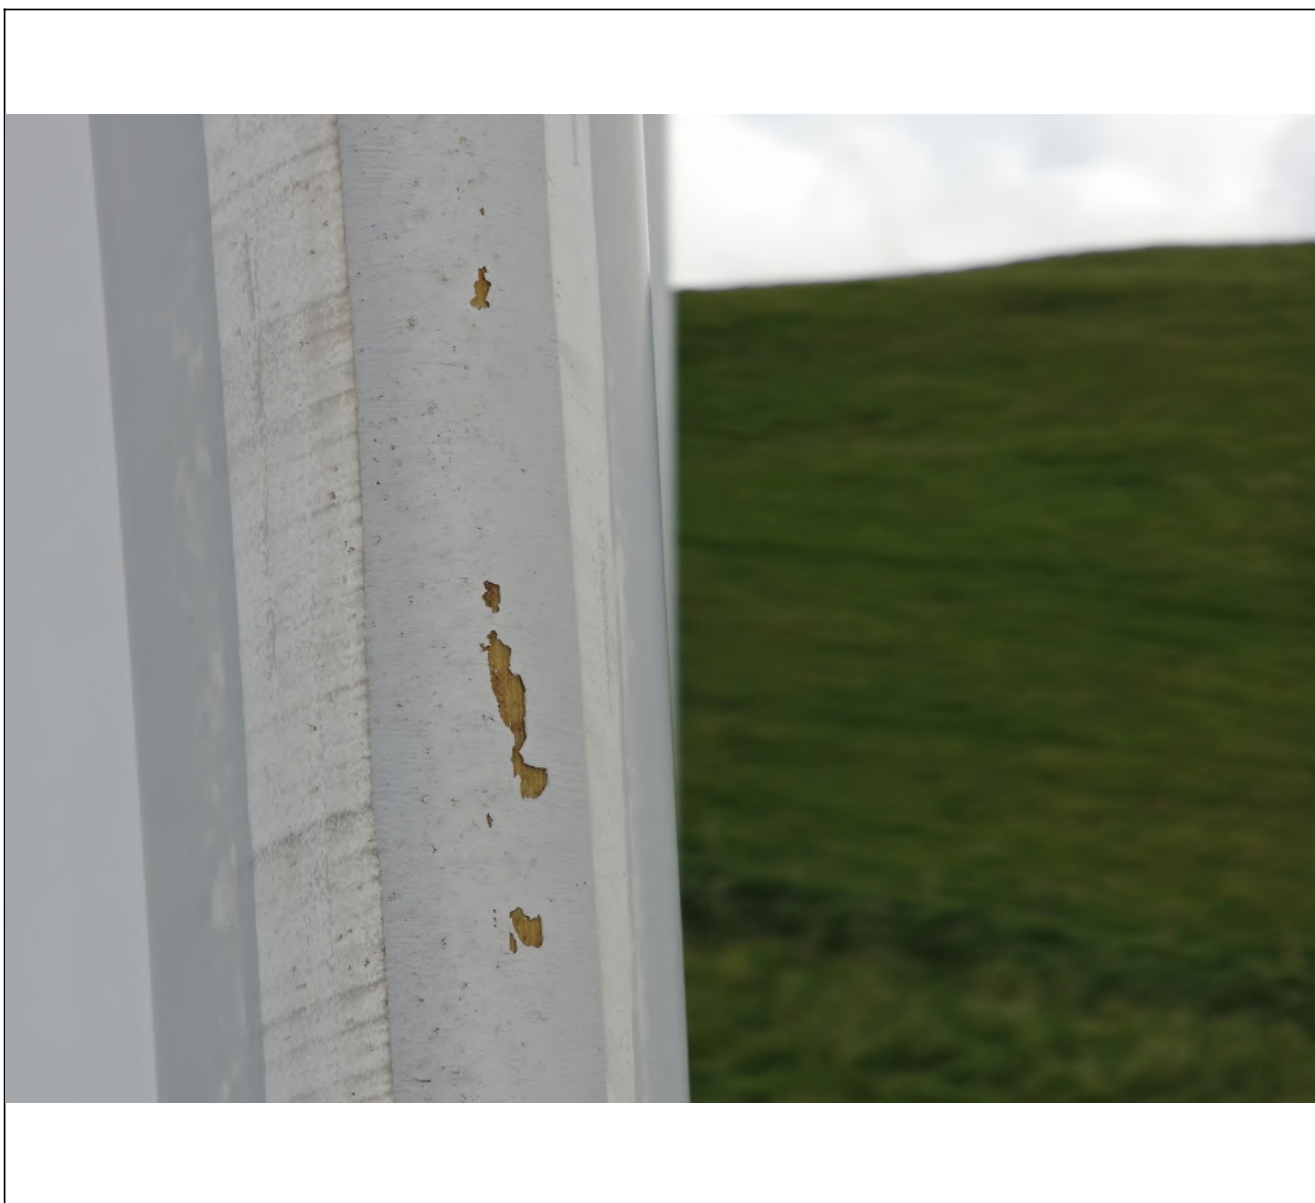
Damage Reference	DN-20	
Damage Category	CAT 2	
Damage Type	Erosion	
Distance From Root (m)	19	
Blade Surface	Leading Edge	
Blade Letter/Number	C	
Blade SN		
Image Ref.		
Description	Gelcoat eroded and laminate exposed

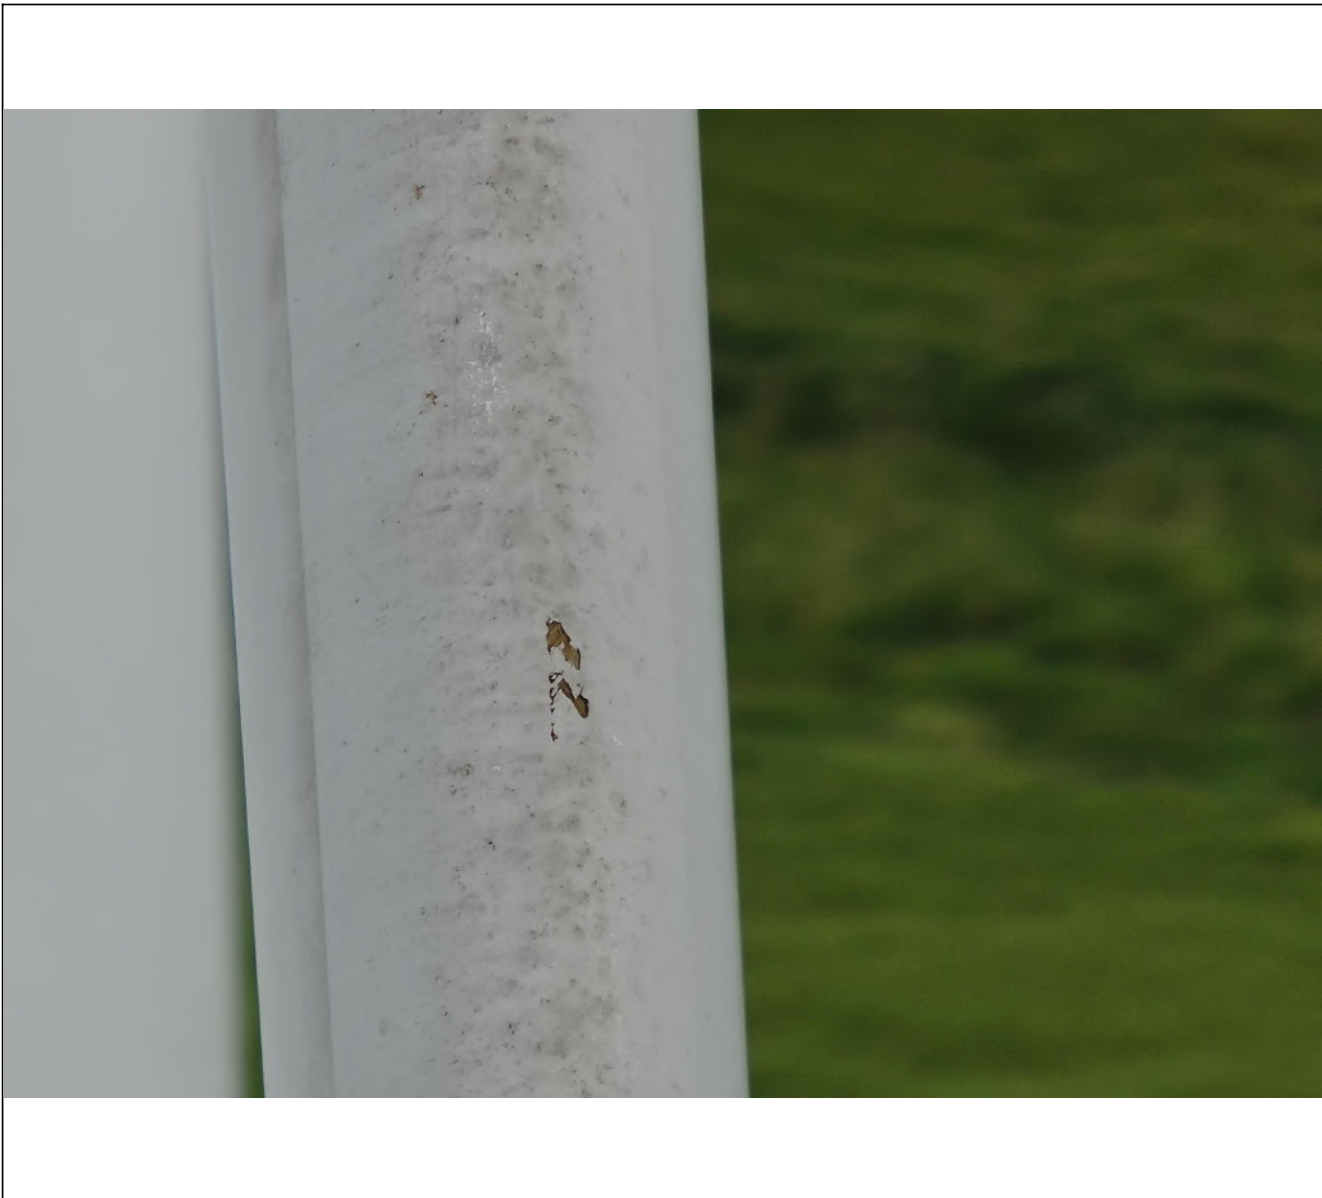
Damage Reference	DN-21	
Damage Category	CAT 2	
Damage Type	Erosion	
Distance From Root (m)	27	
Blade Surface	Leading Edge	
Blade Letter/Number	C	
Blade SN		
Image Ref.		
Description	Gelcoat eroded and laminate exposed

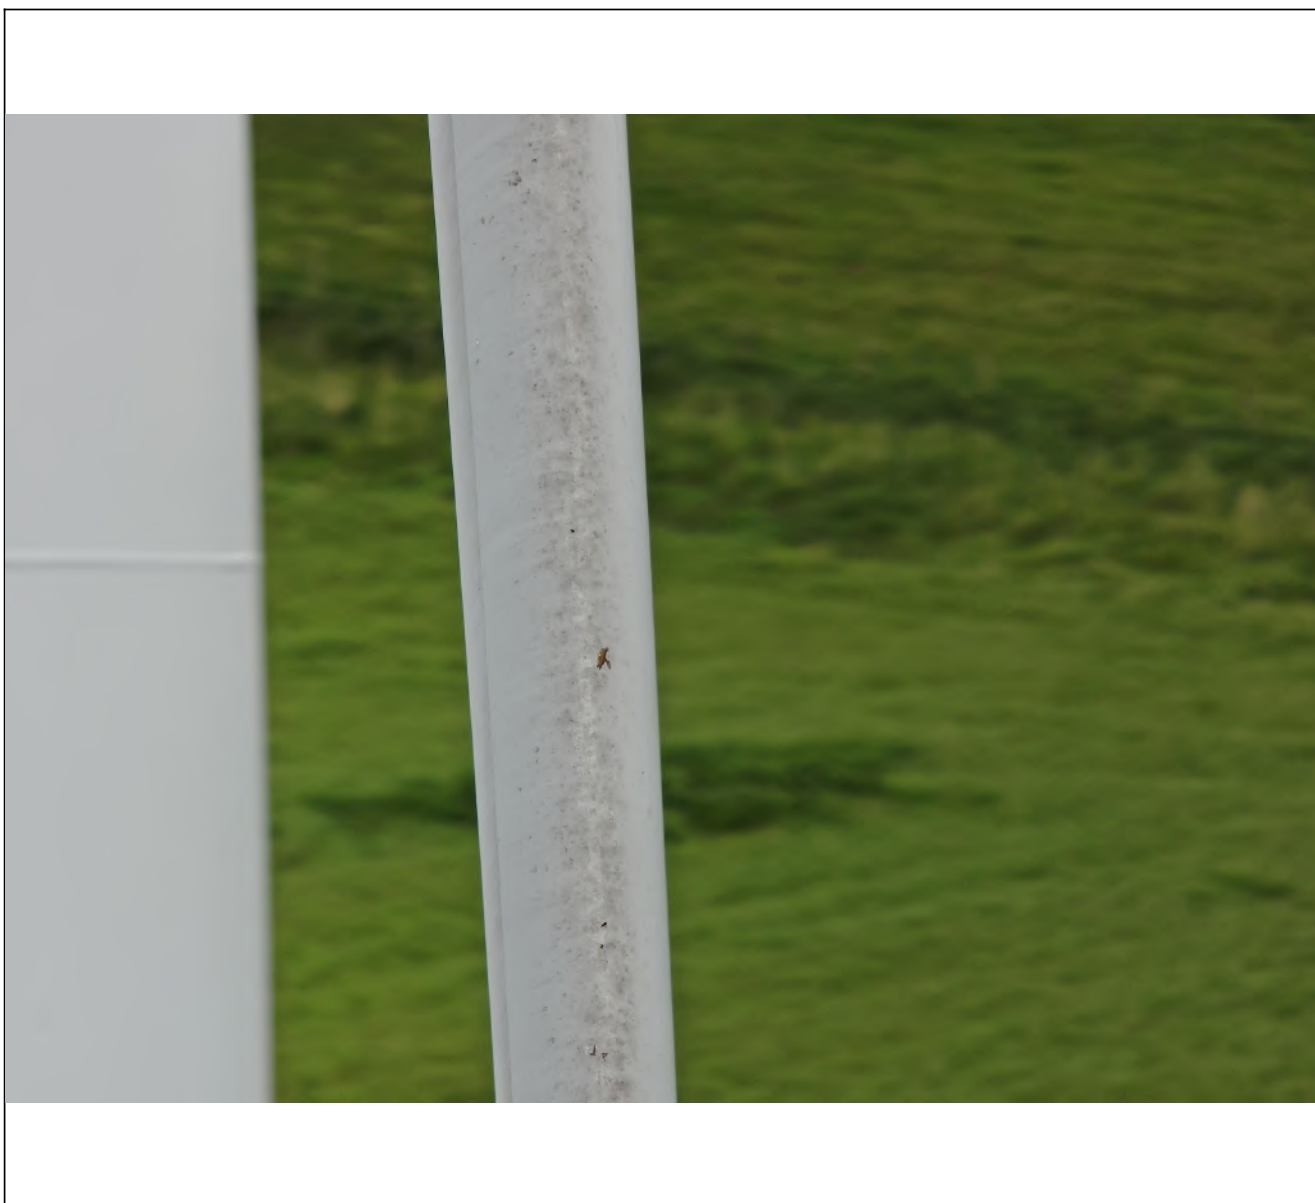
Damage Reference	DN-22	
Damage Category	CAT 2	
Damage Type	Erosion	
Distance From Root (m)	29	
Blade Surface	Leading Edge	
Blade Letter/Number	C	
Blade SN		
Image Ref.		
Description	Gelcoat eroded and laminate exposed

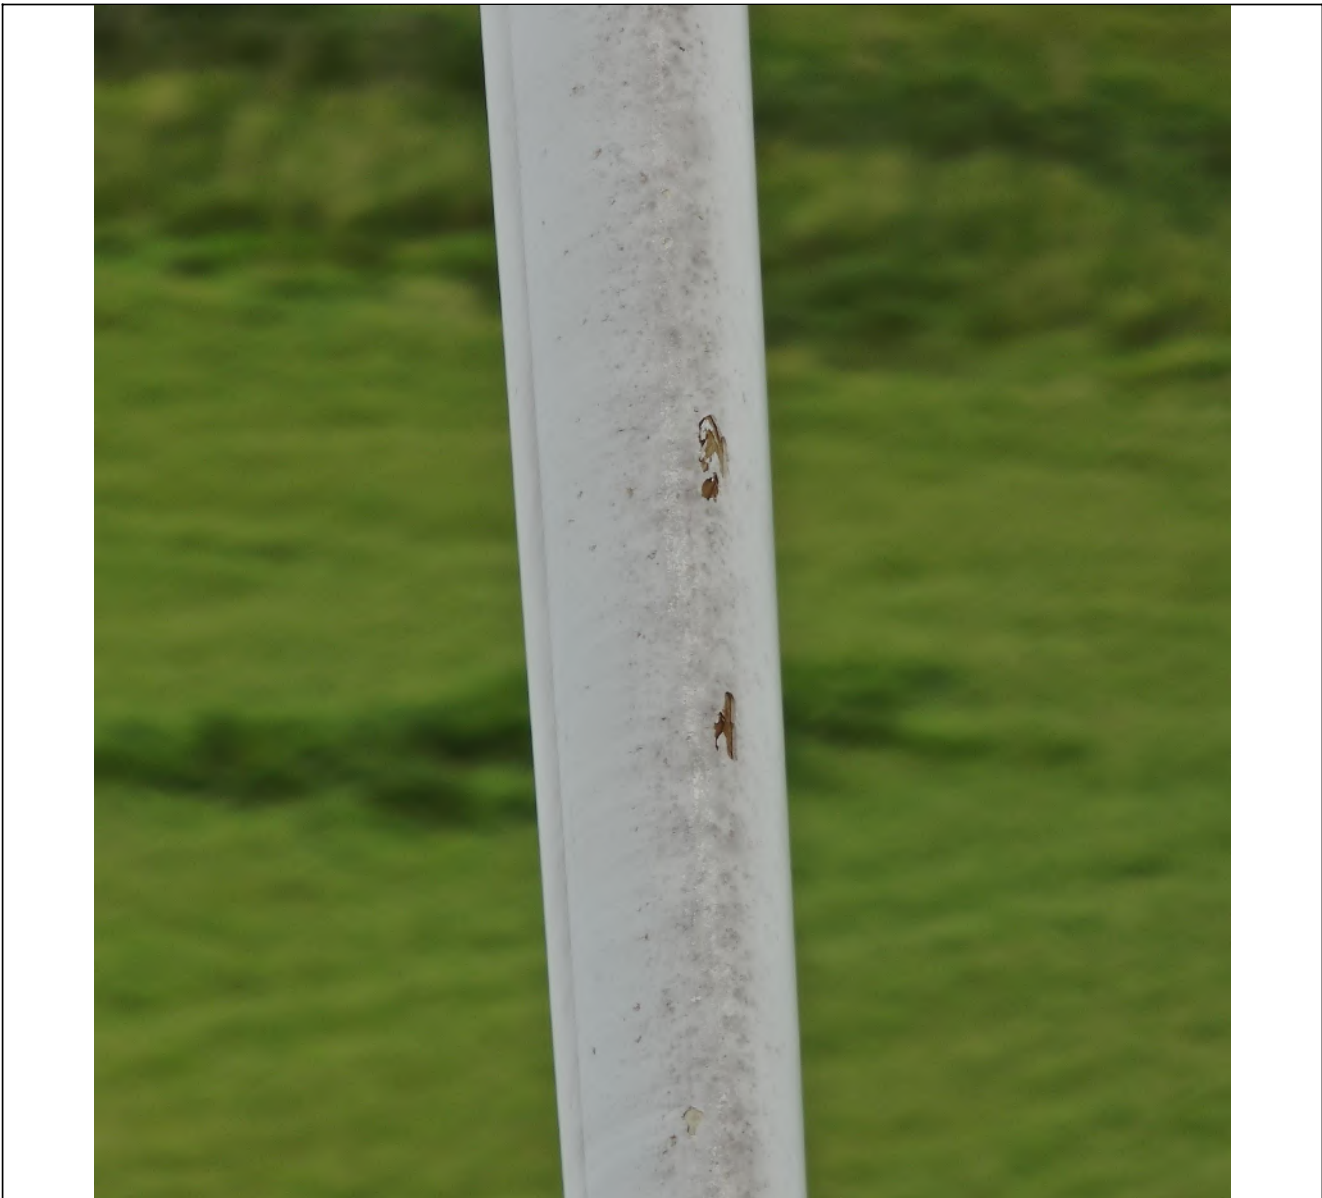
Damage Reference	DN-23	
Damage Category	CAT 2	
Damage Type	Erosion	
Distance From Root (m)	30	
Blade Surface	Leading Edge	
Blade Letter/Number	C	
Blade SN		
Image Ref.		
Description	Gelcoat eroded and laminate exposed

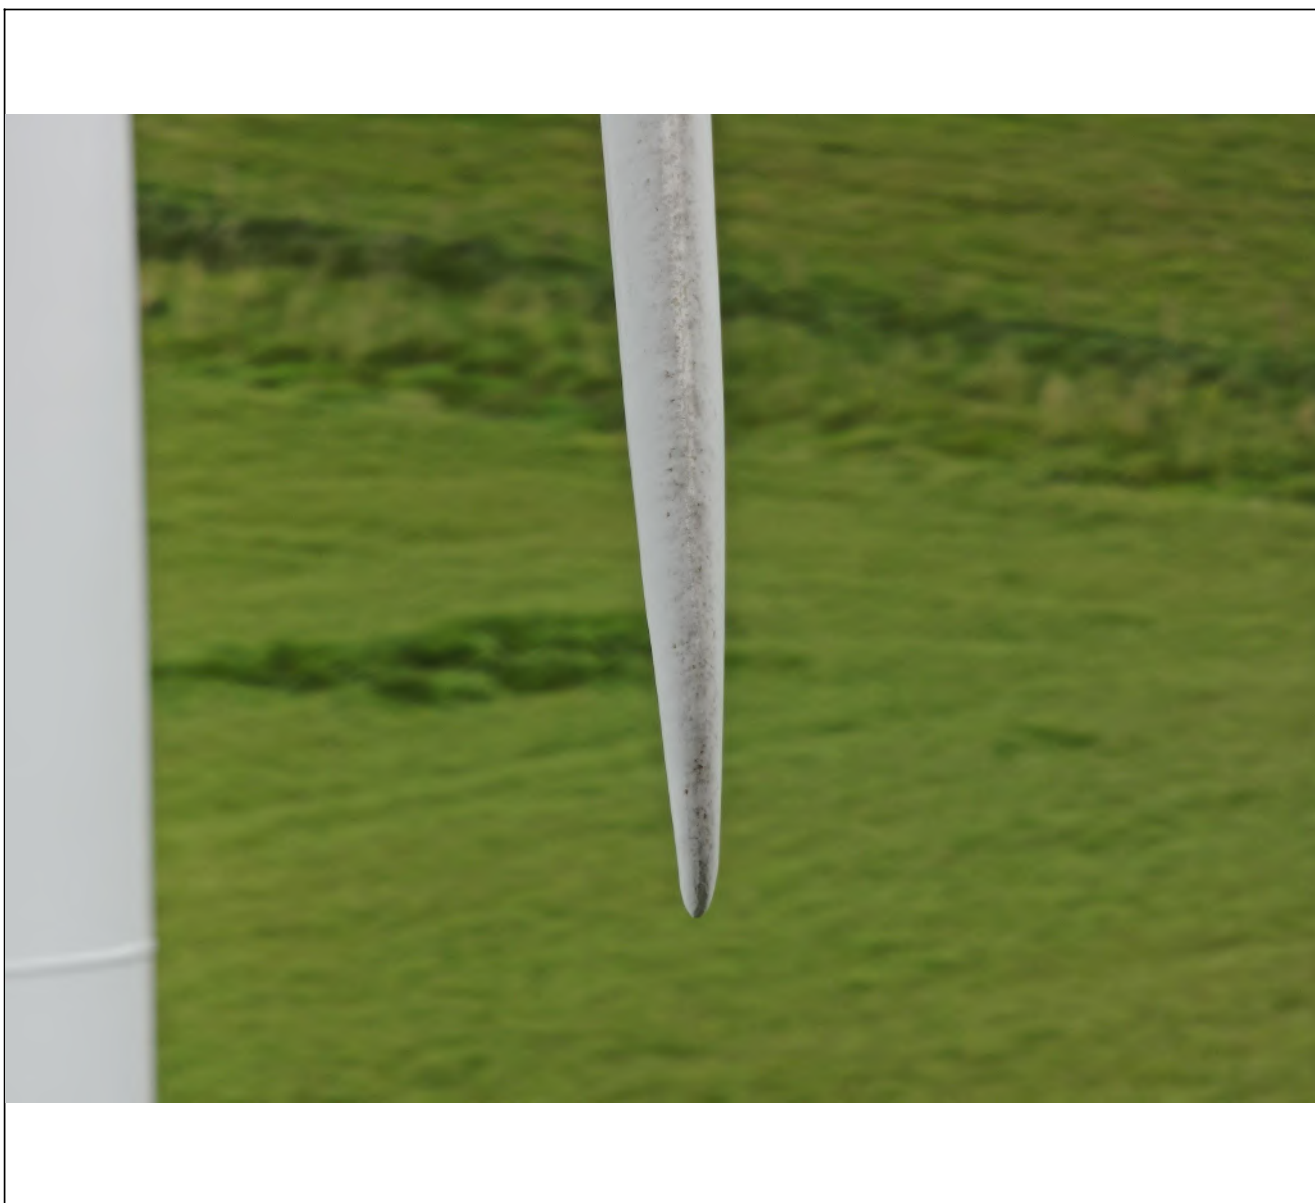
Damage Reference	DN-24	
Damage Category	CAT 2	
Damage Type	Erosion	
Distance From Root (m)	32	
Blade Surface	Leading Edge	
Blade Letter/Number	C	
Blade SN		
Image Ref.		
Description	Erosion to top coat

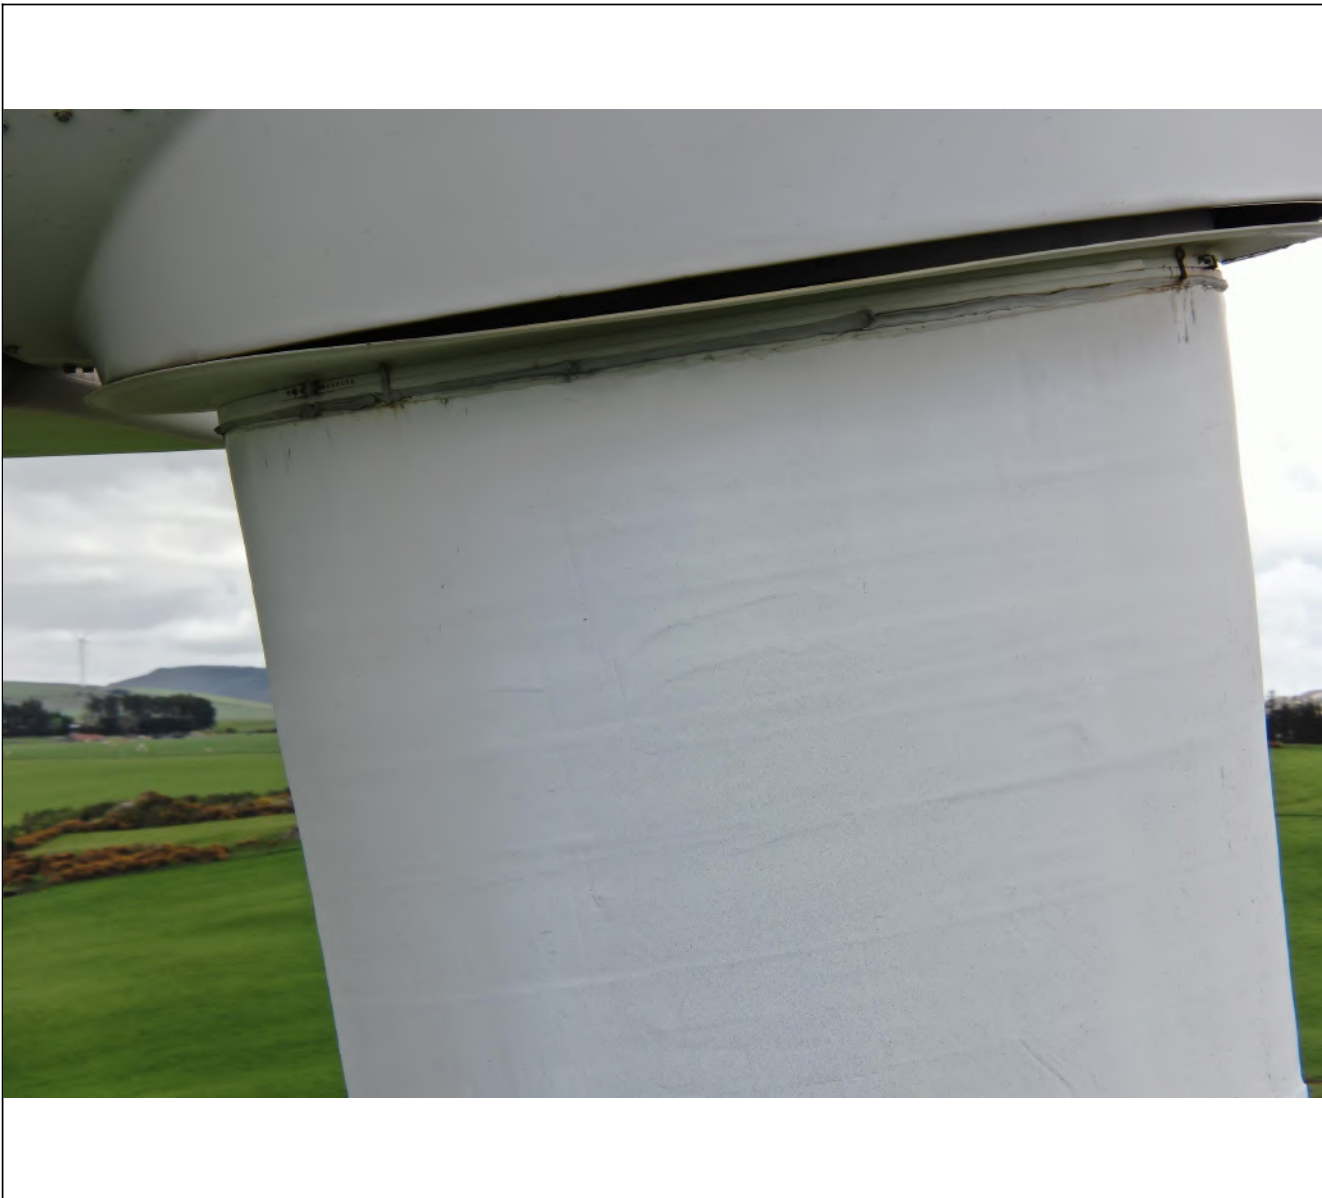
Damage Reference	DN-25	
Damage Category	CAT 2	
Damage Type	Out of alignment	
Distance From Root (m)	0	
Blade Surface	Suction Side	
Blade Letter/Number	C	
Blade SN		
Image Ref.		
Description	Rain deflector not flush with spinner

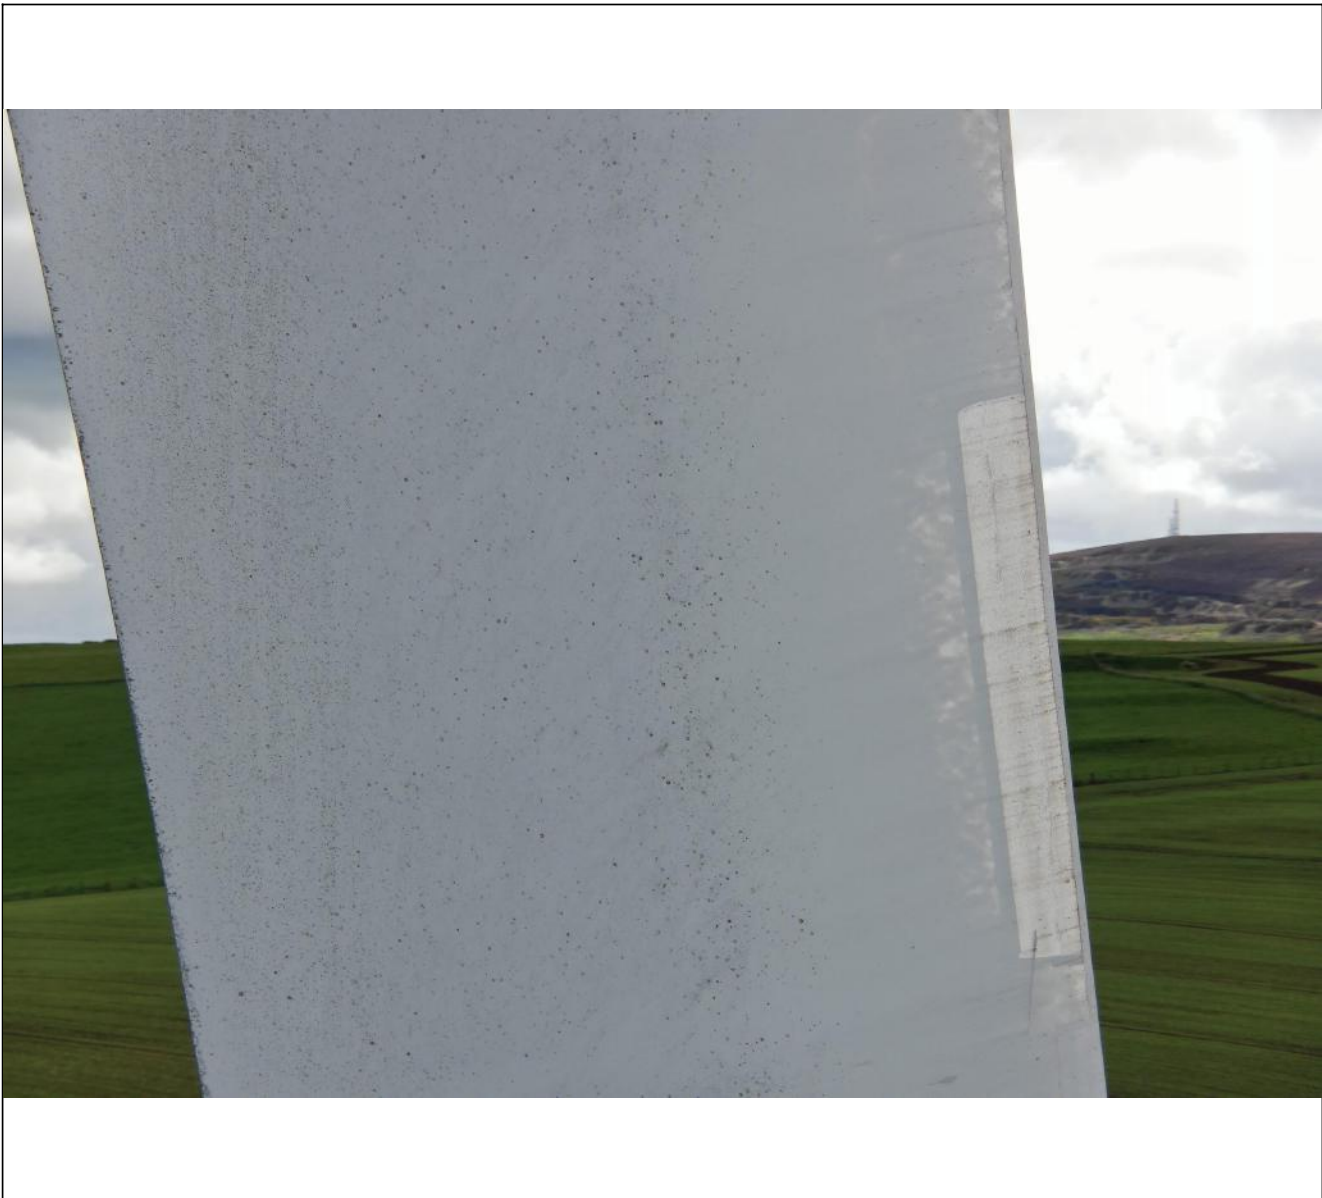
Damage Reference	DN-26	
Damage Category	CAT 1	
Damage Type	General observation	
Distance From Root (m)	20	
Blade Surface	Suction Side	
Blade Letter/Number	C	
Blade SN		
Image Ref.		
Description	Previous repair. Top coat eroding

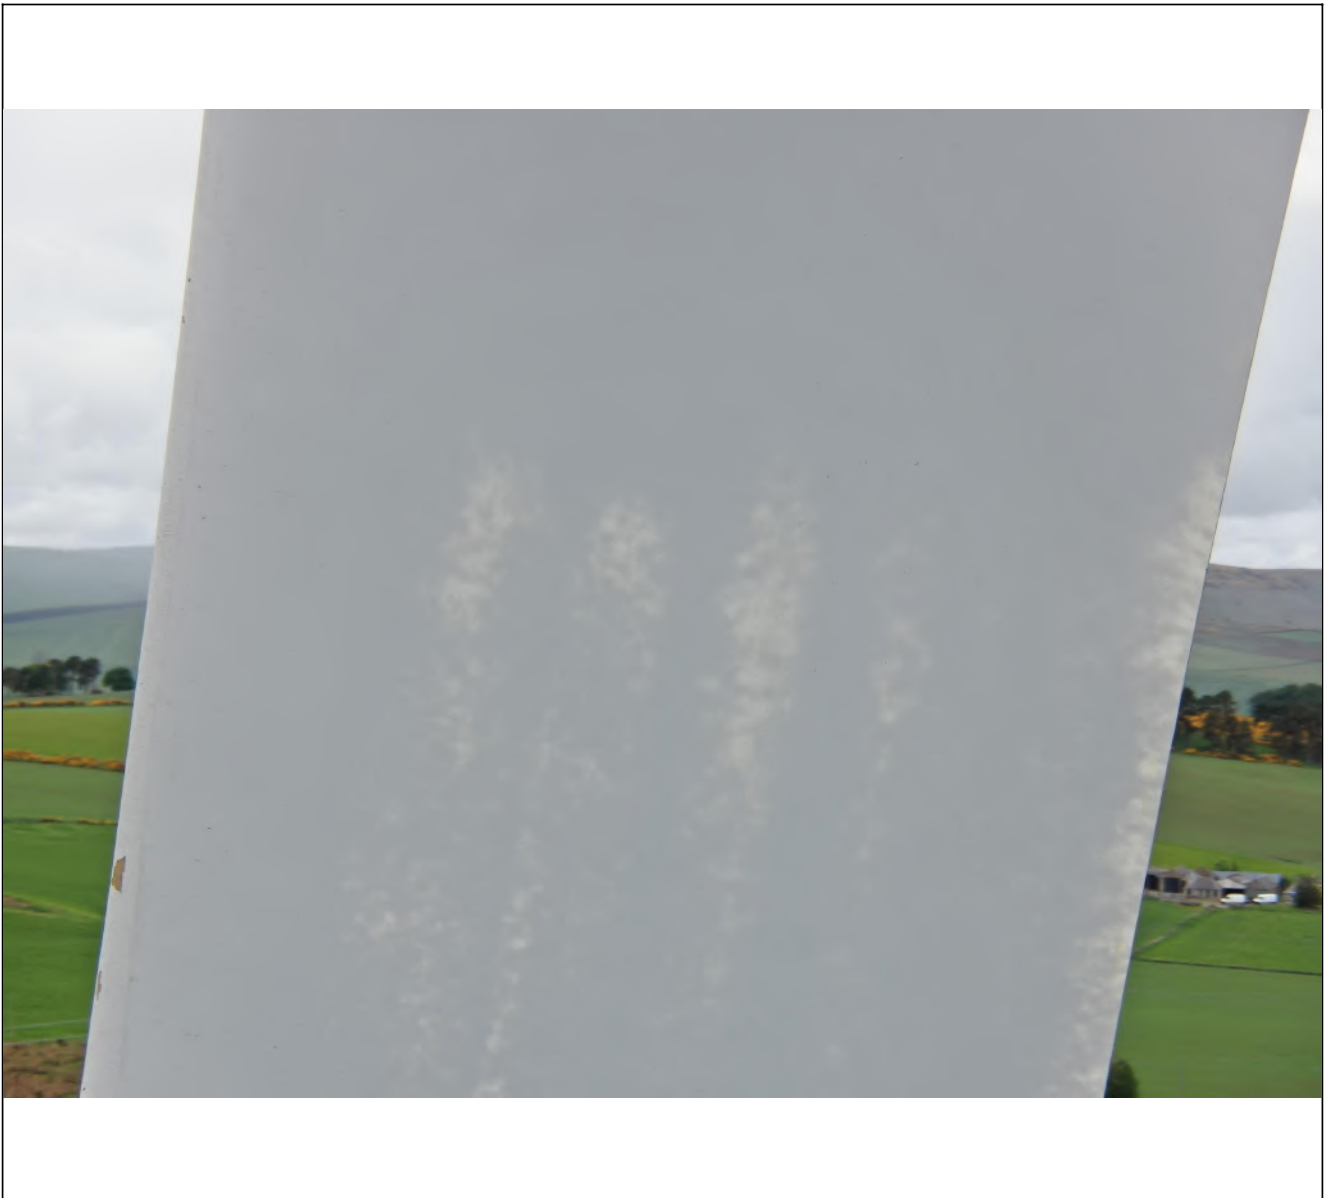
Damage Reference	DN-27	<p>The diagram shows two views of a wind turbine blade. The top view is labeled 'Pressure Side' and the bottom view is labeled 'Suction Side'. Both views show the 'Leading Edge' on the left and the 'Trailing Edge' on the right. A red circle is drawn on the trailing edge of the pressure side, indicating the location of the damage.</p>
Damage Category	CAT 2	
Damage Type	Erosion	
Distance From Root (m)	18	
Blade Surface	Pressure Side	
Blade Letter/Number	C	
Blade SN		
Image Ref.		
Description	Top coat eroded
