## Wind Turbine Blade Inspection Report

### T02

**Report Number:** MECHV-REP-XXX-XXX

**Asset:** T02 - 25035 - Vestas V66

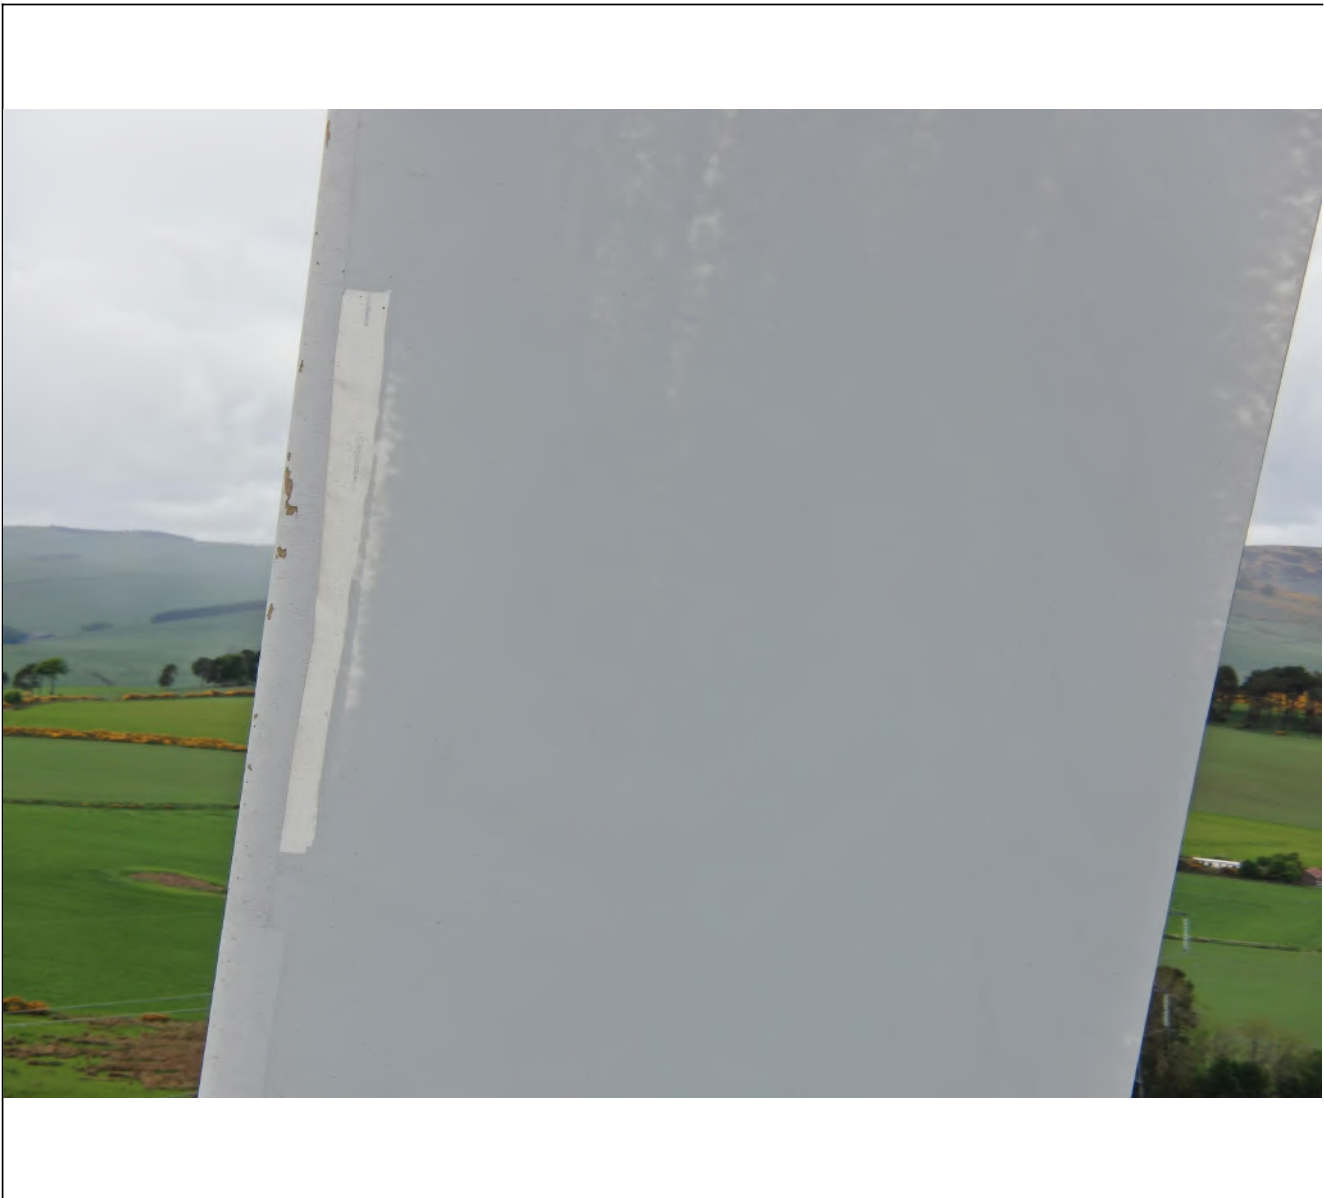
Damage Reference	DN-28	
Damage Category	CAT 2	
Damage Type	Erosion	
Distance From Root (m)	20	
Blade Surface	Pressure Side	
Blade Letter/Number	C	
Blade SN		
Image Ref.		
Description	Previous repair - Top coat eroded

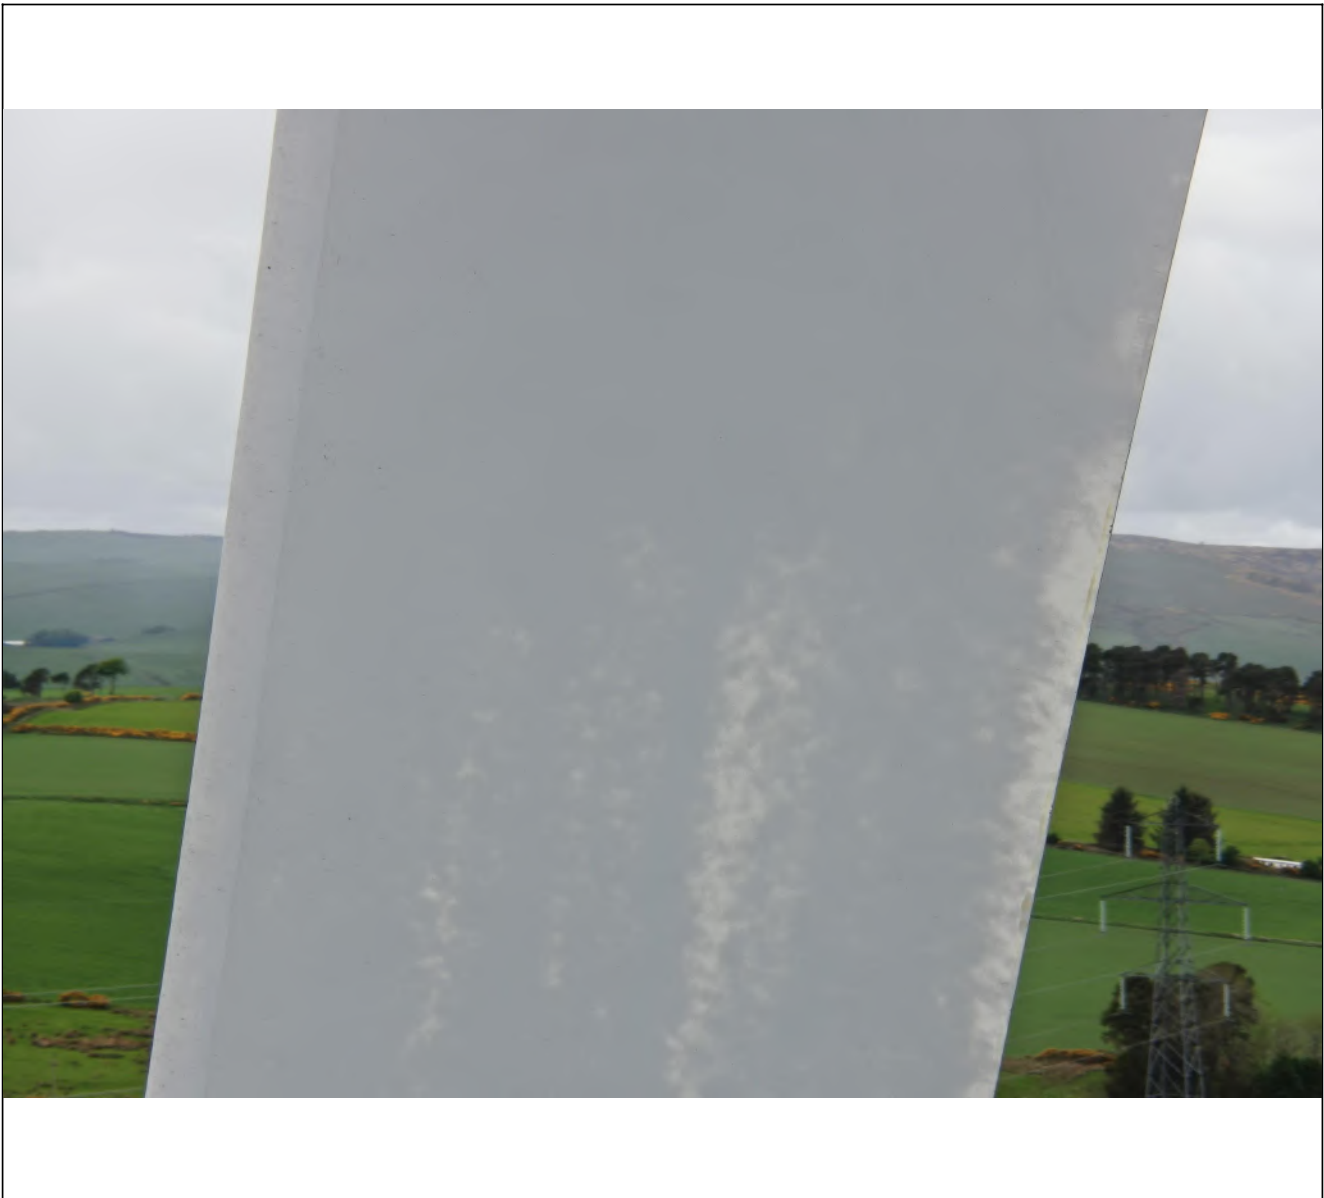
Damage Reference	DN-29	
Damage Category	CAT 2	
Damage Type	Erosion	
Distance From Root (m)	21	
Blade Surface	Pressure Side	
Blade Letter/Number	C	
Blade SN		
Image Ref.		
Description	Top coat eroded

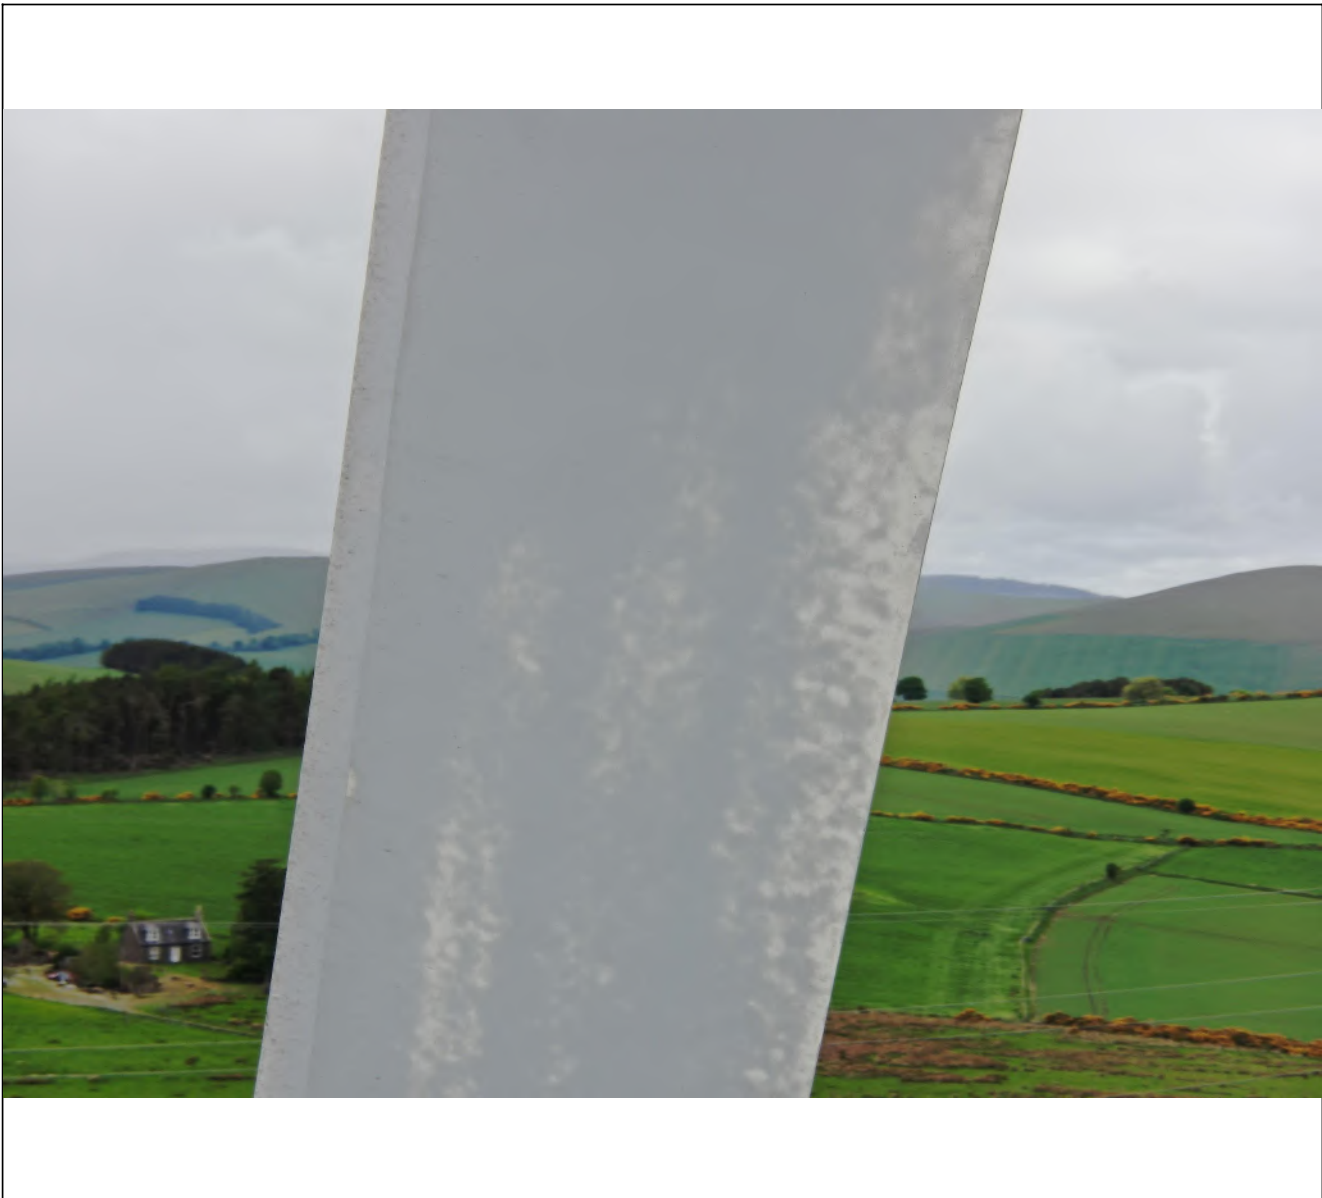
Damage Reference	DN-30	
Damage Category	CAT 2	
Damage Type	Erosion	
Distance From Root (m)	27	
Blade Surface	Pressure Side	
Blade Letter/Number	C	
Blade SN		
Image Ref.		
Description	Top coat eroded

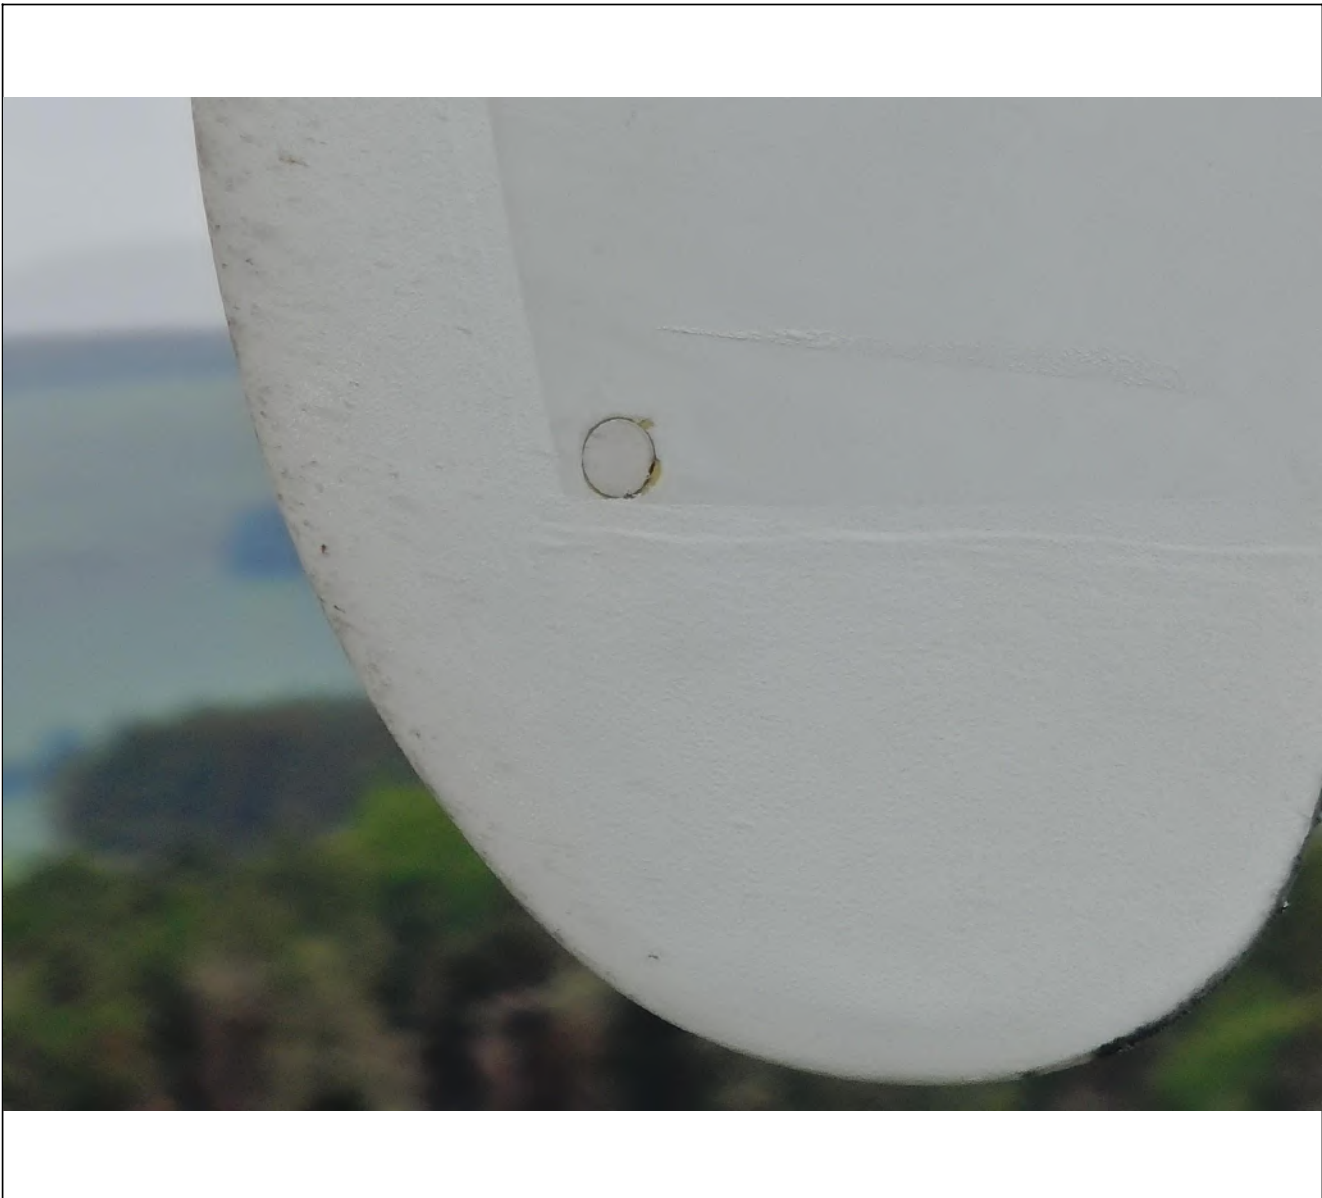
Damage Reference	DN-31	
Damage Category	CAT 2	
Damage Type	Chipping	
Distance From Root (m)	32	
Blade Surface	Pressure Side	
Blade Letter/Number	C	
Blade SN		
Image Ref.		
Description	Minor gelcoat chipping around the lightning receptor
