Wind Turbine Blade Inspection Report

Example Wind Farm

T07

Asset: T07 - 25040 - Vestas V66

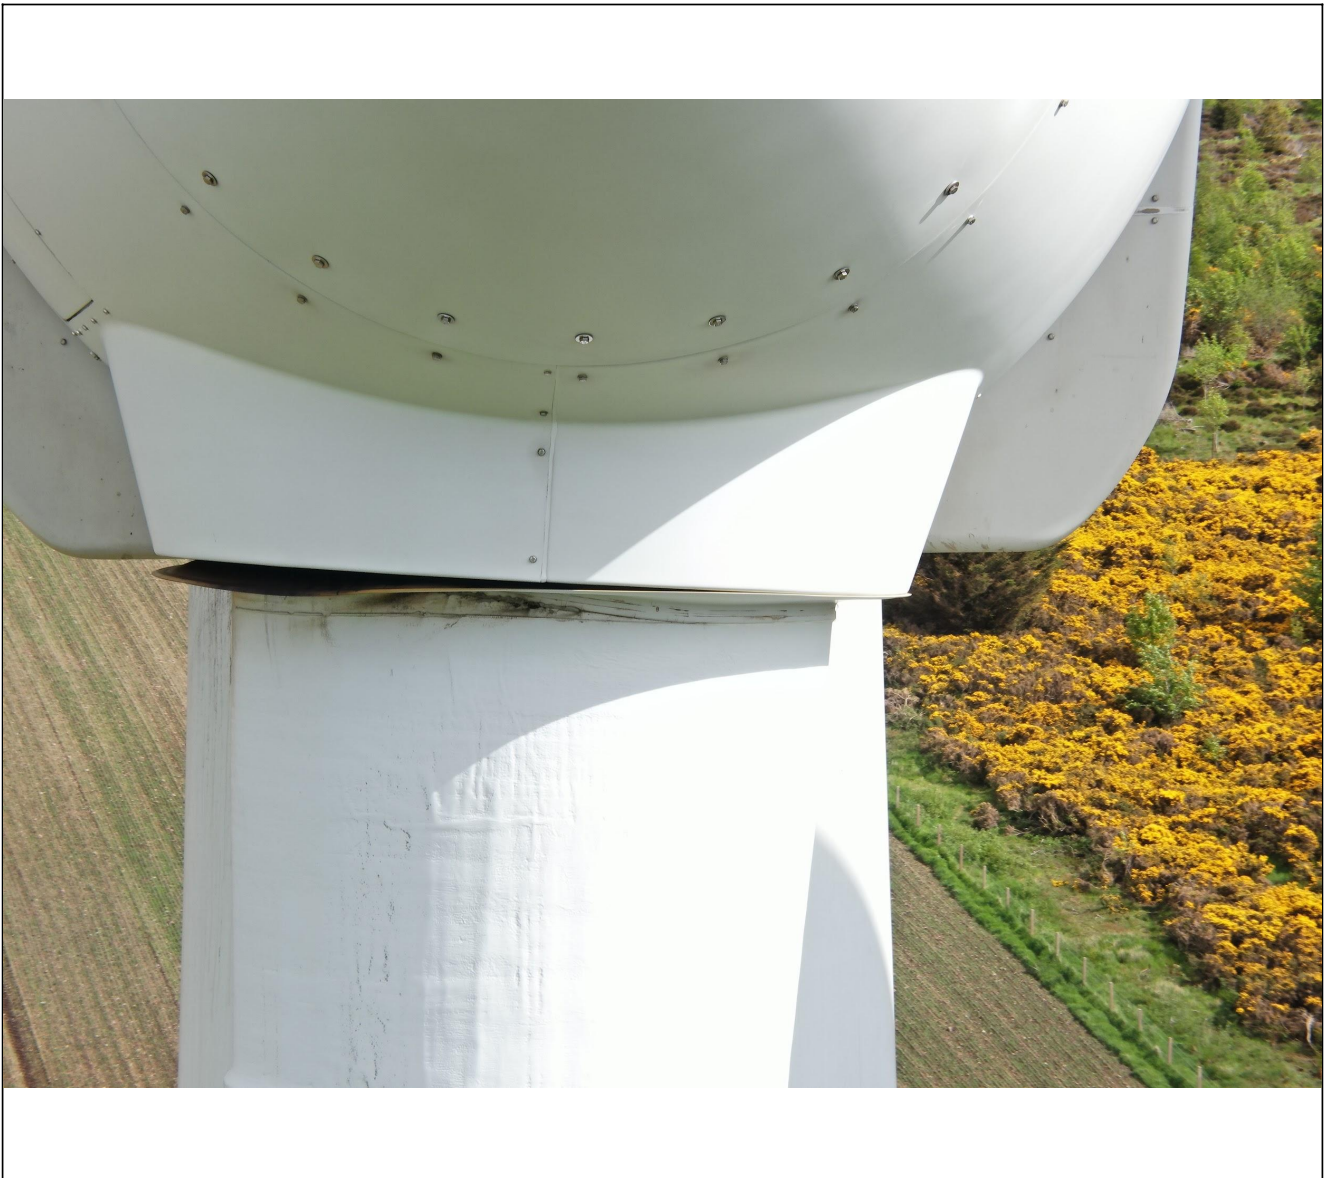
Damage Reference	DN-01	
Damage Category	CAT 2	
Damage Type	Out of alignment	
Distance From Root (m)	0	
Blade Surface	Leading Edge	
Blade Letter/Number	A	
Blade SN		
Image Ref.		
Description	Rain deflector not flush with spinner

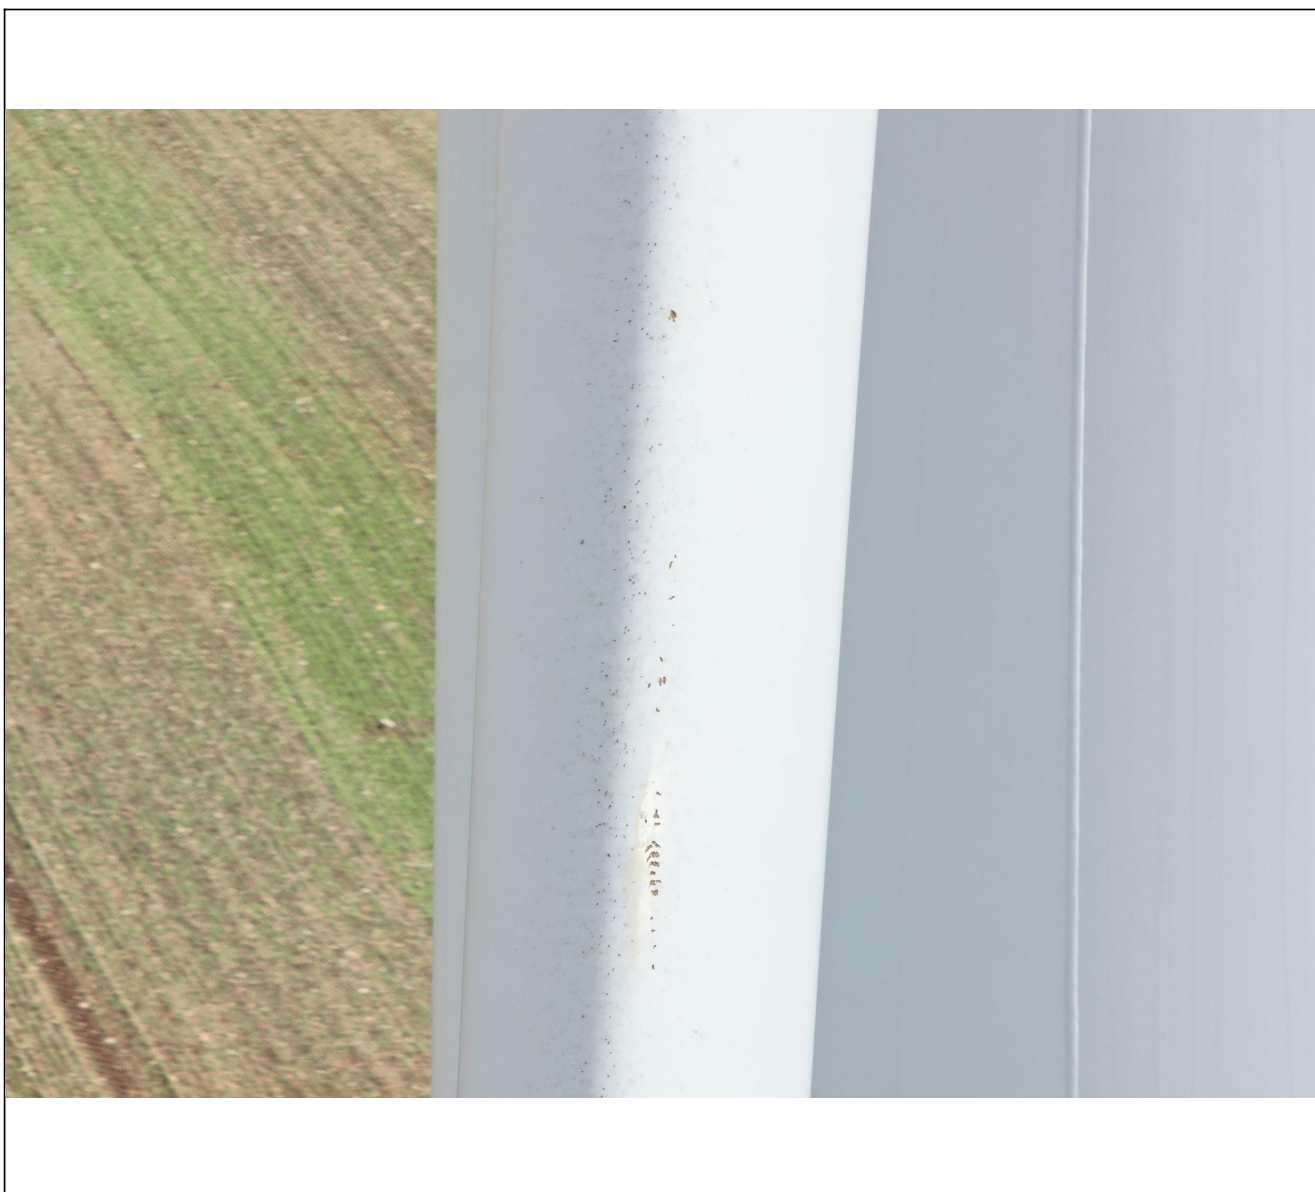
Damage Reference	DN-02	<p>The diagram shows two views of a wind turbine blade. The top view is labeled 'Pressure Side' and the bottom view is labeled 'Suction Side'. Both views show the 'Trailing Edge' and 'Leading Edge'. A red circle on the suction side view highlights a specific location on the leading edge.</p>
Damage Category	CAT 2	
Damage Type	Chipping	
Distance From Root (m)	18	
Blade Surface	Leading Edge	
Blade Letter/Number	A	
Blade SN		
Image Ref.		
Description	Chipping on leading edge. Topcoat chipped and laminate is exposed.

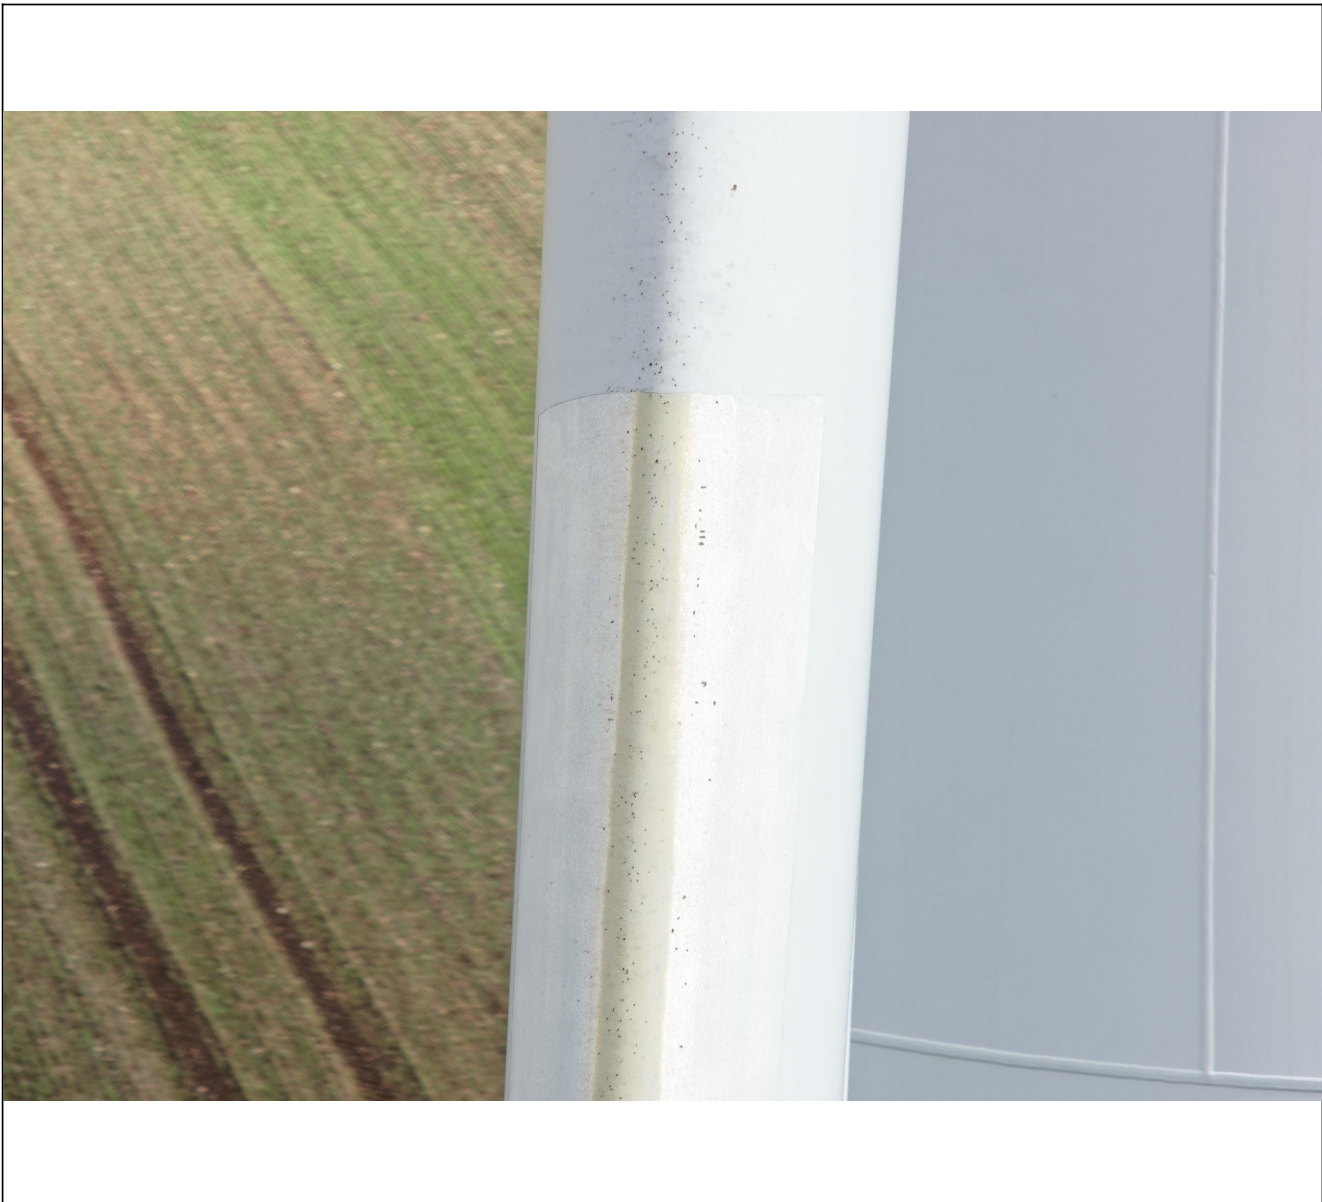
Damage Reference	DN-03	
Damage Category	CAT 2	
Damage Type	General observation	
Distance From Root (m)	19	
Blade Surface	Leading Edge	
Blade Letter/Number	A	
Blade SN		
Image Ref.		
Description	Previous repair - satisfactory

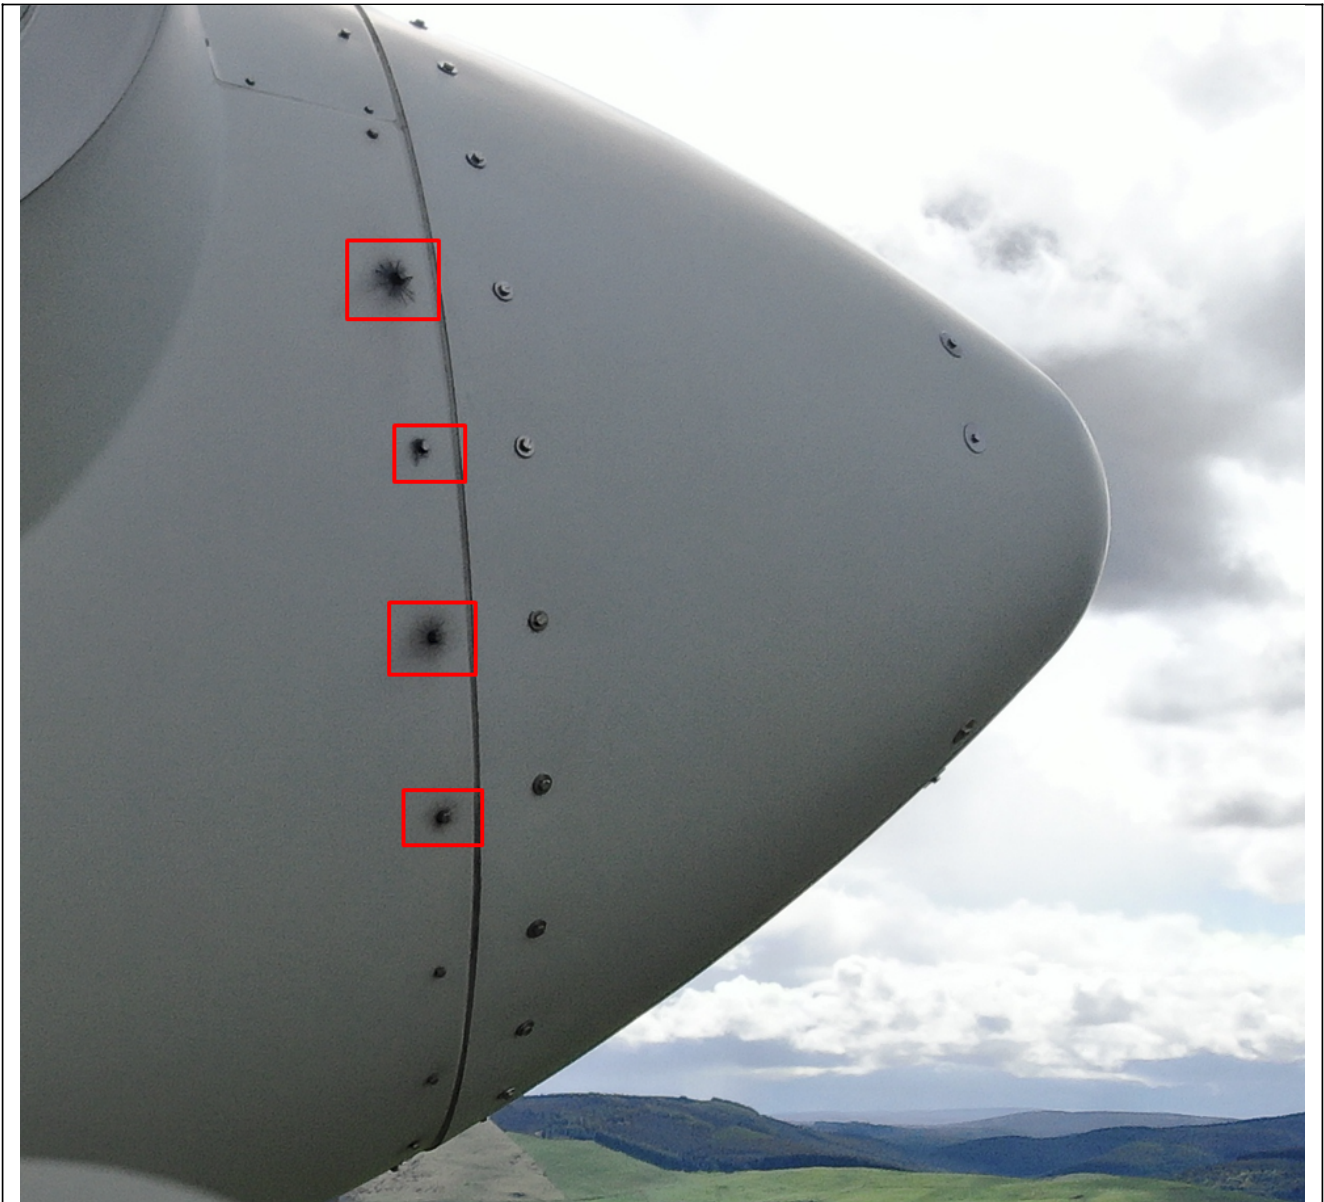
DN-04 / DN-24 / DN-30 / DN-33 : Some fasteners on the spinner are loose and are fretting.

Damage Reference	DN-04	
Damage Category	CAT 3	
Damage Type	Loose Fastener	
Distance From Root (m)	0	
Blade Surface	Suction Side	
Blade Letter/Number	A	
Blade SN		
Image Ref.		
Description	Loose fasteners on hub damaging underlying laminate

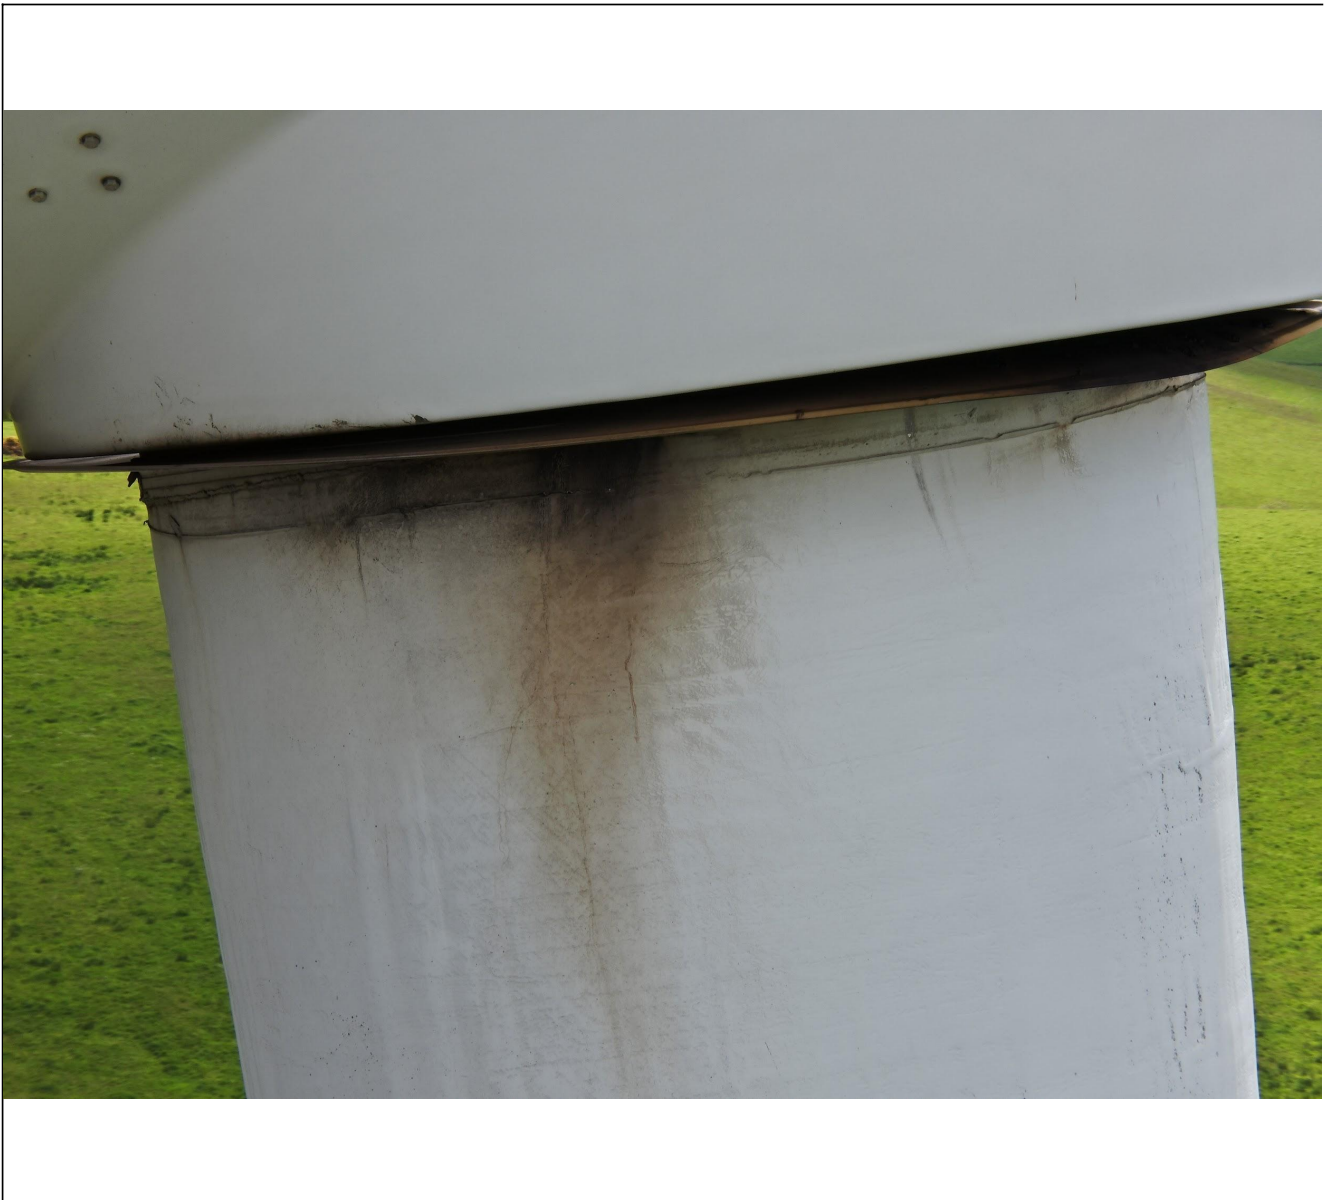
Damage Reference	DN-05	
Damage Category	CAT 2	
Damage Type	Contamination	
Distance From Root (m)	0	
Blade Surface	Suction Side	
Blade Letter/Number	A	
Blade SN		
Image Ref.		
Description	Grease stains on blade.

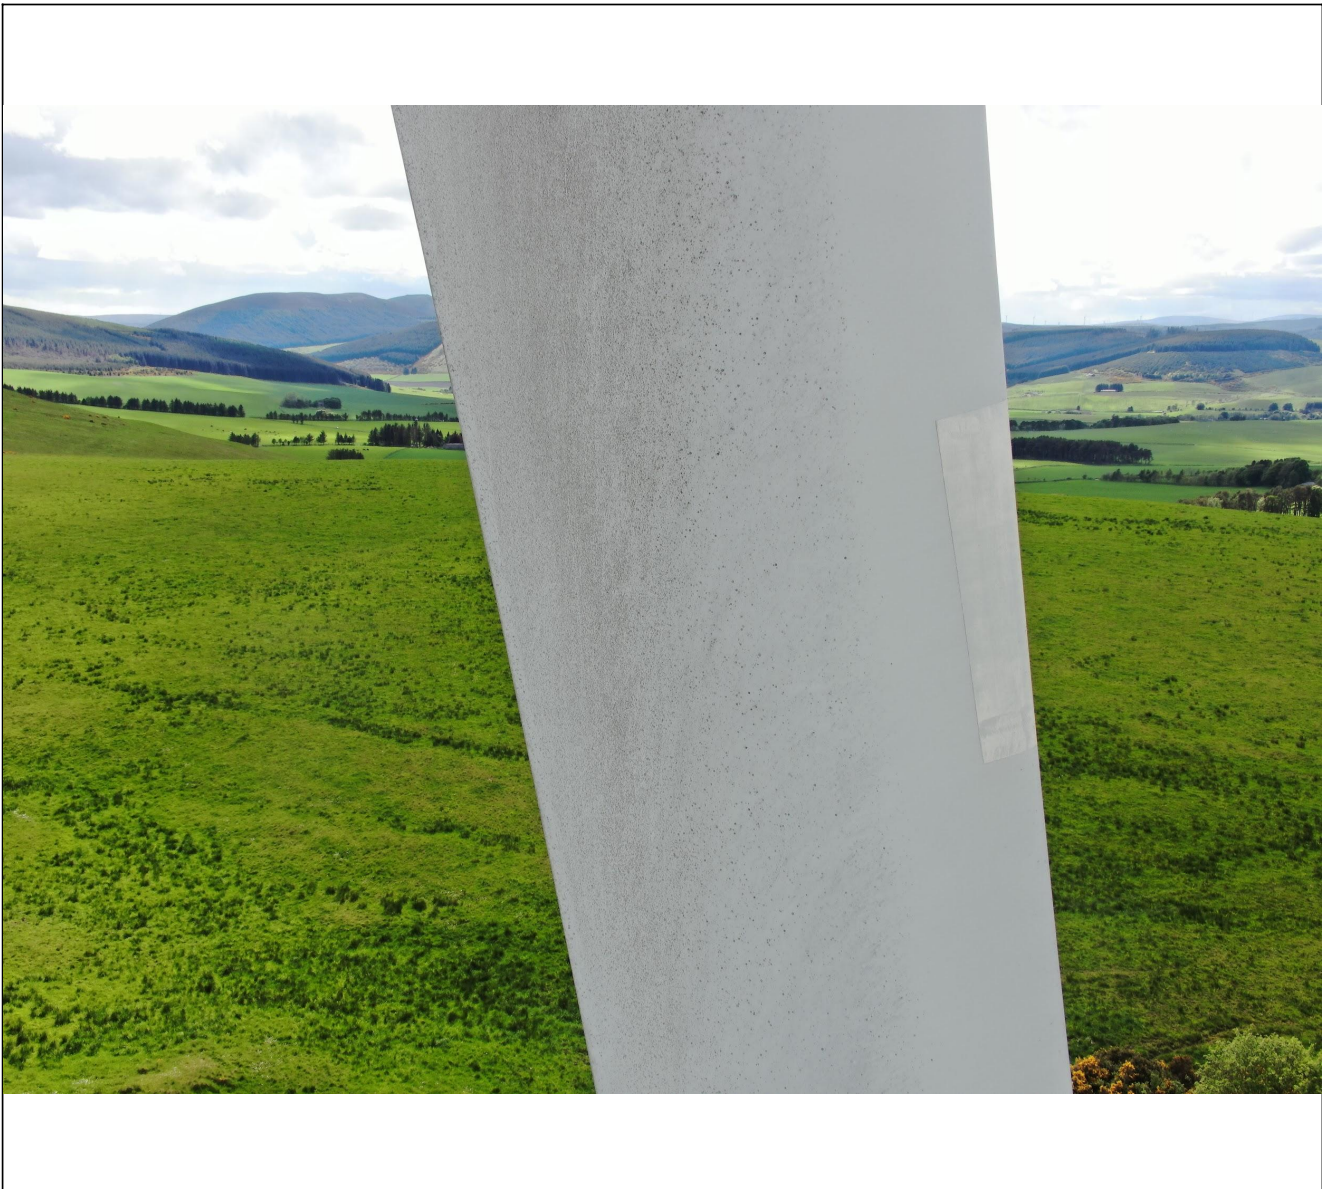
Damage Reference	DN-06	
Damage Category	CAT 1	
Damage Type	General observation	
Distance From Root (m)	20	
Blade Surface	Suction Side	
Blade Letter/Number	A	
Blade SN		
Image Ref.		
Description	Previous repair - Satisfactory

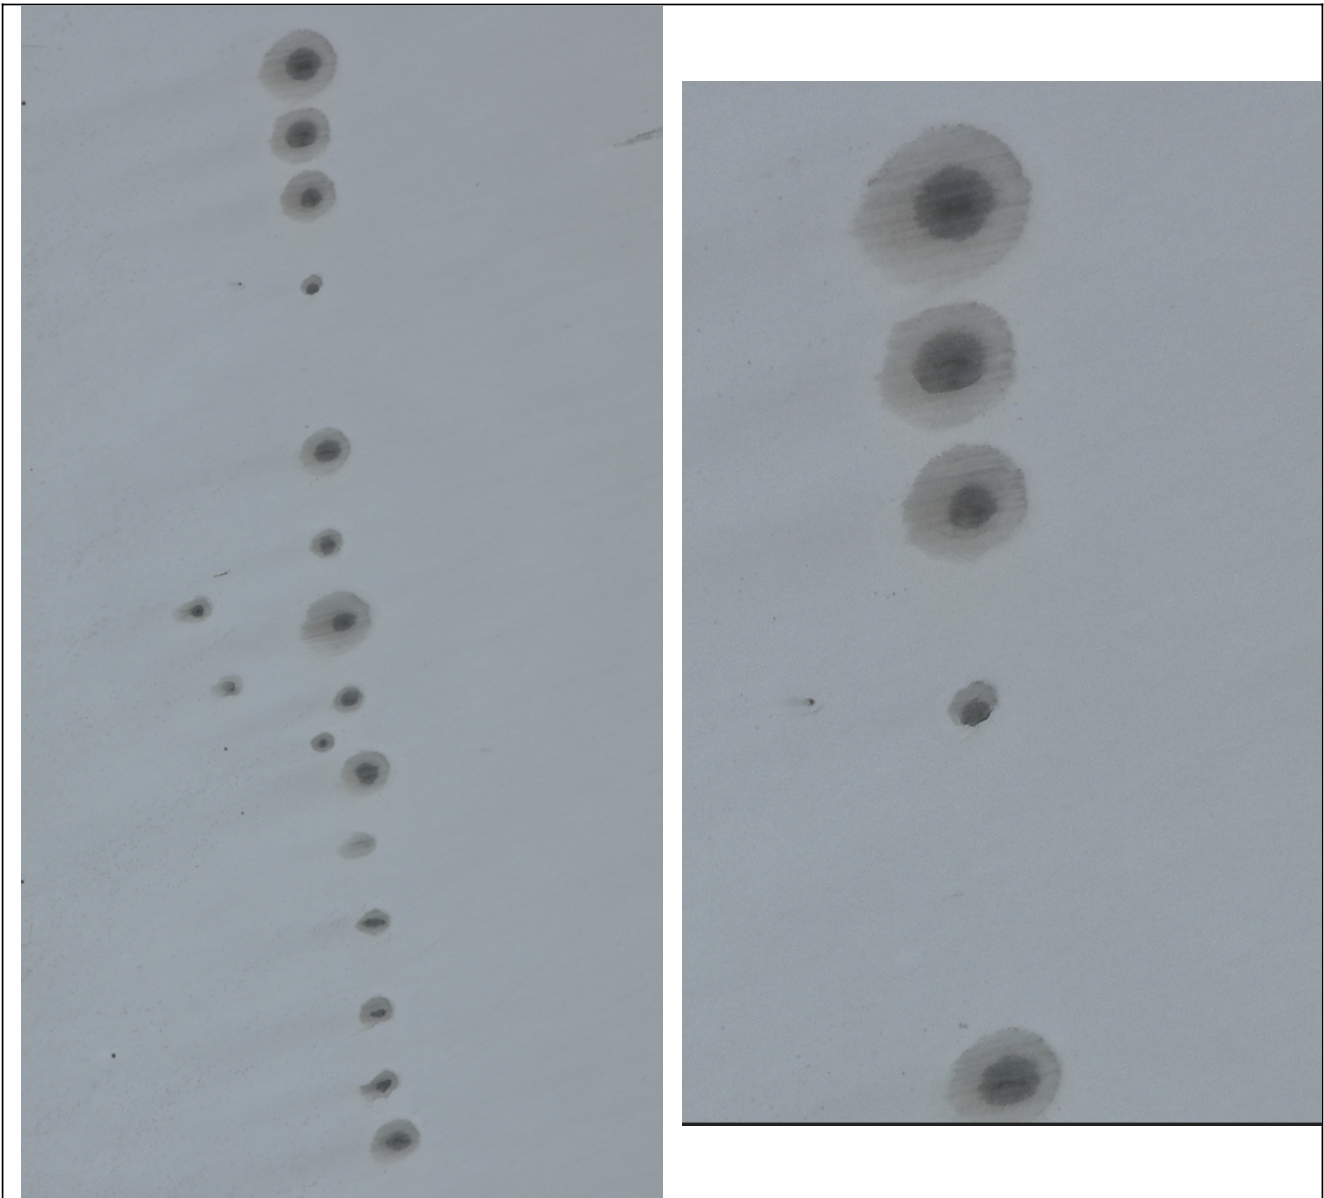
DN-07 / DN-08 / DN-10 / DN-34 / DN-37 / DN-38 : Apparent "drill and fill" repairs along the blade spar line. Noted for information.

Damage Reference	DN-07	
Damage Category	CAT 2	
Damage Type	Contamination	
Distance From Root (m)	27	
Blade Surface	Suction Side	
Blade Letter/Number	A	
Blade SN		
Image Ref.		
Description	Previous repairs along blade spar. Oil leaking through from the inside.

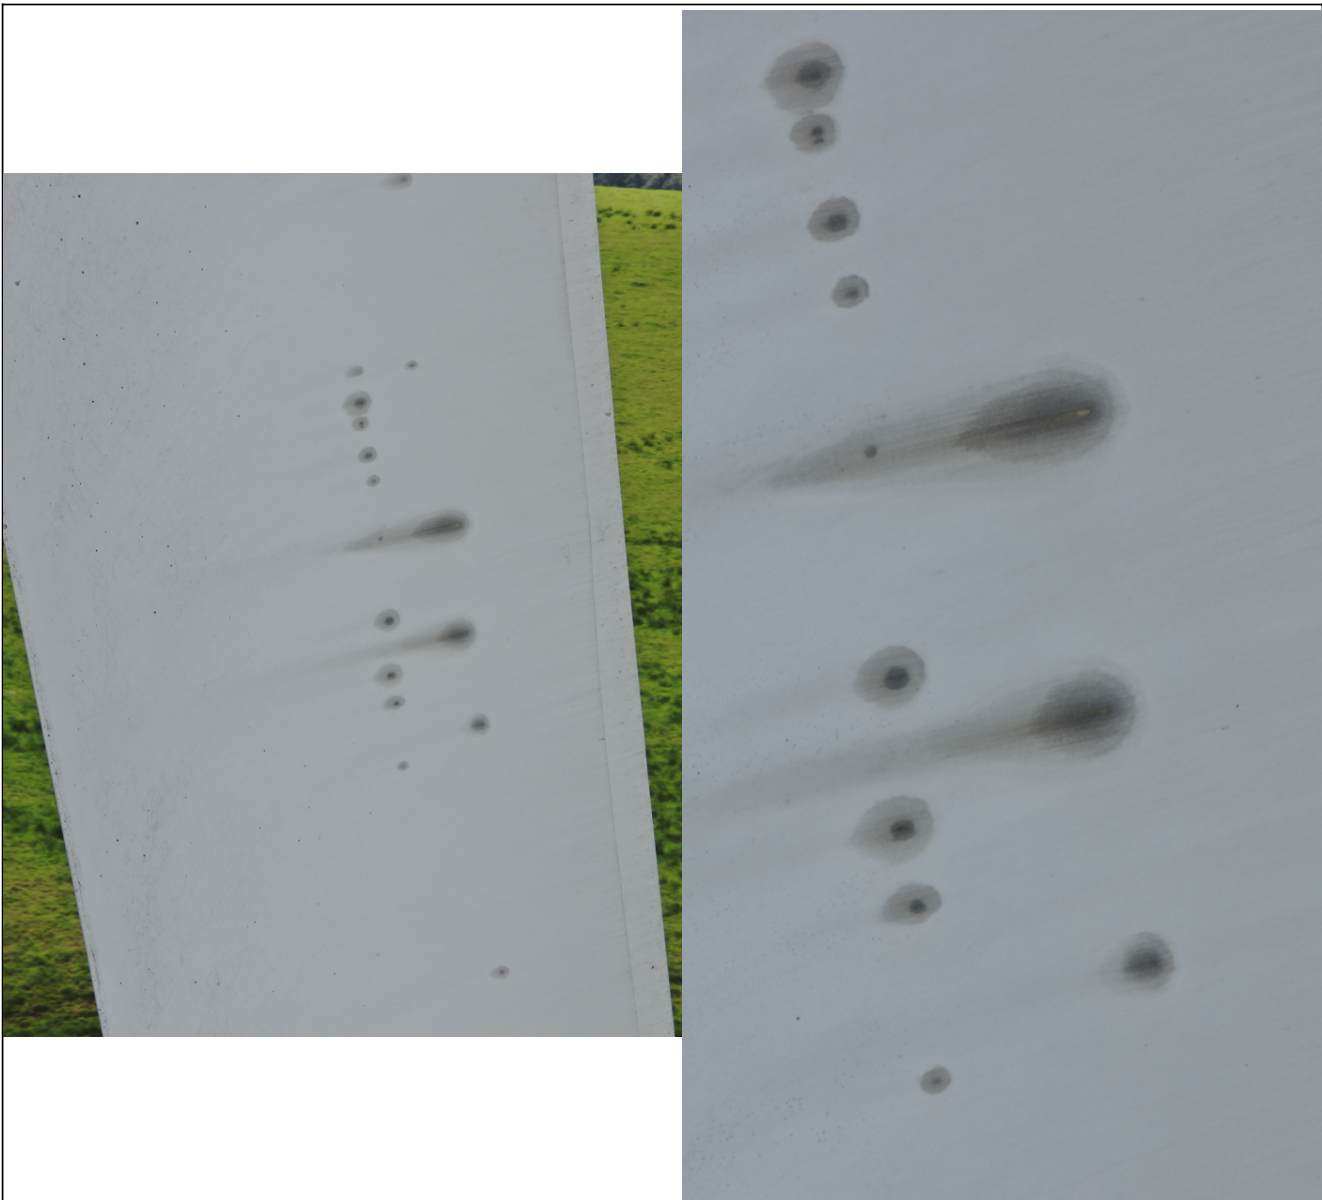
Damage Reference	DN-08	
Damage Category	CAT 2	
Damage Type	Contamination	
Distance From Root (m)	29	
Blade Surface	Suction Side	
Blade Letter/Number	A	
Blade SN		
Image Ref.		
Description	Previous repairs along blade spar. Oil leaking through from the inside.

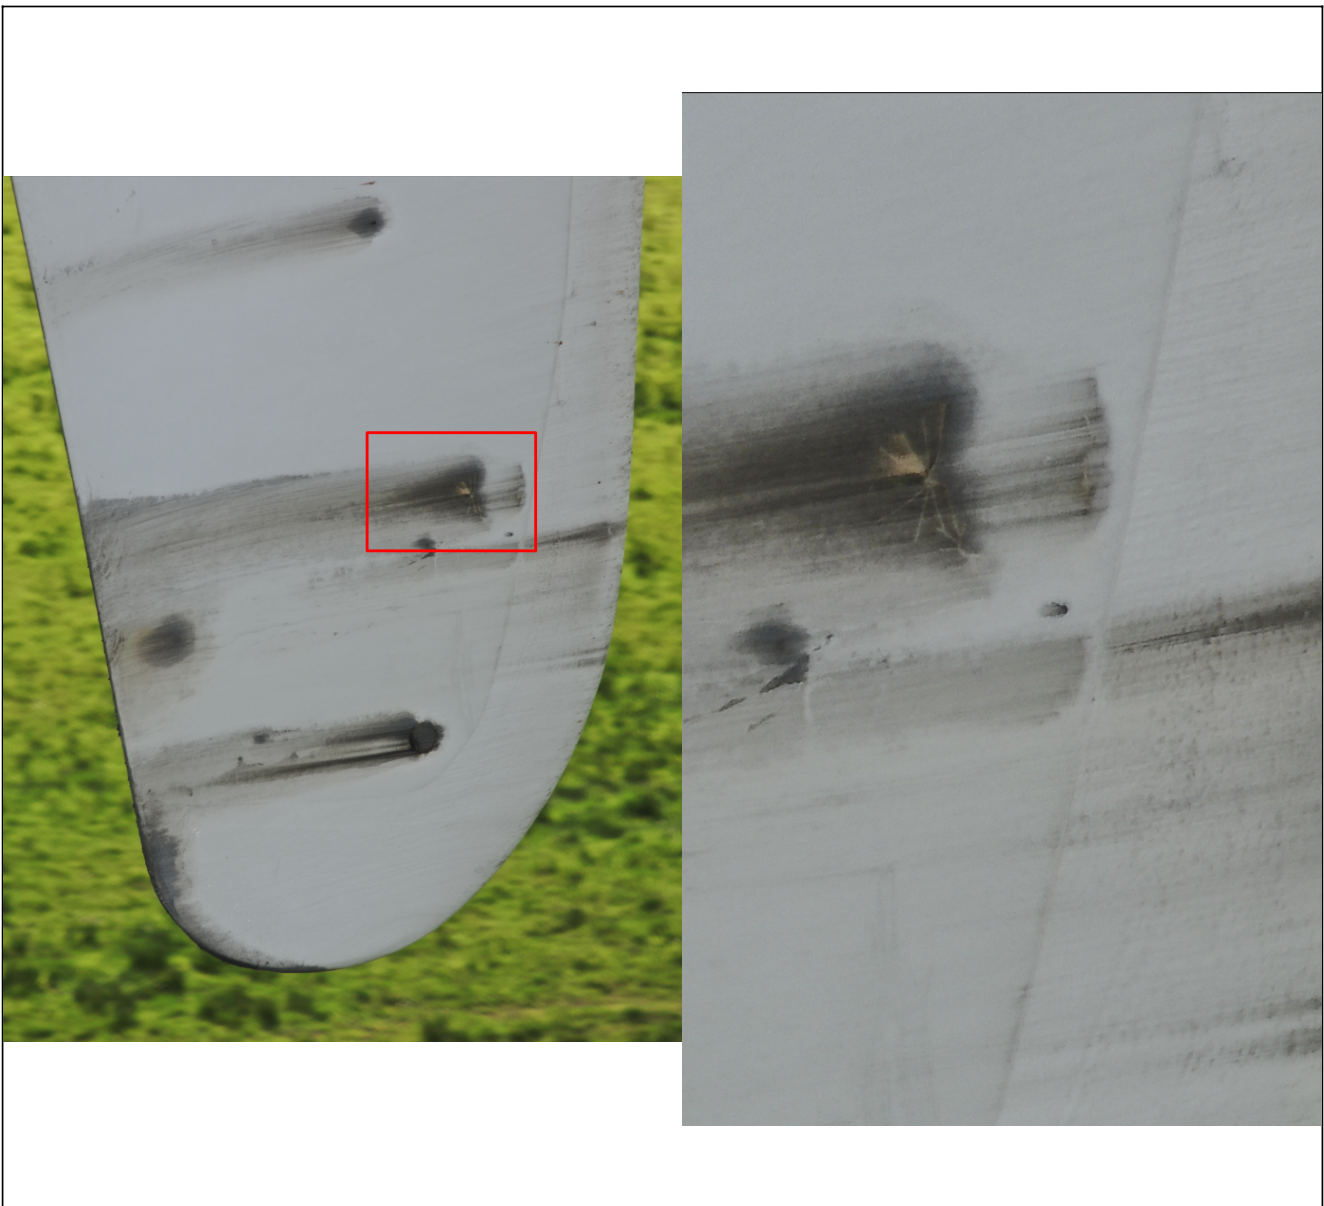
DN-09 : Spider cracks in the gelcoat can be seen in a small area near the blade tip. These have been observed on other blades in the same area. Cause is unknown.

Damage Reference	DN-09	
Damage Category	CAT 3	
Damage Type	Cracking	
Distance From Root (m)	32	
Blade Surface	Suction Side	
Blade Letter/Number	A	
Blade SN		
Image Ref.		
Description	Cracks in top coat. These same cracks appear on some other blades in the same location. Also lightning receptor slightly melted due to lightning strike.

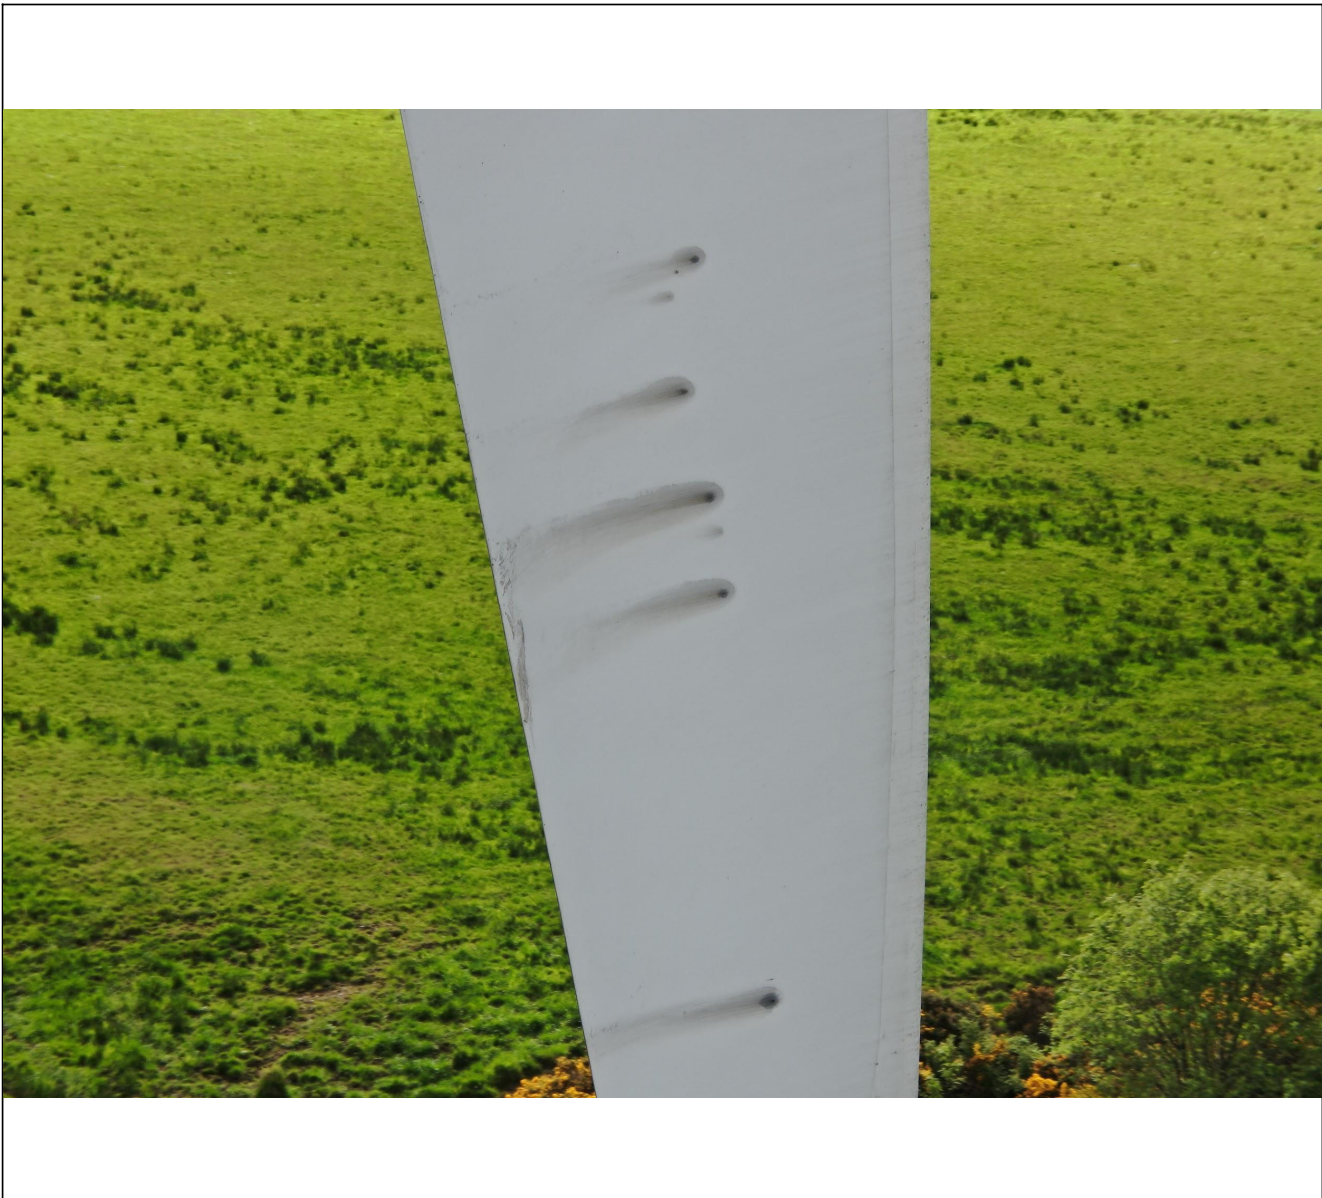
Damage Reference	DN-10	
Damage Category	CAT 2	
Damage Type	Contamination	
Distance From Root (m)	31	
Blade Surface	Suction Side	
Blade Letter/Number	A	
Blade SN		
Image Ref.		
Description	Previous repairs along blade spar. Oil leaking through from the inside.

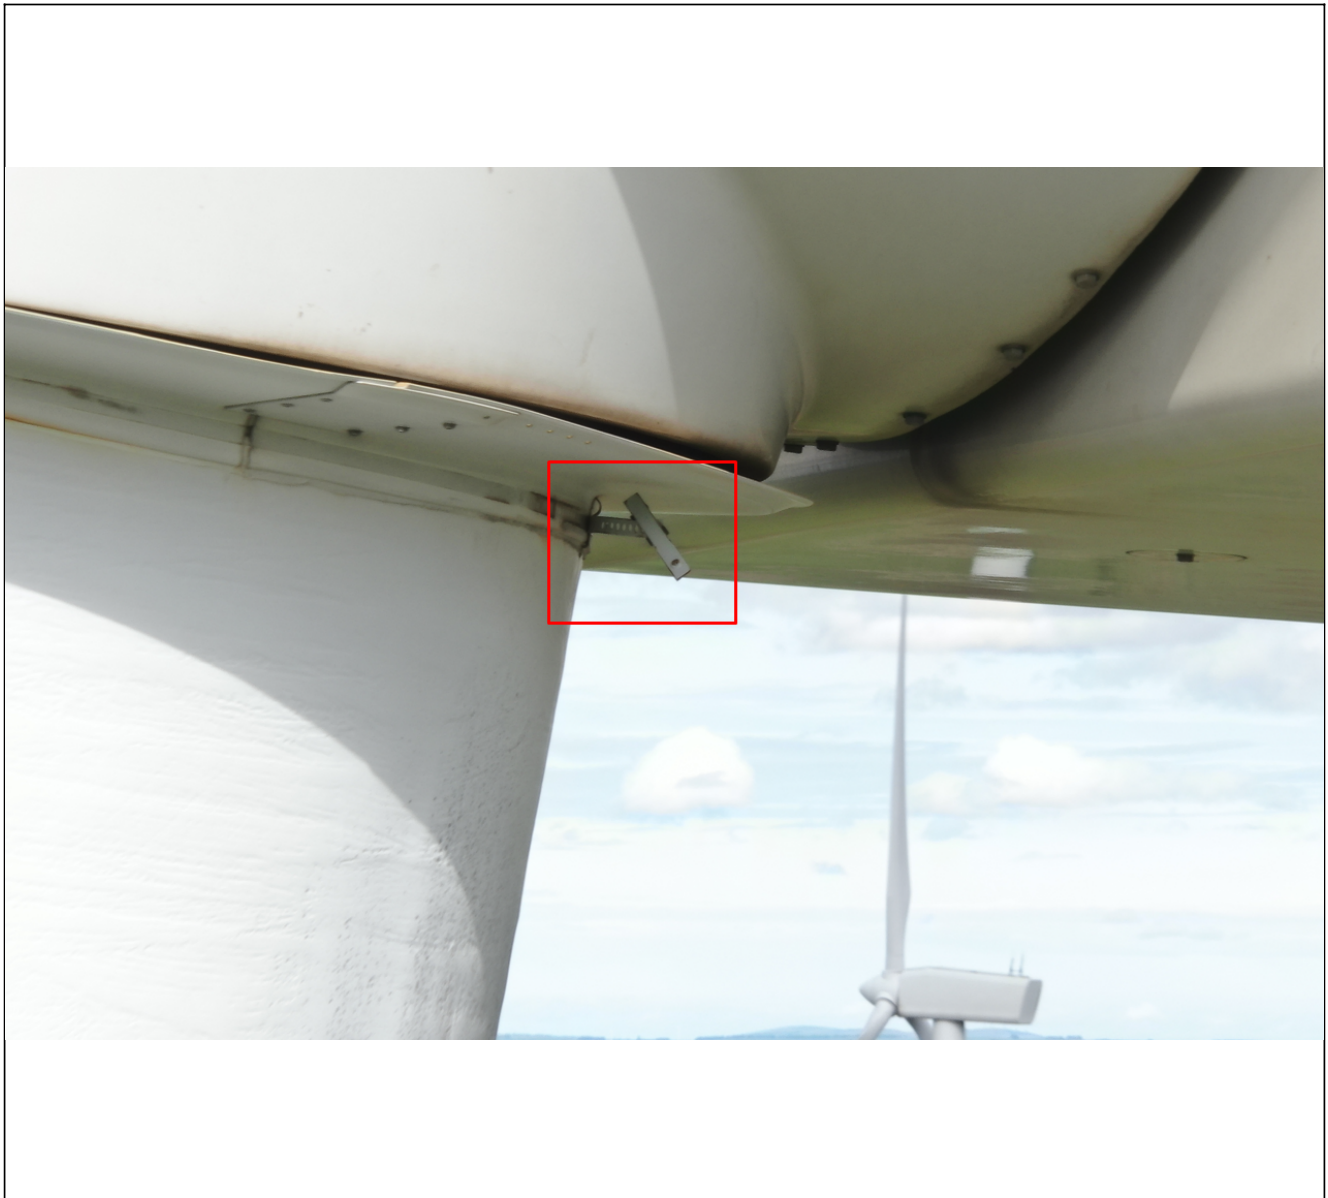
Damage Reference	DN-11	
Damage Category	CAT 2	
Damage Type	Loose	
Distance From Root (m)	0	
Blade Surface	Pressure Side	
Blade Letter/Number	A	
Blade SN		
Image Ref.		
Description	Clip has come loose

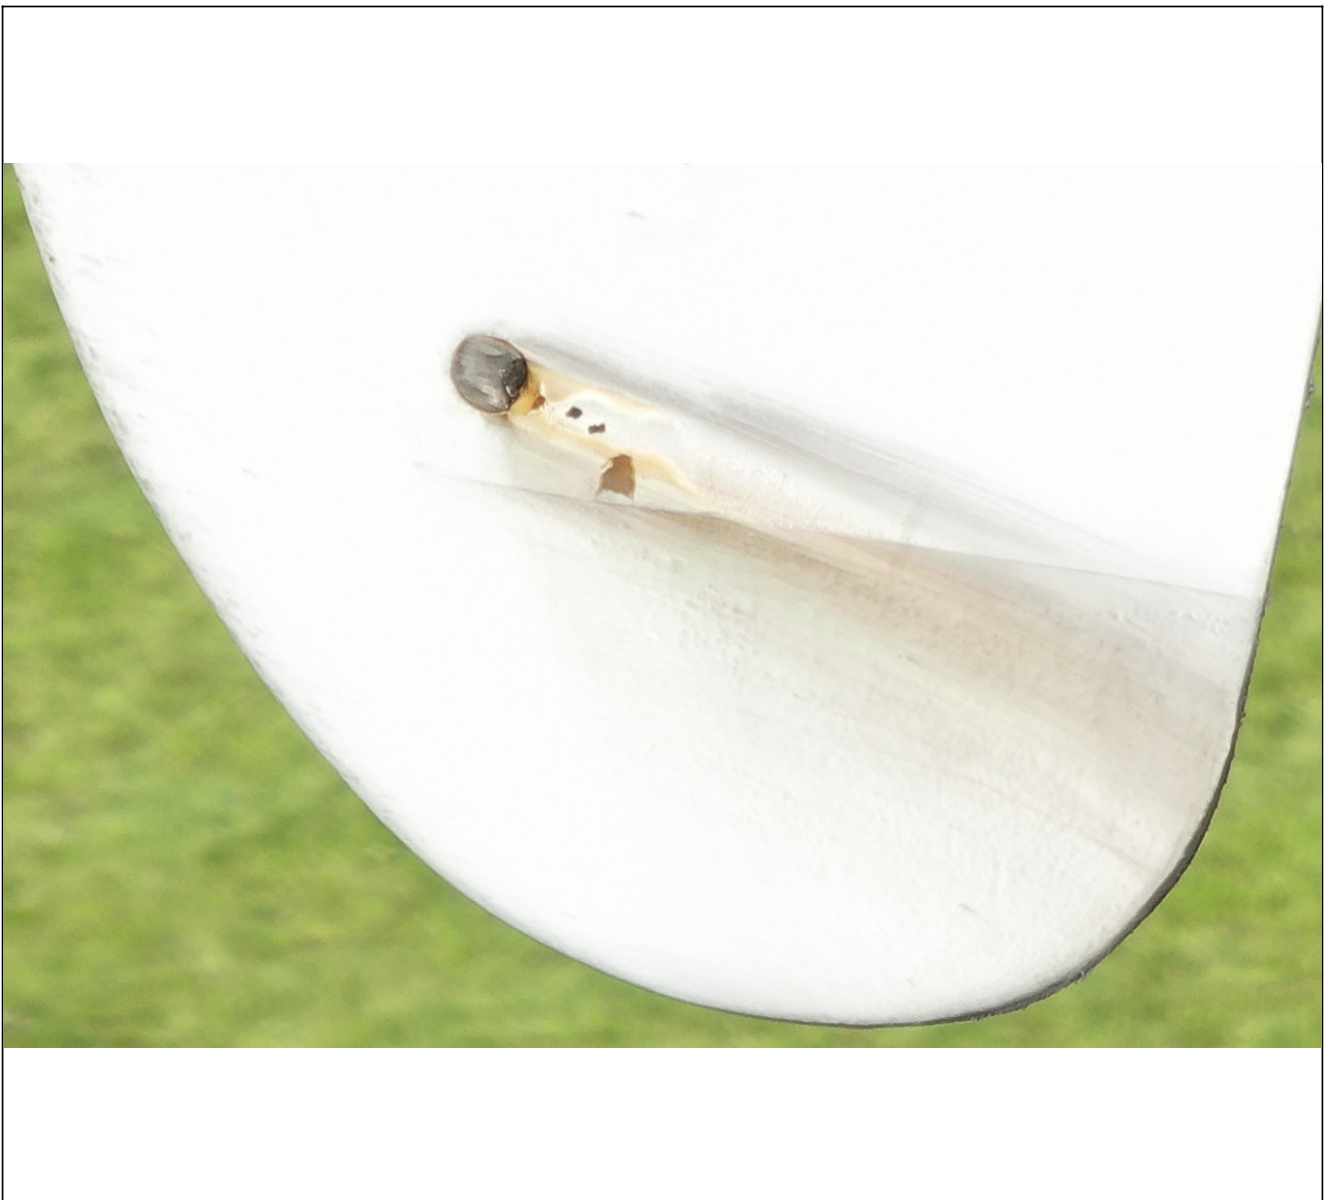
Damage Reference	DN-12	
Damage Category	CAT 2	
Damage Type	Lightning damage	
Distance From Root (m)	32	
Blade Surface	Pressure Side	
Blade Letter/Number	A	
Blade SN		
Image Ref.		
Description	Lightning receptor struck by lightning. Causing topcoat to chip and exposing laminate

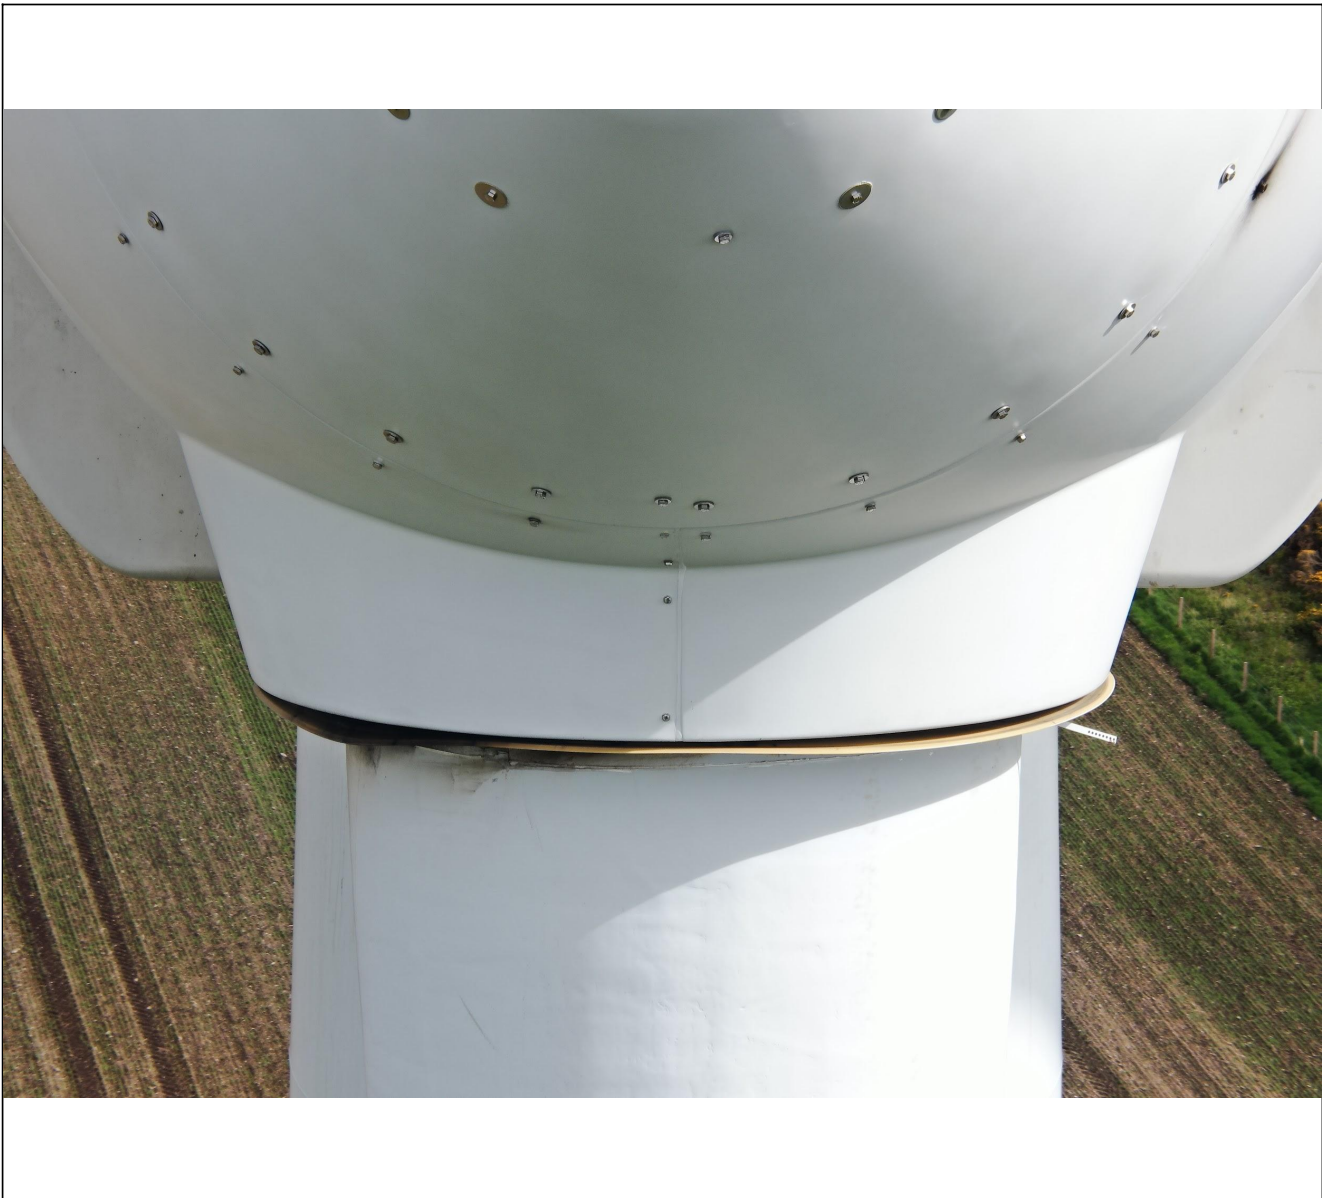
Damage Reference	DN-13	
Damage Category	CAT 2	
Damage Type	Out of alignment	
Distance From Root (m)	0	
Blade Surface	Leading Edge	
Blade Letter/Number	B	
Blade SN		
Image Ref.		
Description	Rain deflector not flush with spinner

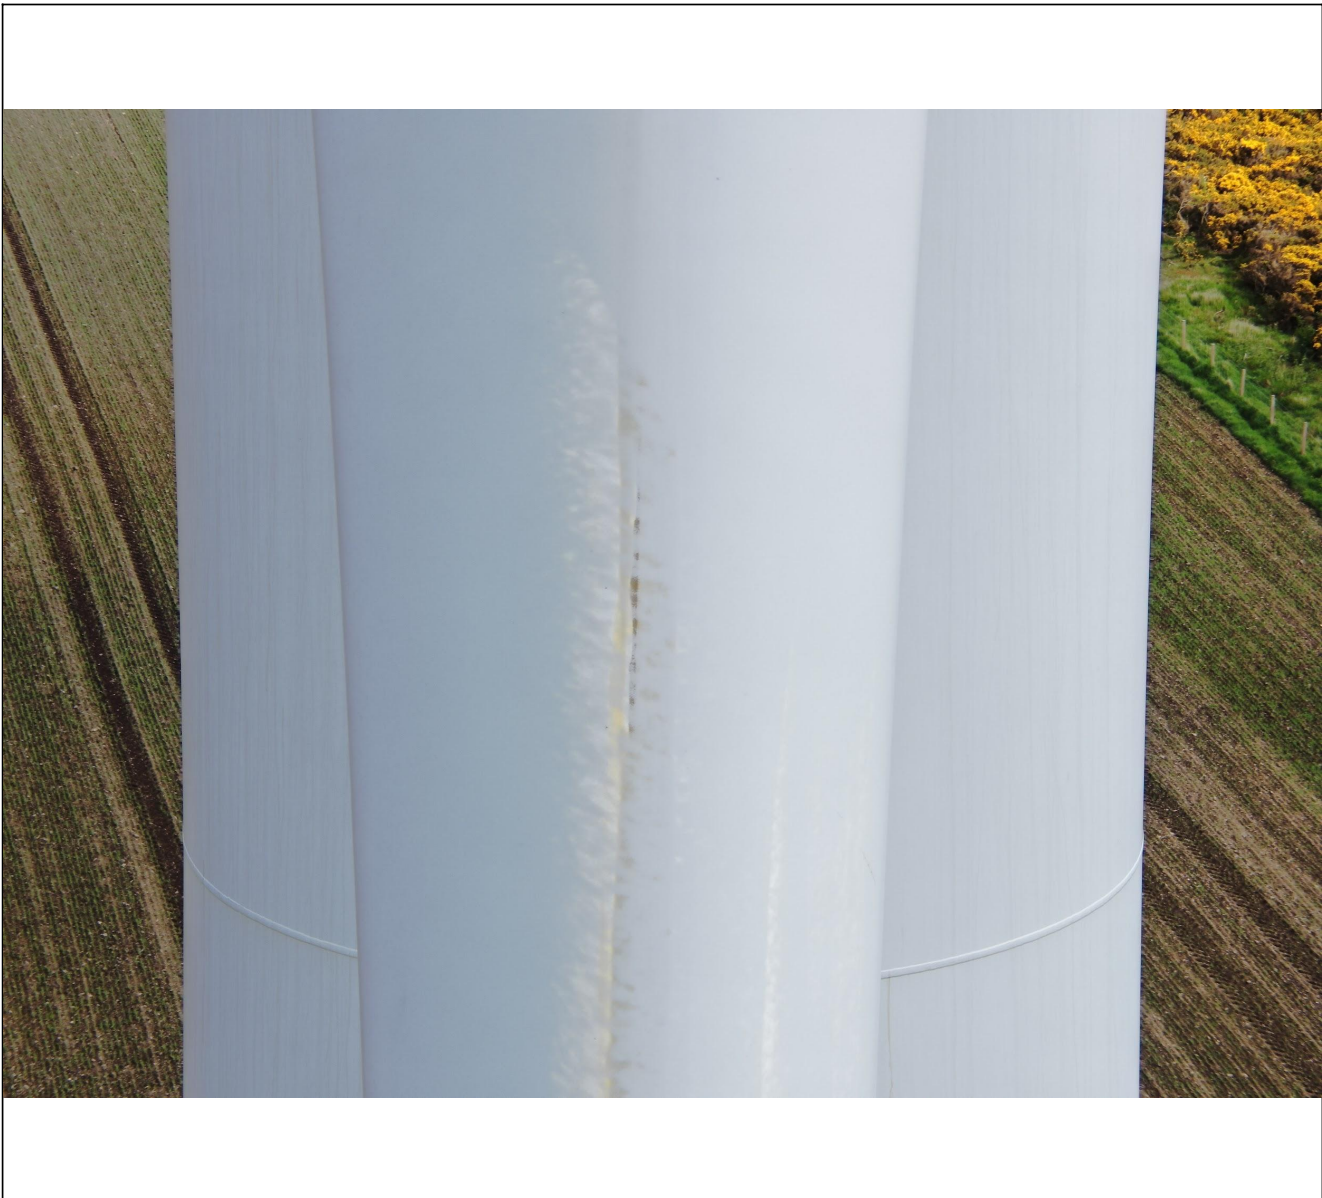
Damage Reference	DN-14	
Damage Category	CAT 2	
Damage Type	Erosion	
Distance From Root (m)	7	
Blade Surface	Leading Edge	
Blade Letter/Number	B	
Blade SN		
Image Ref.		
Description	Topcoat eroded away. Exposing gelcoat.
