Wind Turbine Blade Inspection Report

Example Wind Farm

T07

Asset: T07 - 25040 - Vestas V66

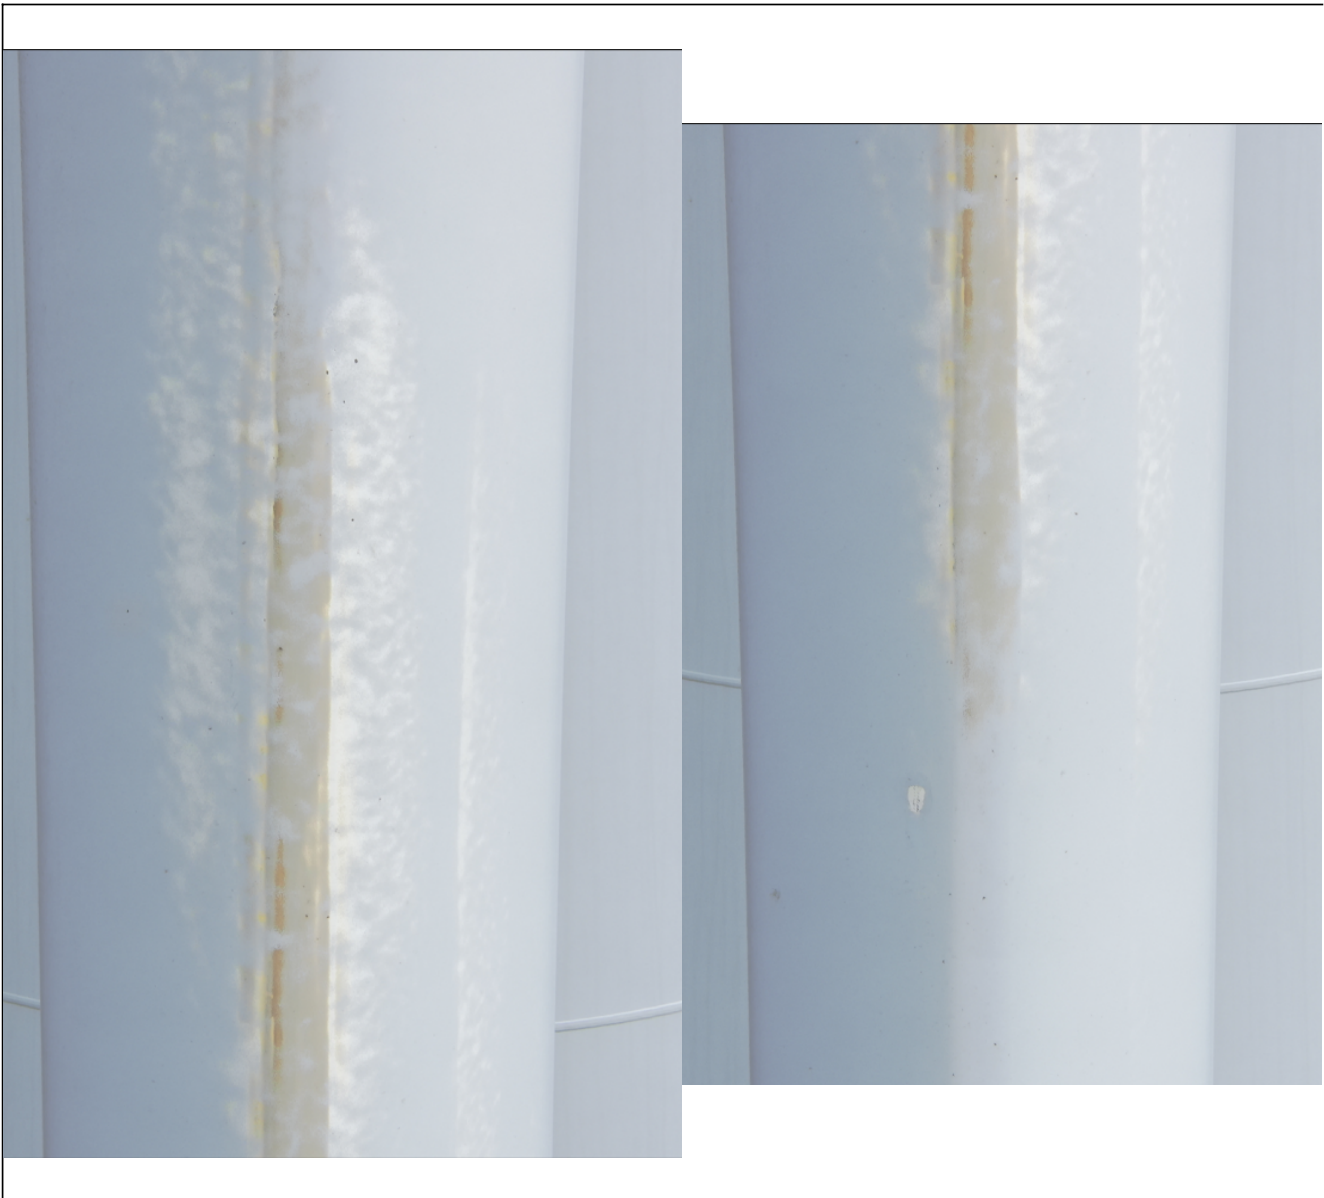
Damage Reference	DN-15	
Damage Category	CAT 2	
Damage Type	Erosion	
Distance From Root (m)	10	
Blade Surface	Leading Edge	
Blade Letter/Number	B	
Blade SN		
Image Ref.		
Description	Topcoat eroded away. Exposing gelcoat.

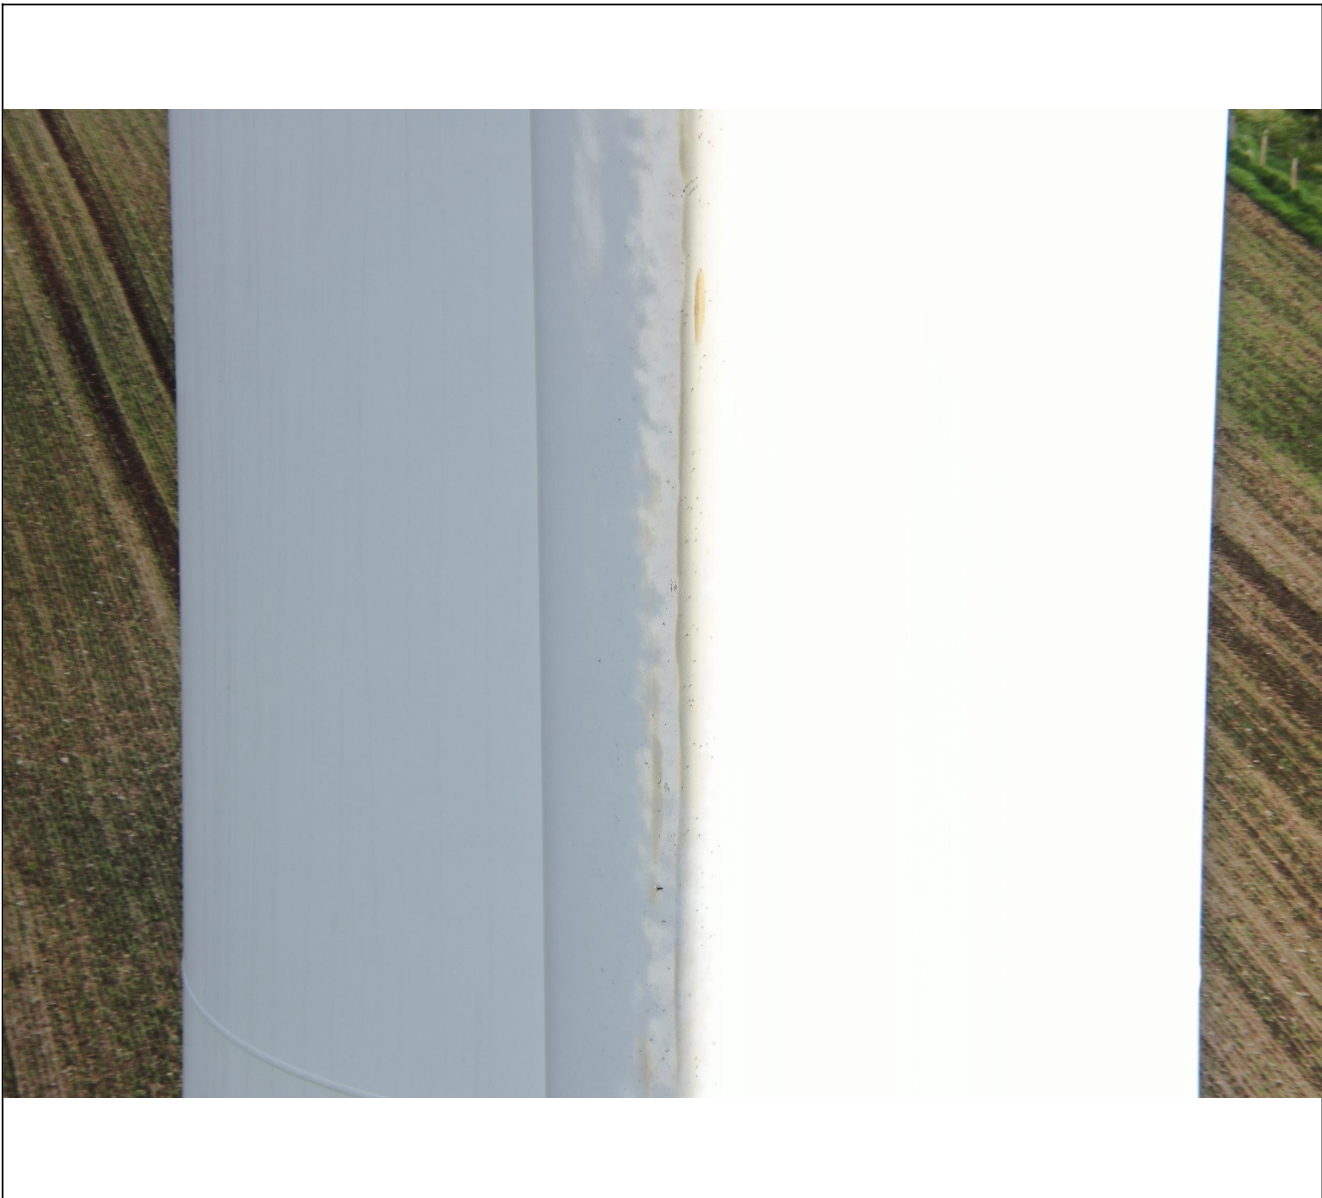
Damage Reference	DN-16	
Damage Category	CAT 2	
Damage Type	Erosion	
Distance From Root (m)	15	
Blade Surface	Leading Edge	
Blade Letter/Number	A	
Blade SN		
Image Ref.		
Description	Topcoat eroded away. Exposing gelcoat.

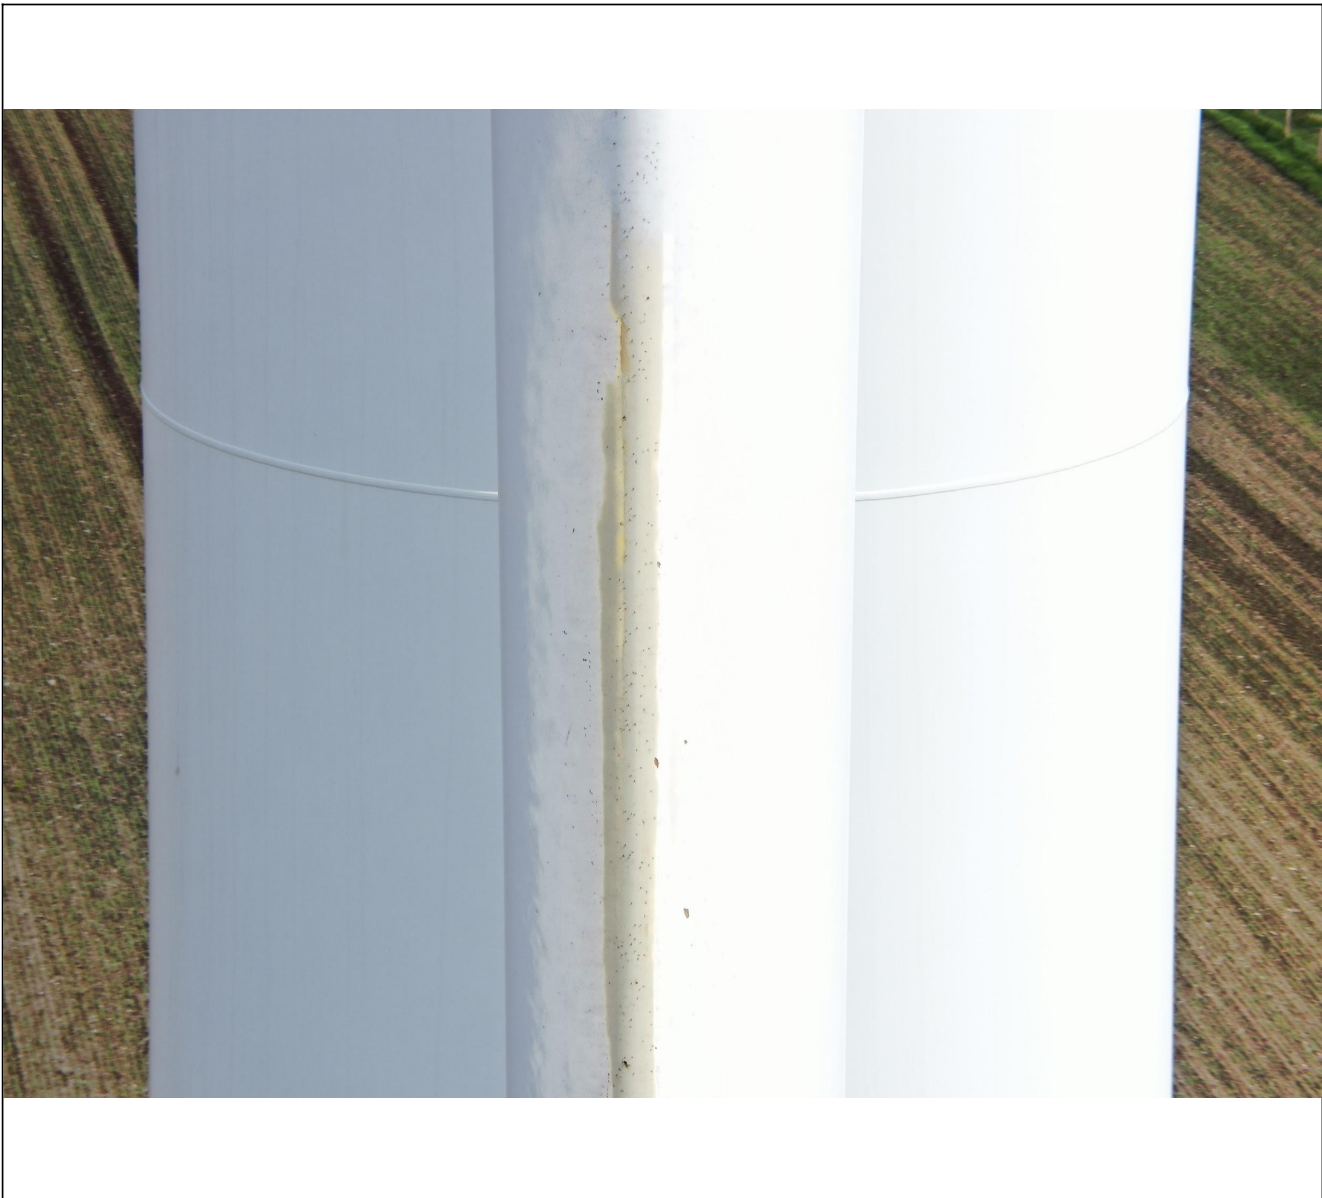
Damage Reference	DN-17	
Damage Category	CAT 2	
Damage Type	Erosion	
Distance From Root (m)	18	
Blade Surface	Leading Edge	
Blade Letter/Number	A	
Blade SN		
Image Ref.		
Description	Topcoat eroded away. Exposing gelcoat.

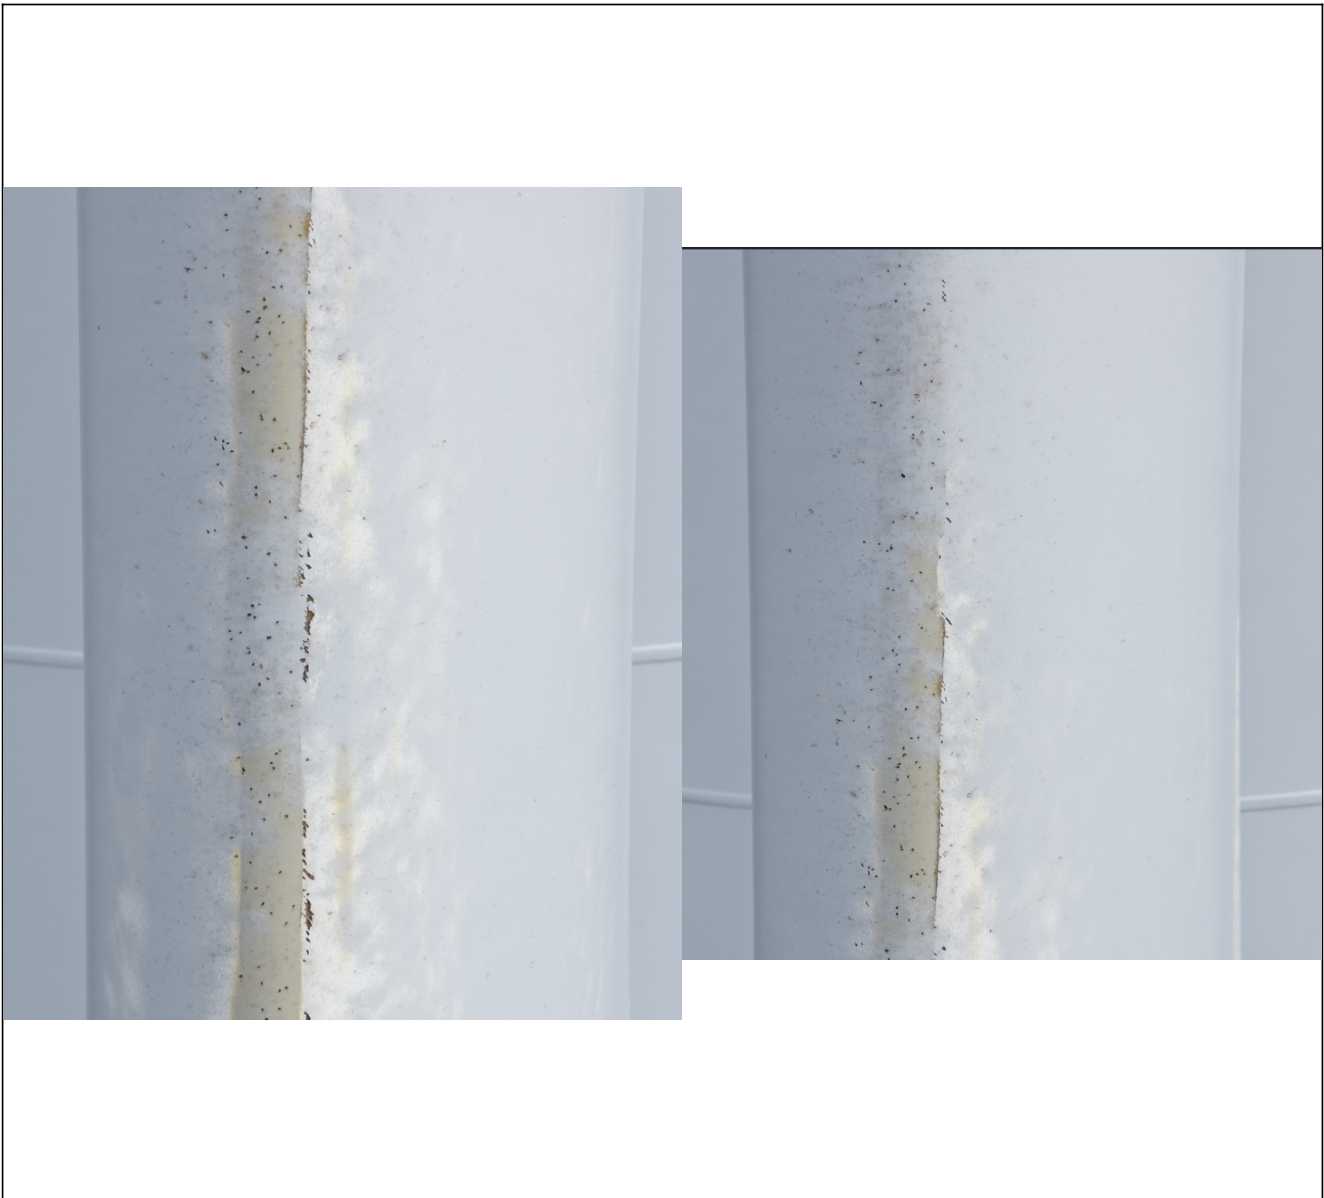
Damage Reference	DN-18	
Damage Category	CAT 2	
Damage Type	Erosion	
Distance From Root (m)	20	
Blade Surface	Leading Edge	
Blade Letter/Number	B	
Blade SN		
Image Ref.		
Description	Topcoat eroded away. Exposing gelcoat and bits of laminate.

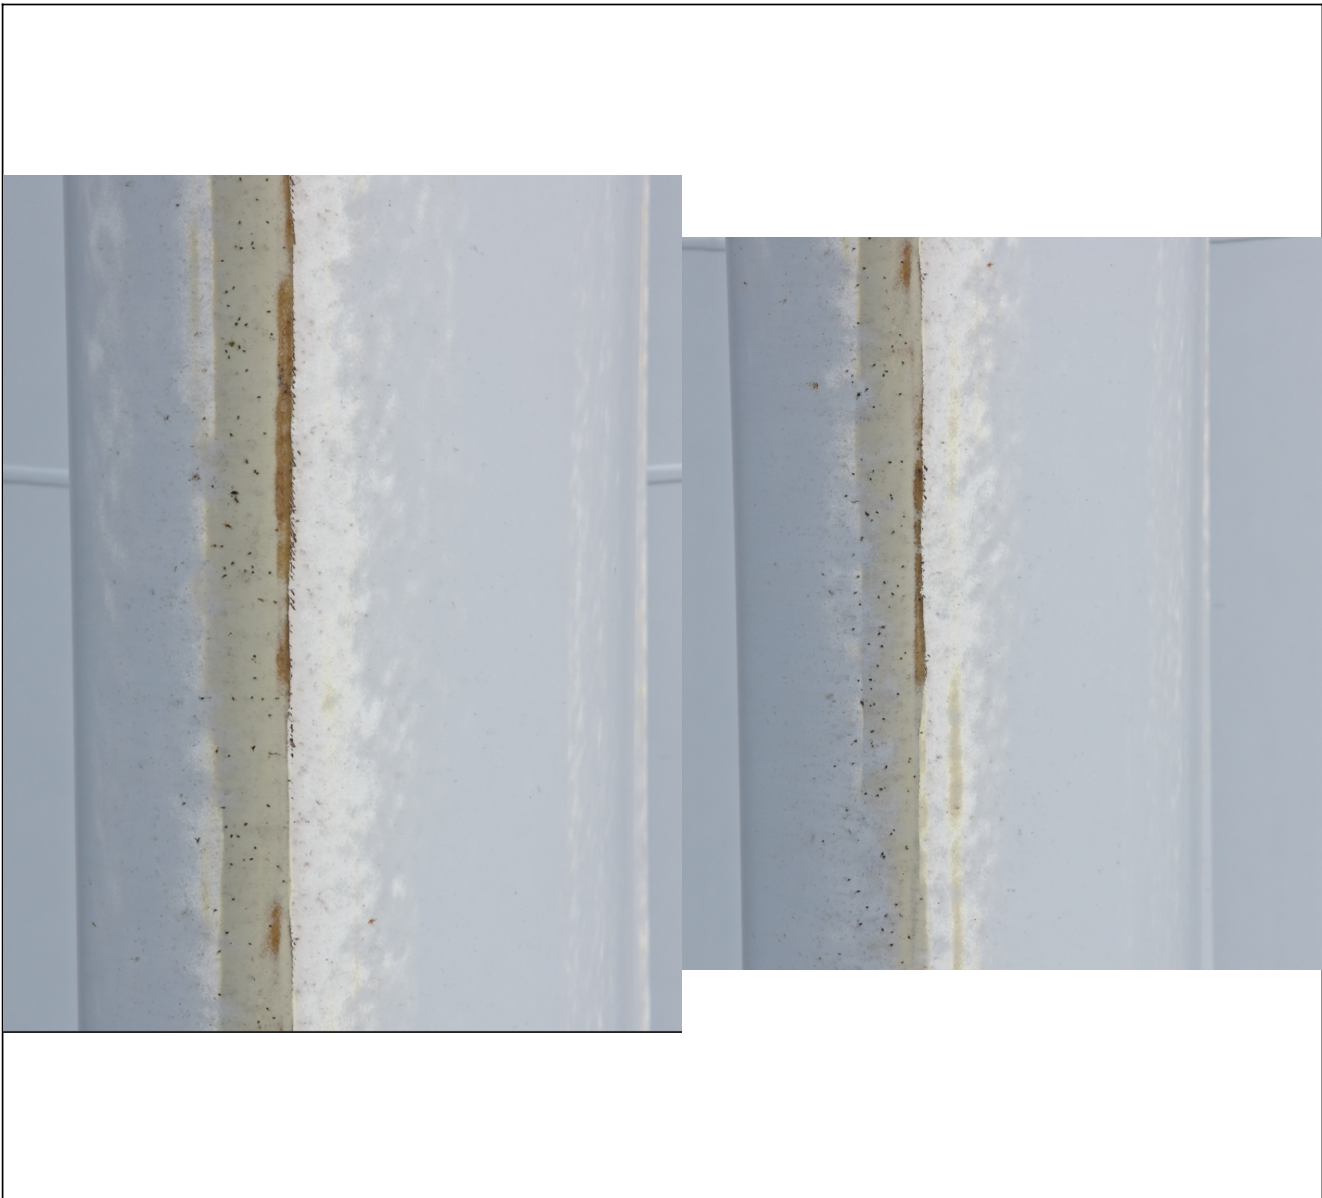
Damage Reference	DN-19	
Damage Category	CAT 2	
Damage Type	Erosion	
Distance From Root (m)	21	
Blade Surface	Leading Edge	
Blade Letter/Number	B	
Blade SN		
Image Ref.		
Description	Topcoat eroded away. Exposing gelcoat and bits of laminate.

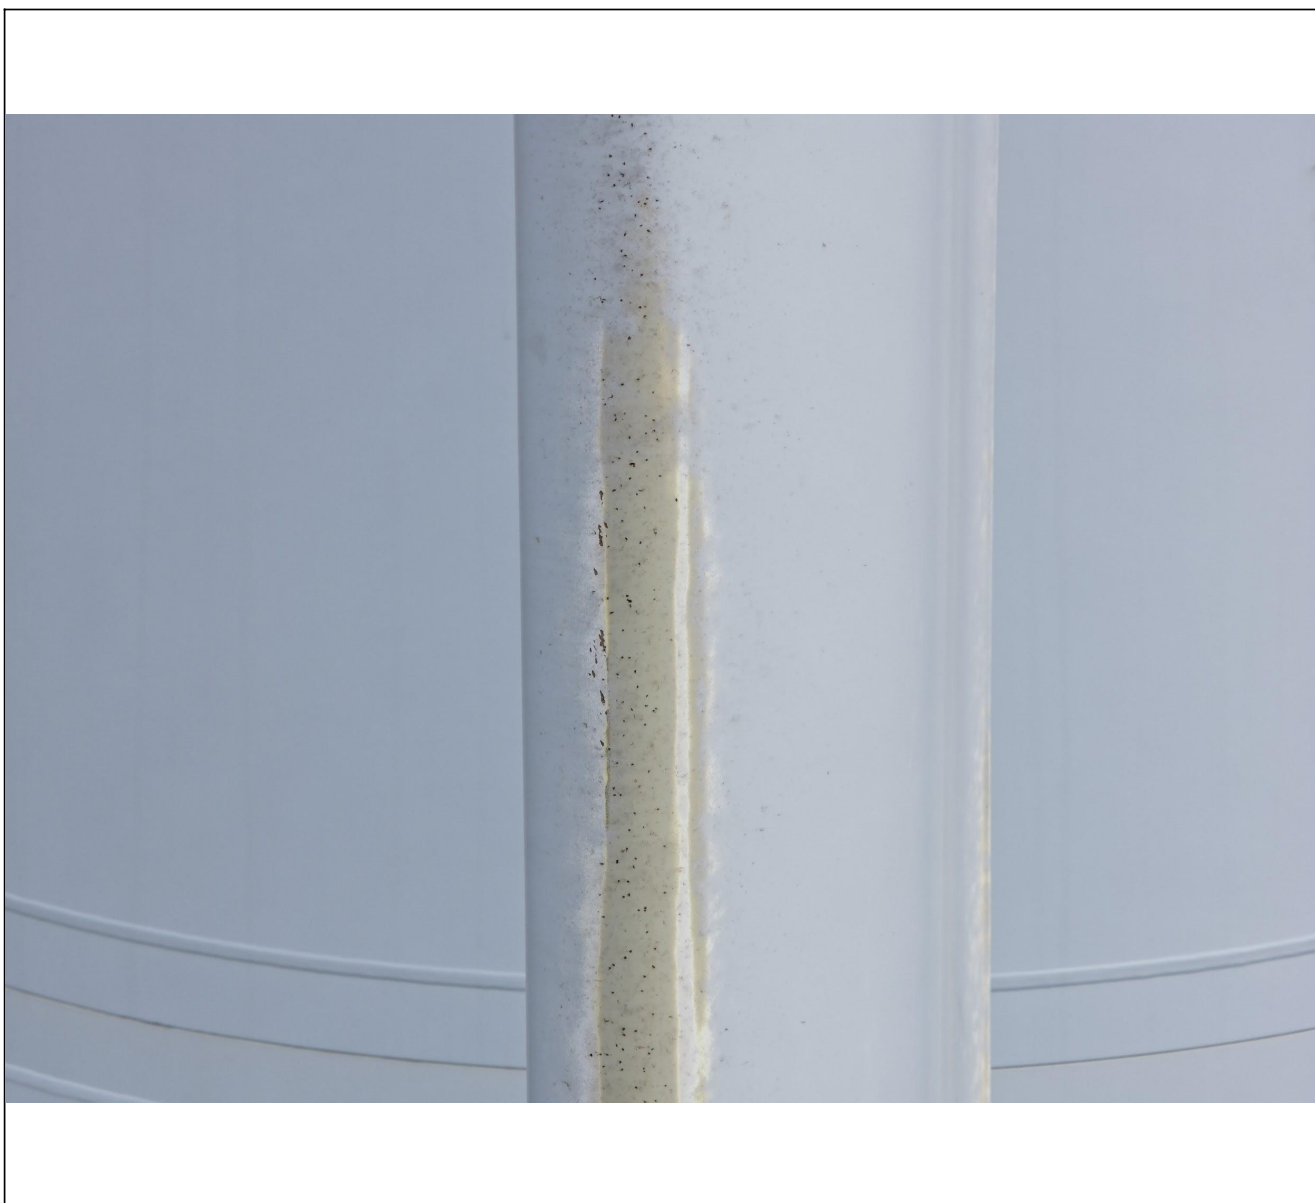
Damage Reference	DN-20	
Damage Category	CAT 2	
Damage Type	Erosion	
Distance From Root (m)	22	
Blade Surface	Leading Edge	
Blade Letter/Number	B	
Blade SN		
Image Ref.		
Description	Topcoat eroded away. Exposing gelcoat.

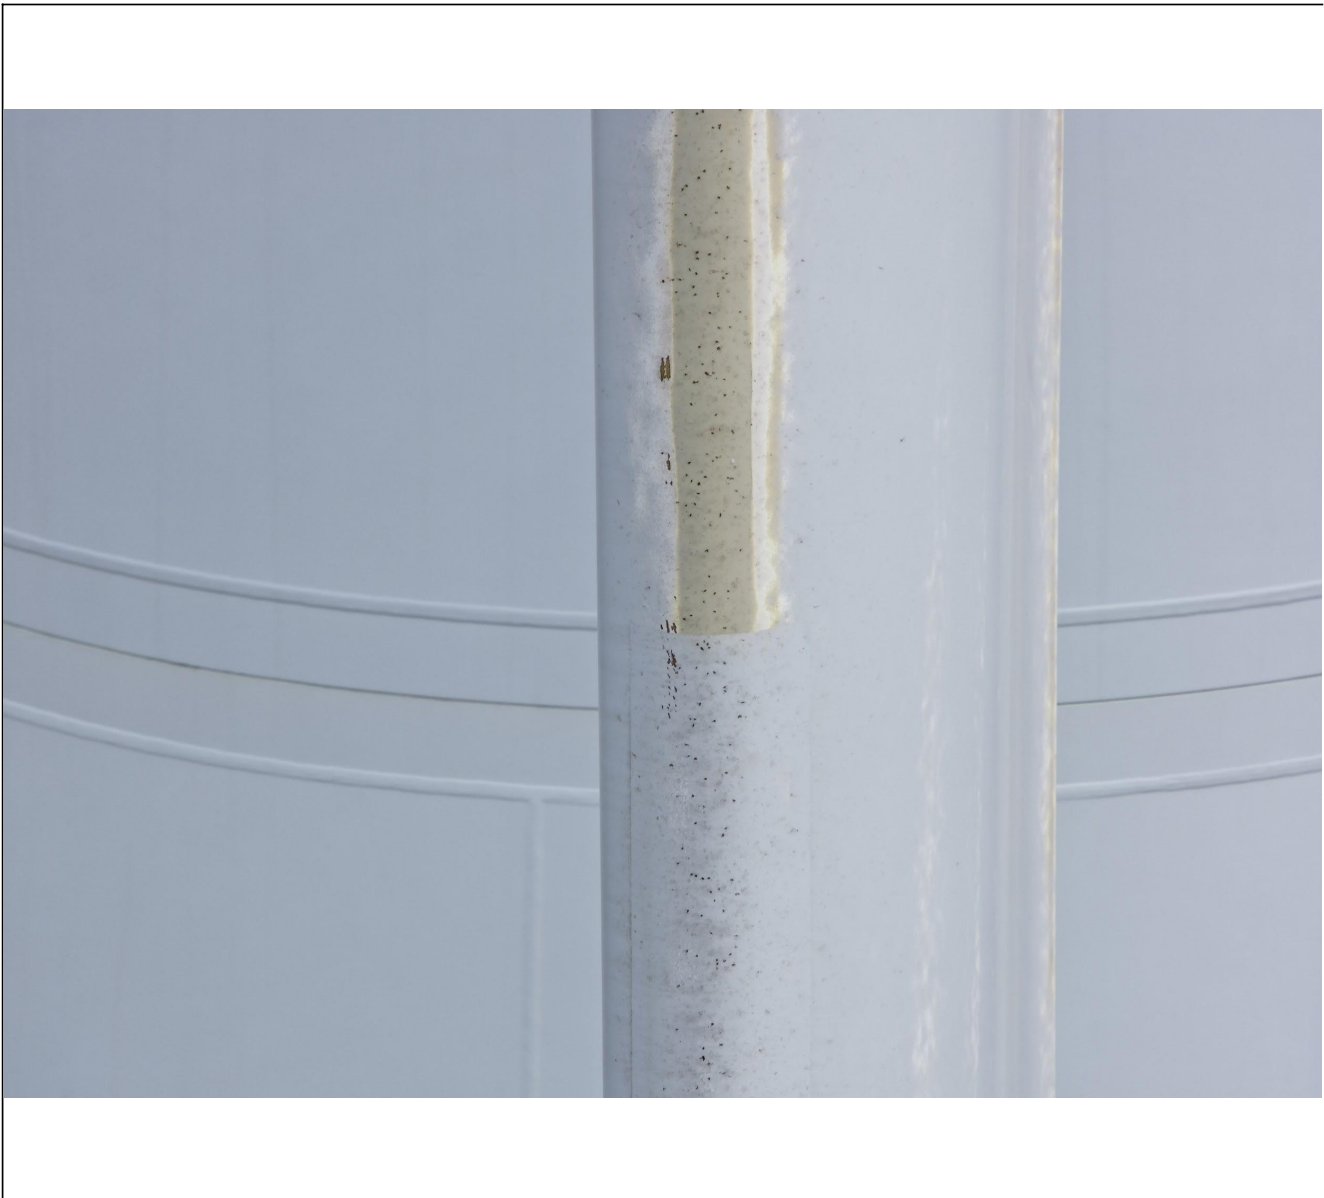
Damage Reference	DN-21	
Damage Category	CAT 2	
Damage Type	Erosion	
Distance From Root (m)	23	
Blade Surface	Leading Edge	
Blade Letter/Number	B	
Blade SN		
Image Ref.		
Description	Topcoat eroded away. Exposing gelcoat and bits of laminate.

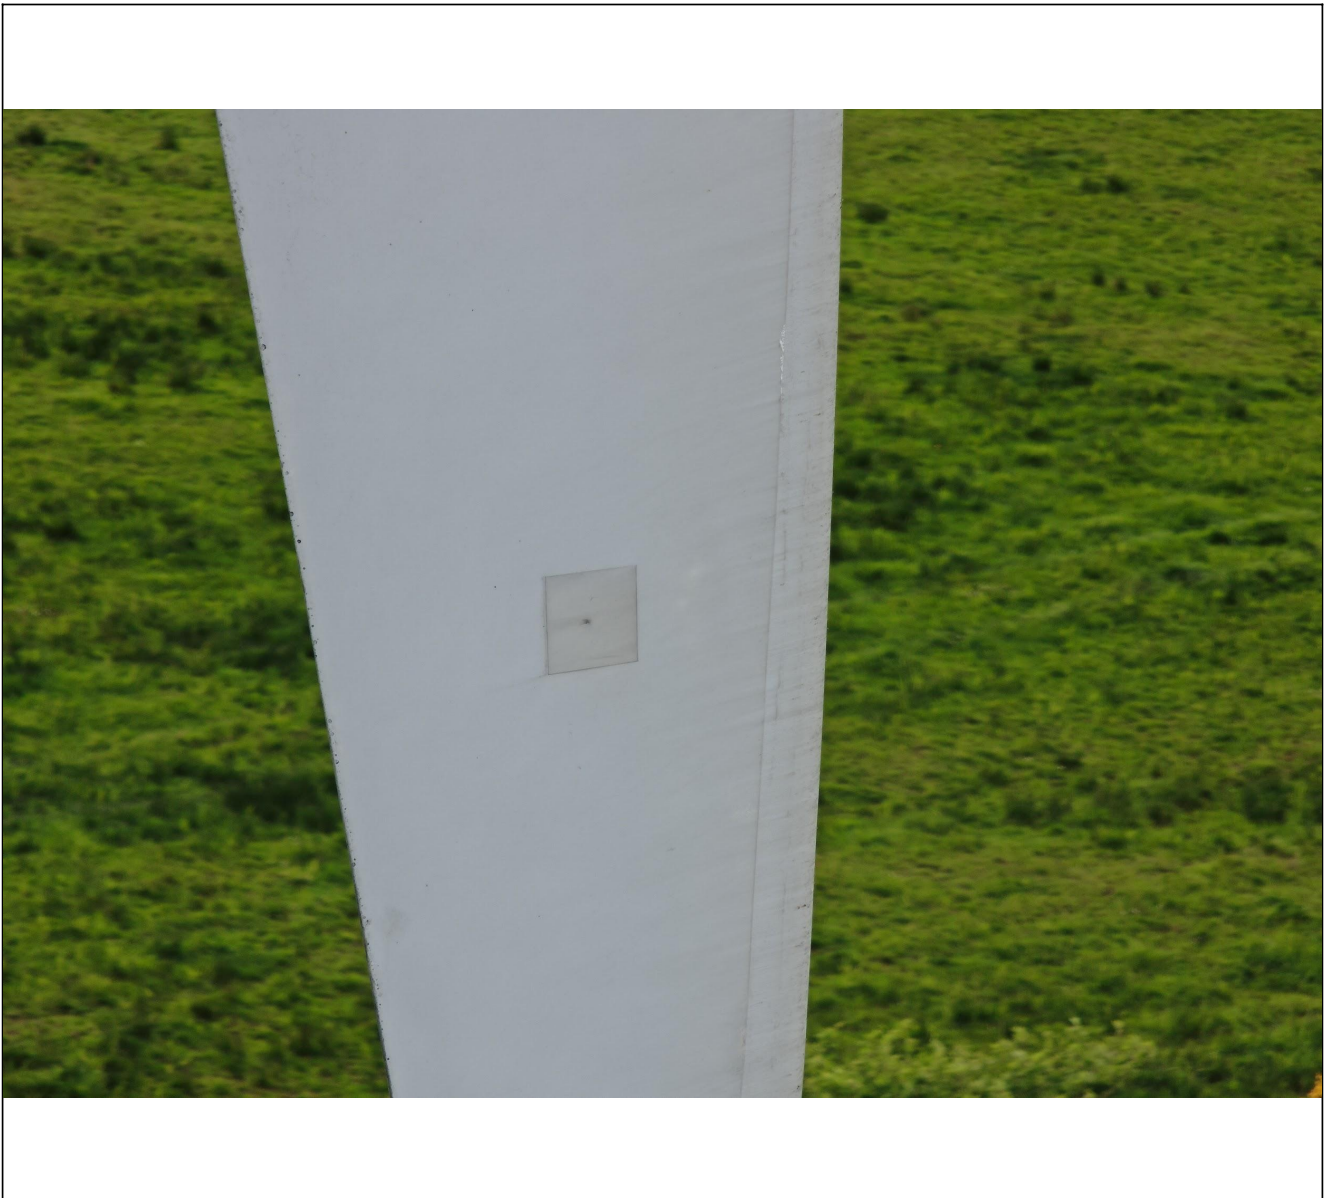
Damage Reference	DN-22	
Damage Category	CAT 1	
Damage Type	General observation	
Distance From Root (m)	31	
Blade Surface	Suction Side	
Blade Letter/Number	B	
Blade SN		
Image Ref.		
Description	Previous repair - Satisfactory

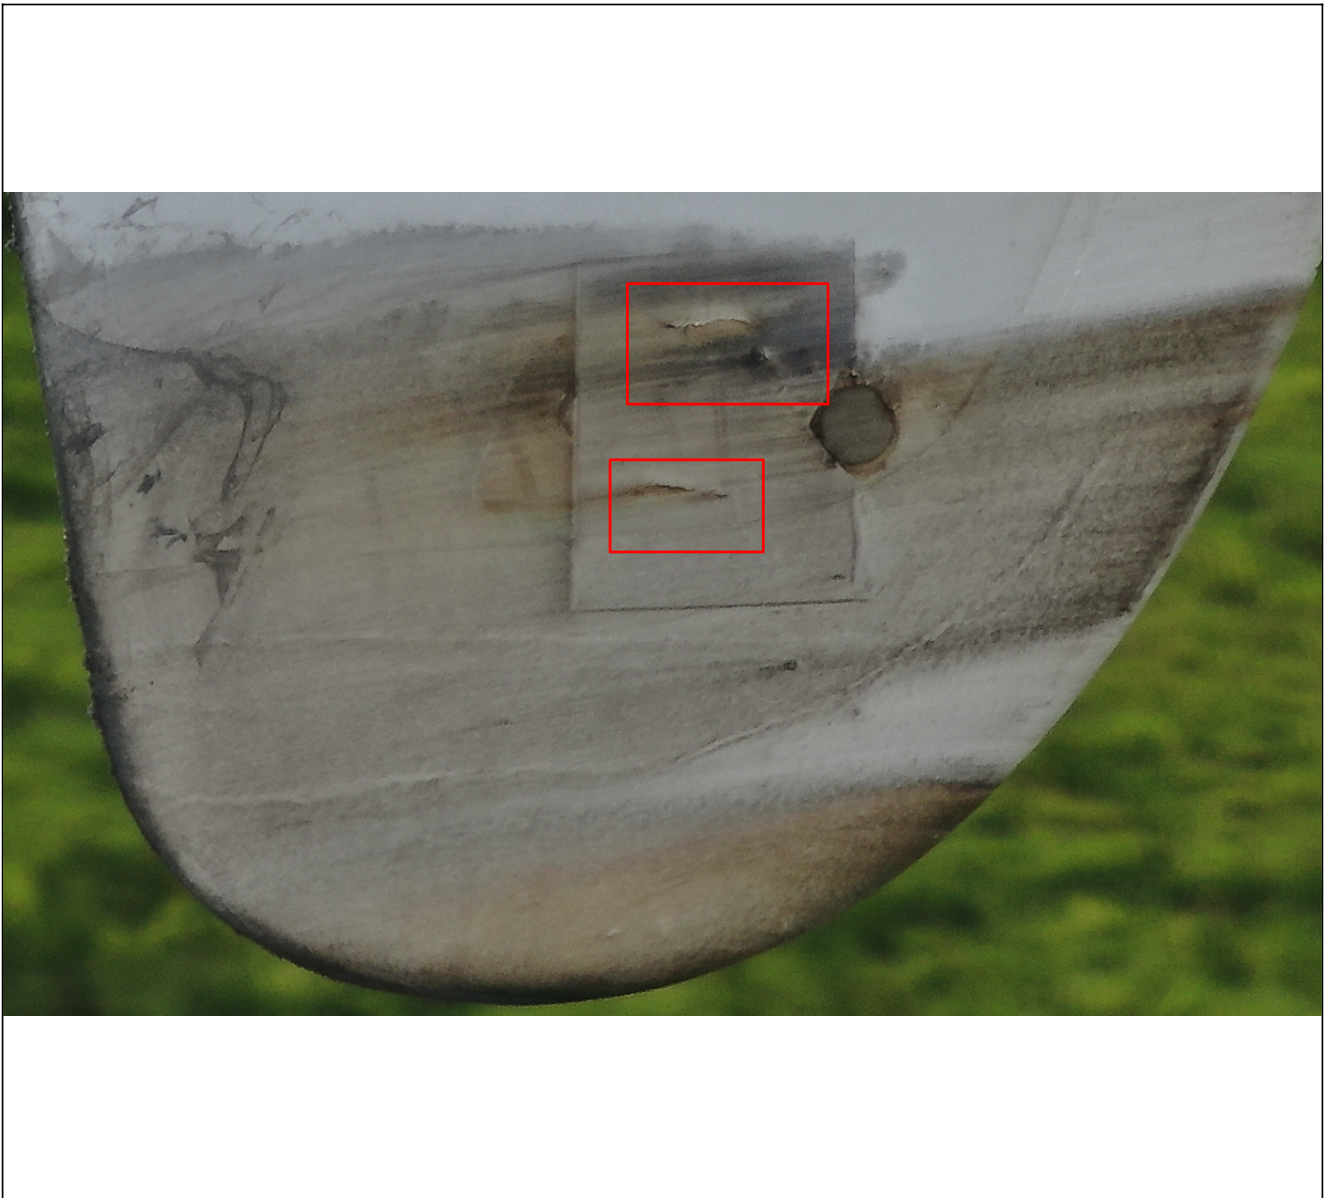
Damage Reference	DN-23	
Damage Category	CAT 2	
Damage Type	Cracking	
Distance From Root (m)	32	
Blade Surface	Suction Side	
Blade Letter/Number	B	
Blade SN		
Image Ref.		
Description	Previous repair - Cracking in area that was repaired

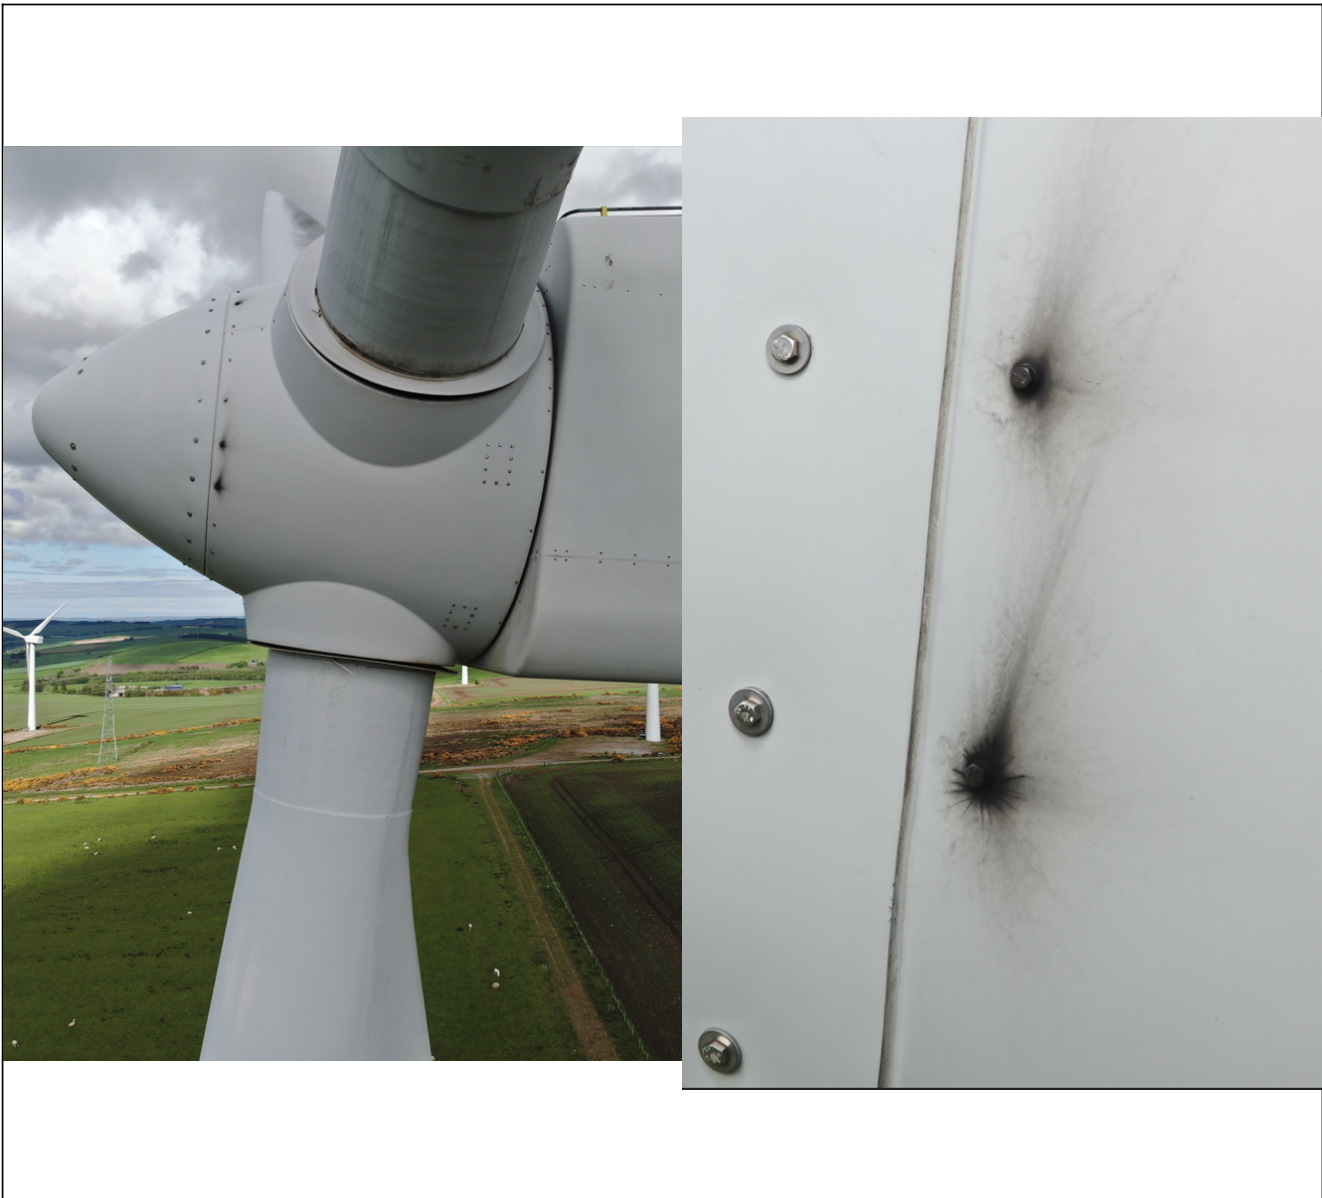
DN-04 / DN-24 / DN-30 / DN-33 : Some fasteners on the spinner are loose and are fretting.

Damage Reference	DN-24	
Damage Category	CAT 3	
Damage Type	Loose Fastener	
Distance From Root (m)	0	
Blade Surface	Pressure Side	
Blade Letter/Number	B	
Blade SN		
Image Ref.		
Description	Loose fasteners on hub damaging underlying laminate

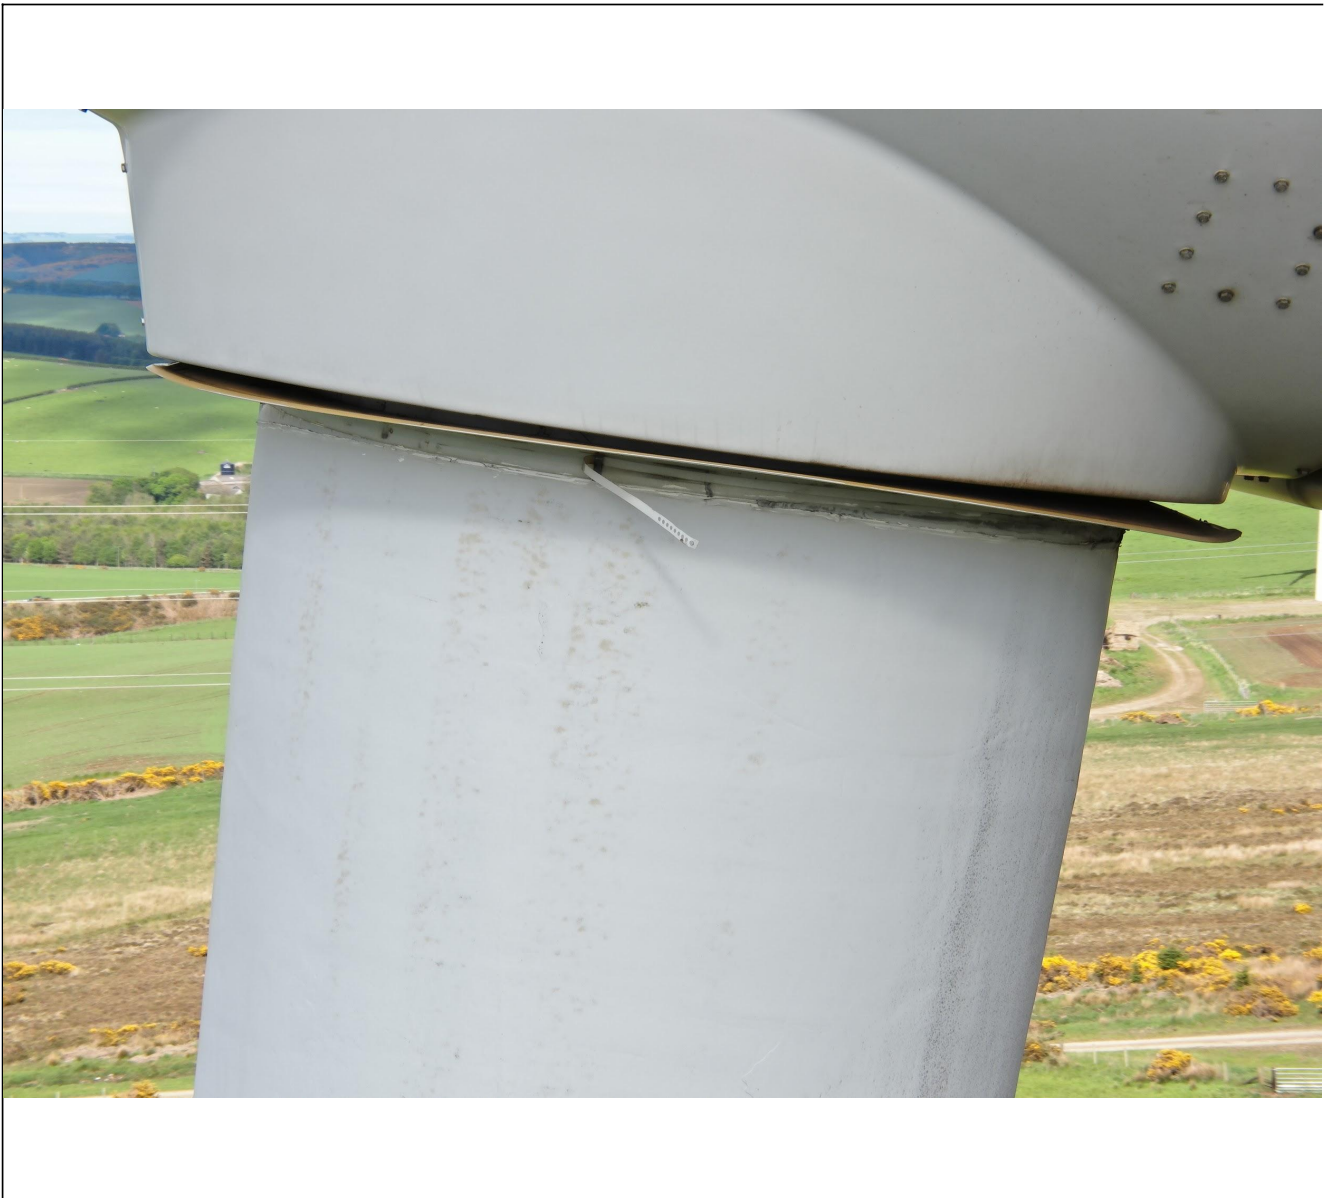
Damage Reference	DN-25	
Damage Category	CAT 2	
Damage Type	Loose	
Distance From Root (m)	0	
Blade Surface	Pressure Side	
Blade Letter/Number	B	
Blade SN		
Image Ref.		
Description	Metal tie has come loose under the rain deflector

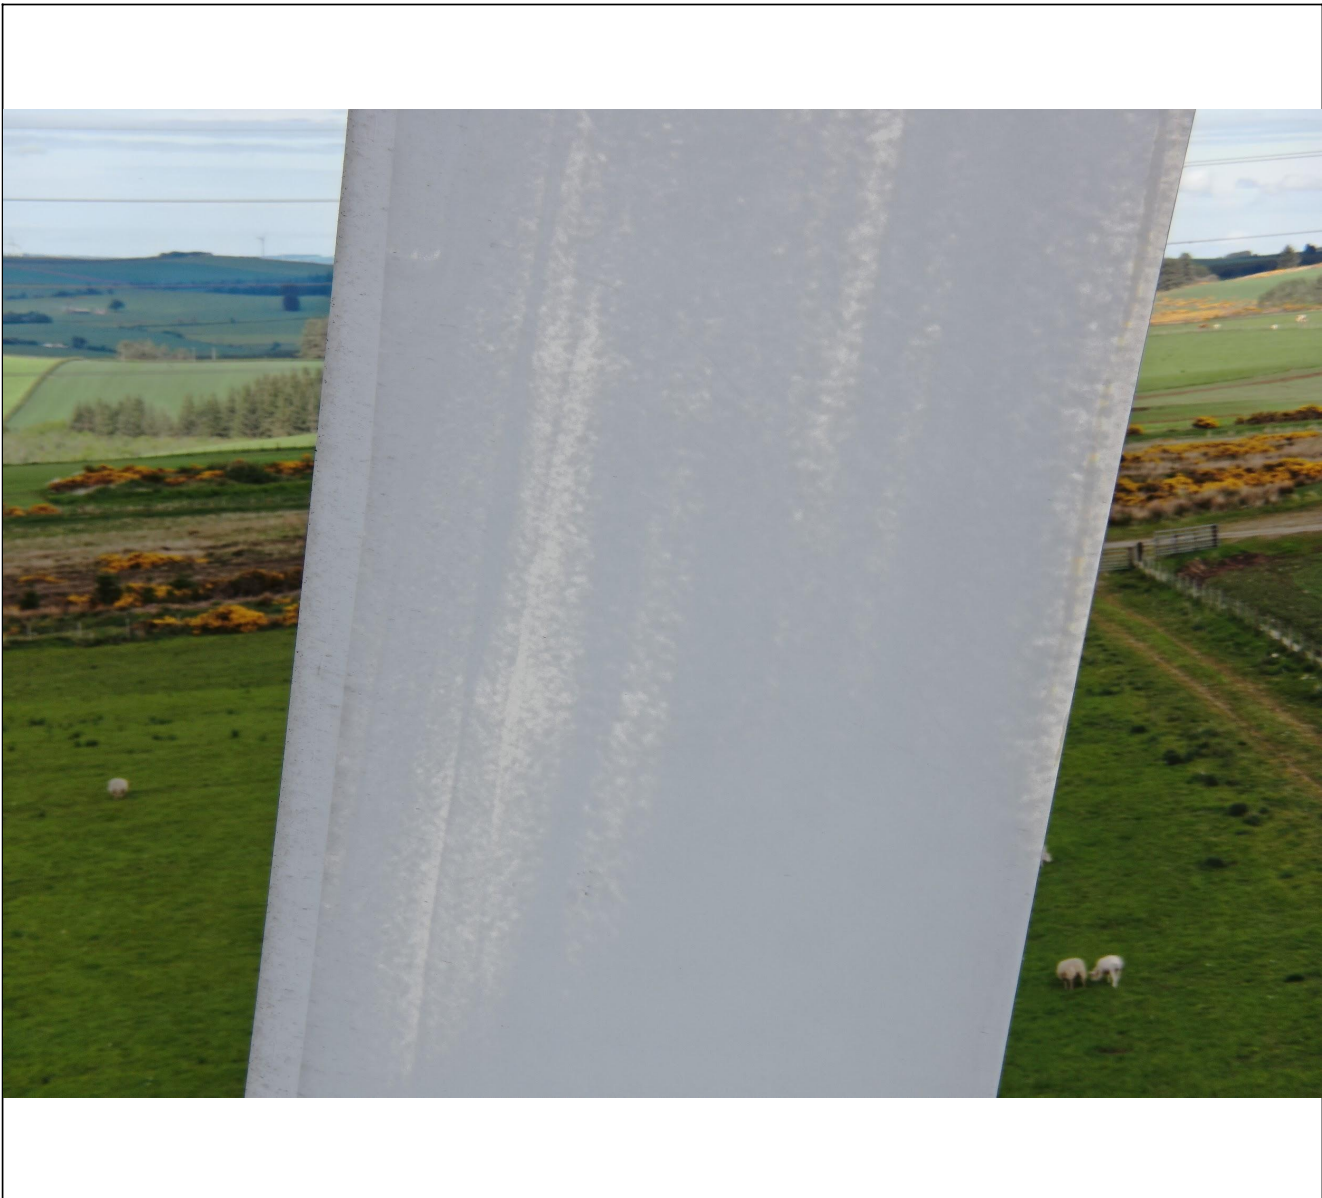
Damage Reference	DN-26	
Damage Category	CAT 2	
Damage Type	Erosion	
Distance From Root (m)	26	
Blade Surface	Pressure Side	
Blade Letter/Number	B	
Blade SN		
Image Ref.		
Description	Topcoat eroded

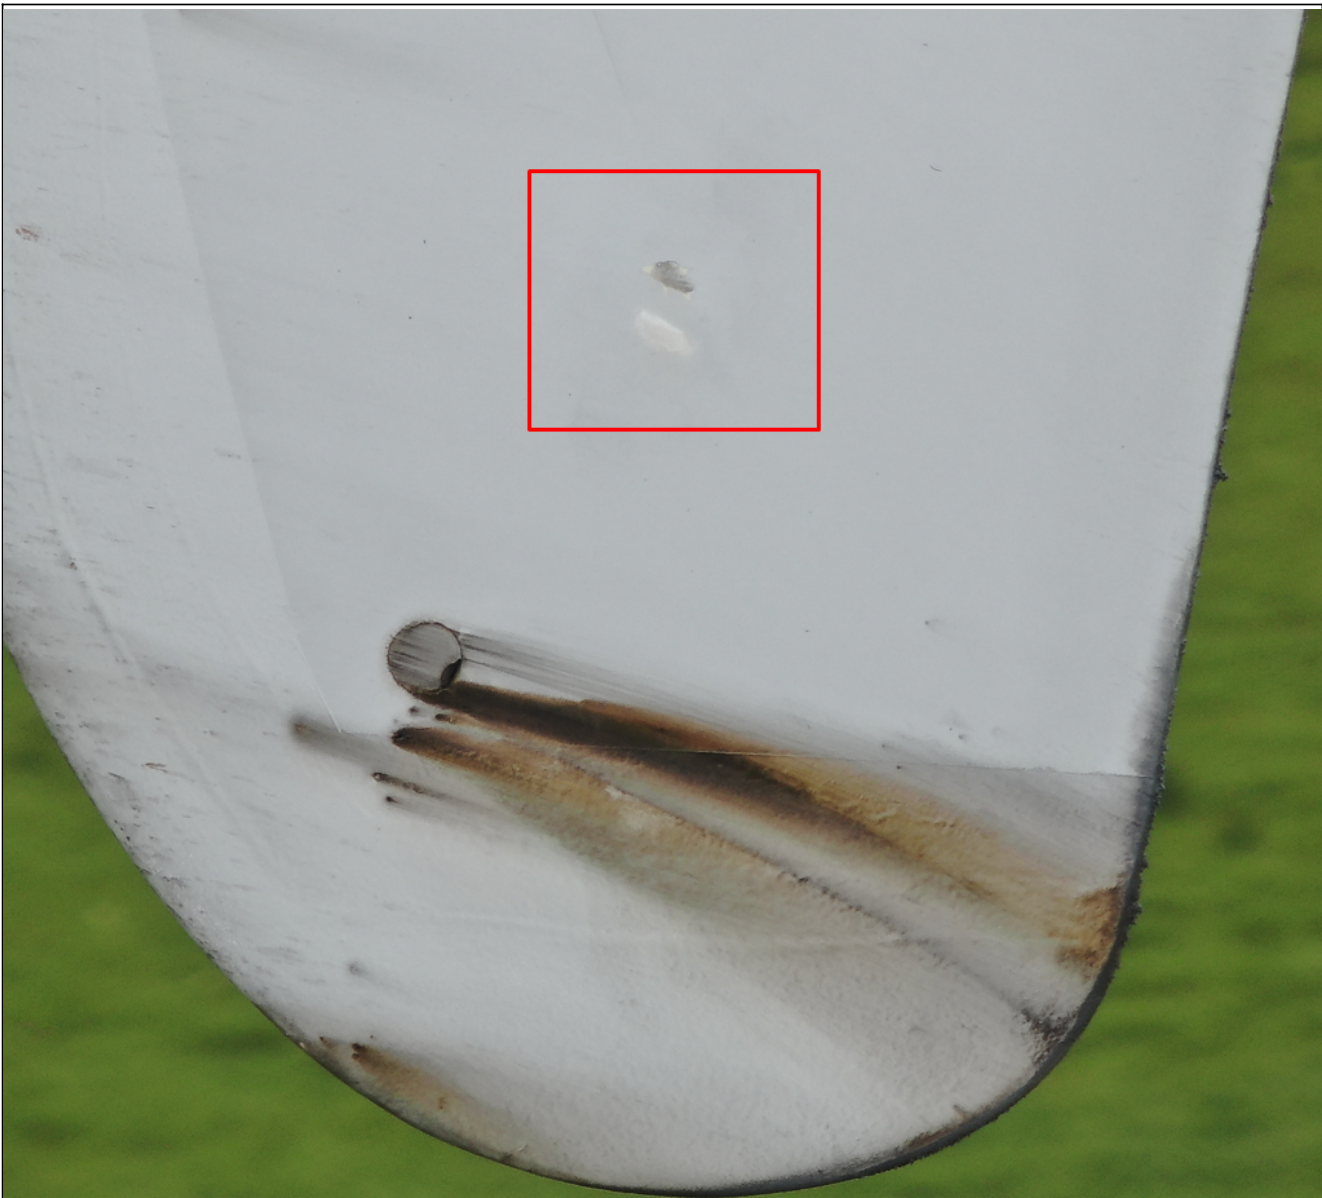
Damage Reference	DN-27	
Damage Category	CAT 2	
Damage Type	Chipping	
Distance From Root (m)	32	
Blade Surface	Pressure Side	
Blade Letter/Number	B	
Blade SN		
Image Ref.		
Description	Chipping to topcoat. Exposing gelcoat.

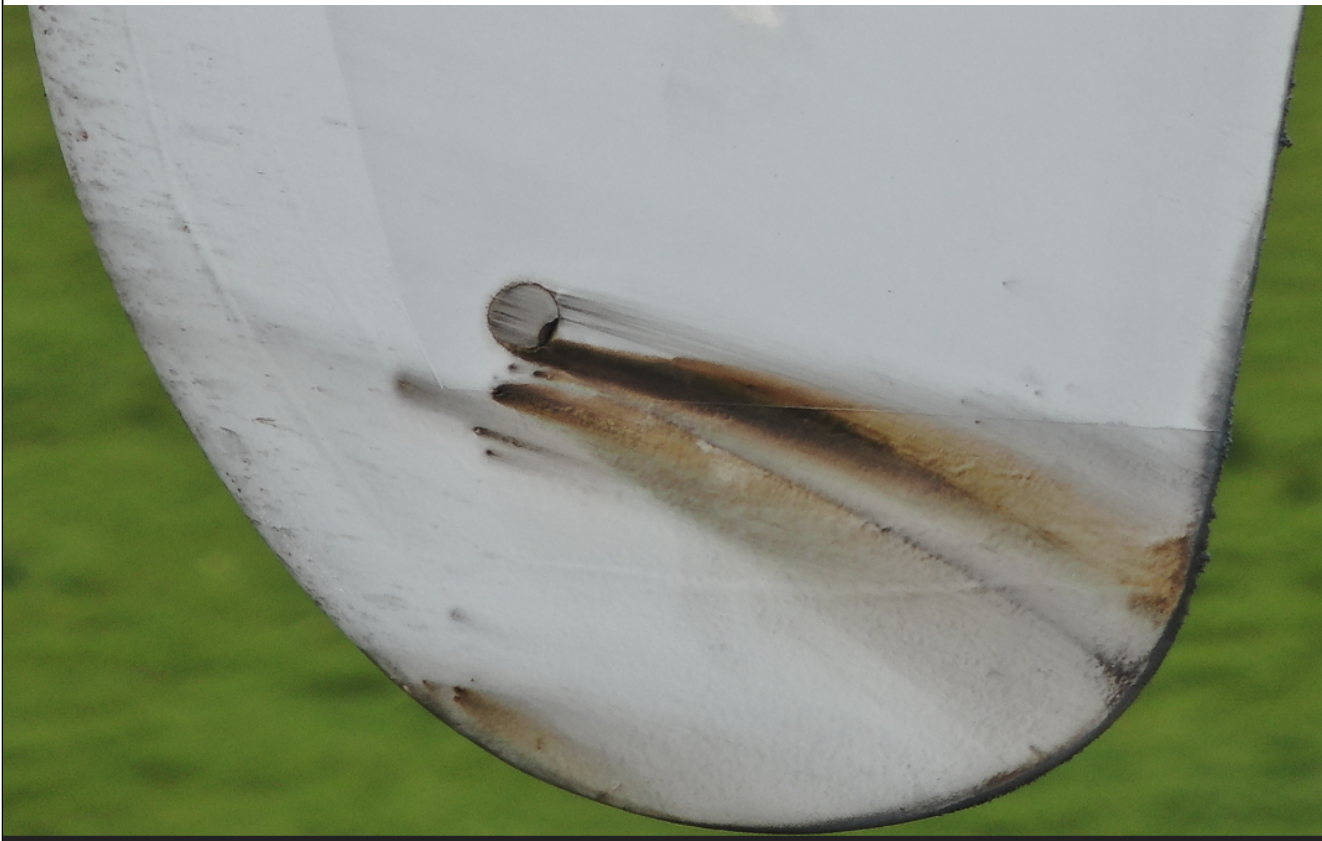
Damage Reference	DN-28	
Damage Category	CAT 2	
Damage Type	Lightning damage	
Distance From Root (m)	32	
Blade Surface	Pressure Side	
Blade Letter/Number	B	
Blade SN		
Image Ref.		
Description	Lightning receptor hit by lightning and slightly melted.
