Wind Turbine Blade Inspection Report

Example Wind Farm

T07

Asset: T07 - 25040 - Vestas V66

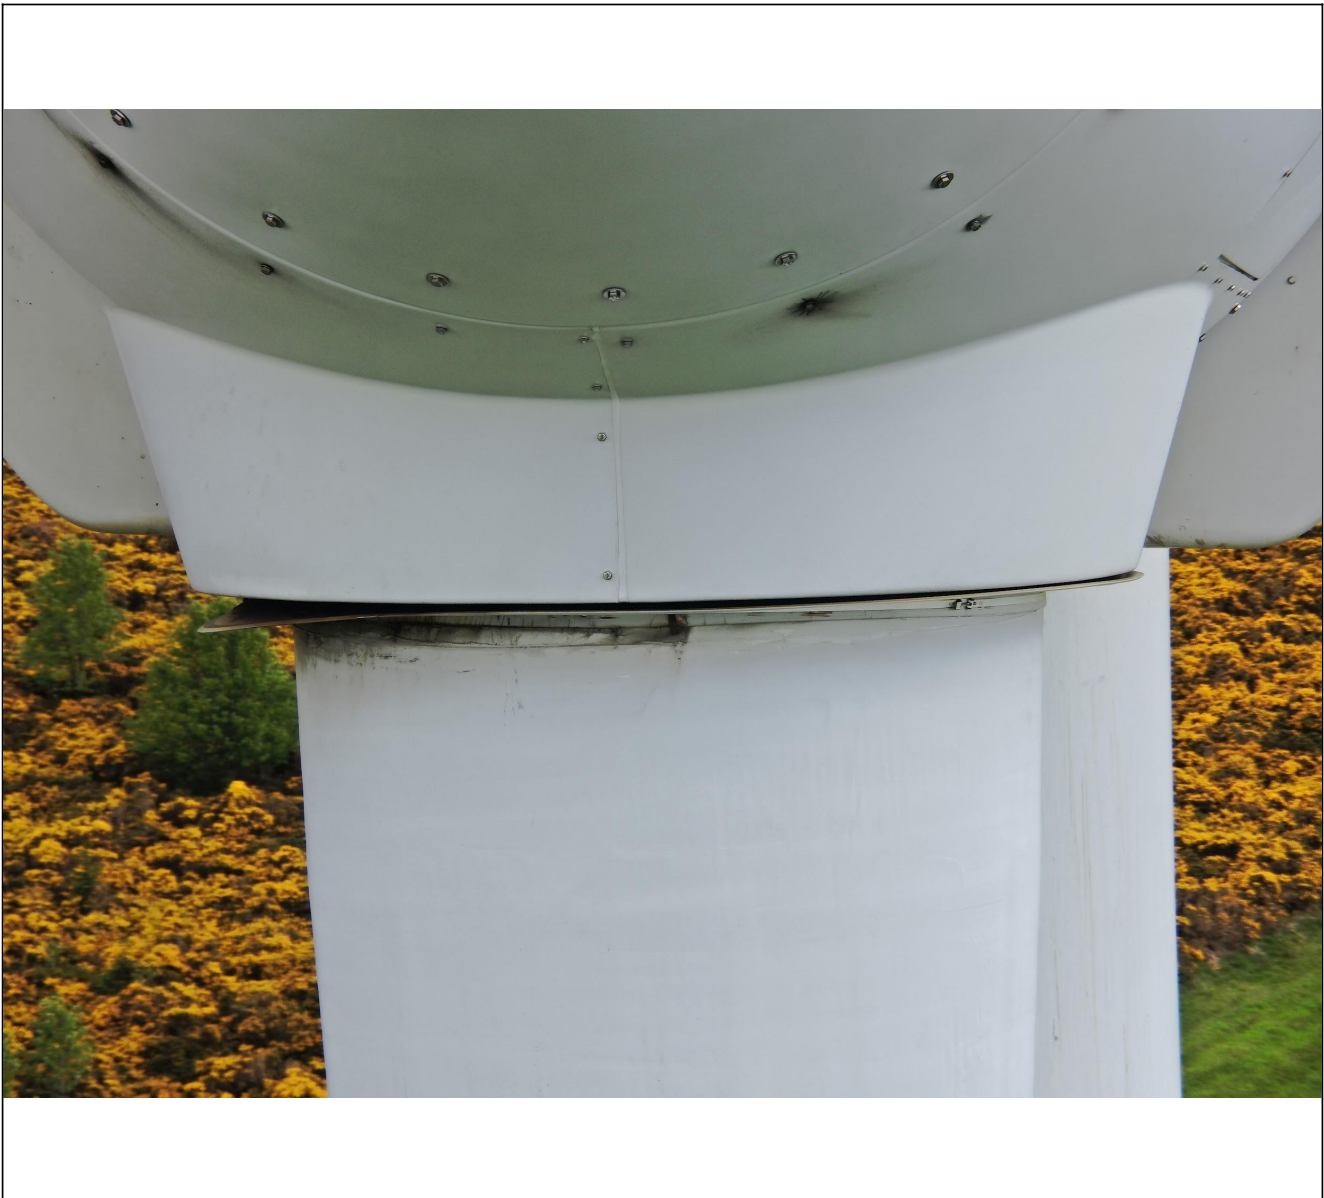
Damage Reference	DN-29	
Damage Category	CAT 2	
Damage Type	Out of alignment	
Distance From Root (m)	0	
Blade Surface	Leading Edge	
Blade Letter/Number	C	
Blade SN		
Image Ref.		
Description	Rain deflector not flush with spinner

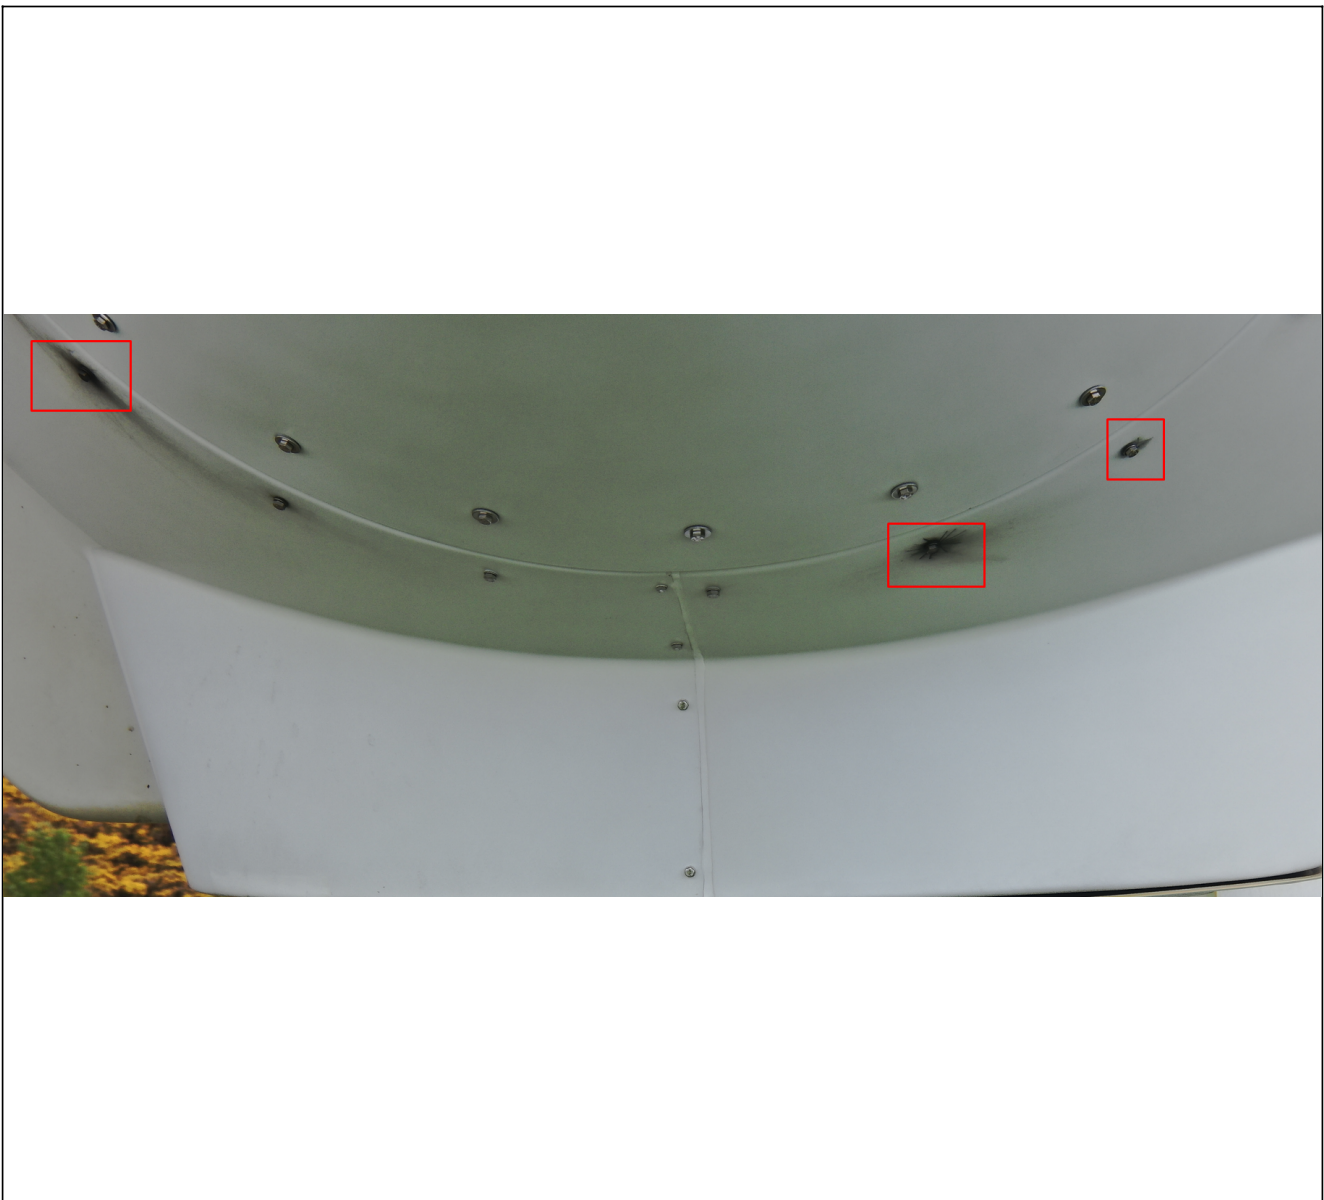
DN-04 / DN-24 / DN-30 / DN-33 : Some fasteners on the spinner are loose and are fretting.

Damage Reference	DN-30	
Damage Category	CAT 3	
Damage Type	Loose Fastener	
Distance From Root (m)	0	
Blade Surface	Leading Edge	
Blade Letter/Number	C	
Blade SN		
Image Ref.		
Description	Loose fasteners on hub damaging underlying laminate

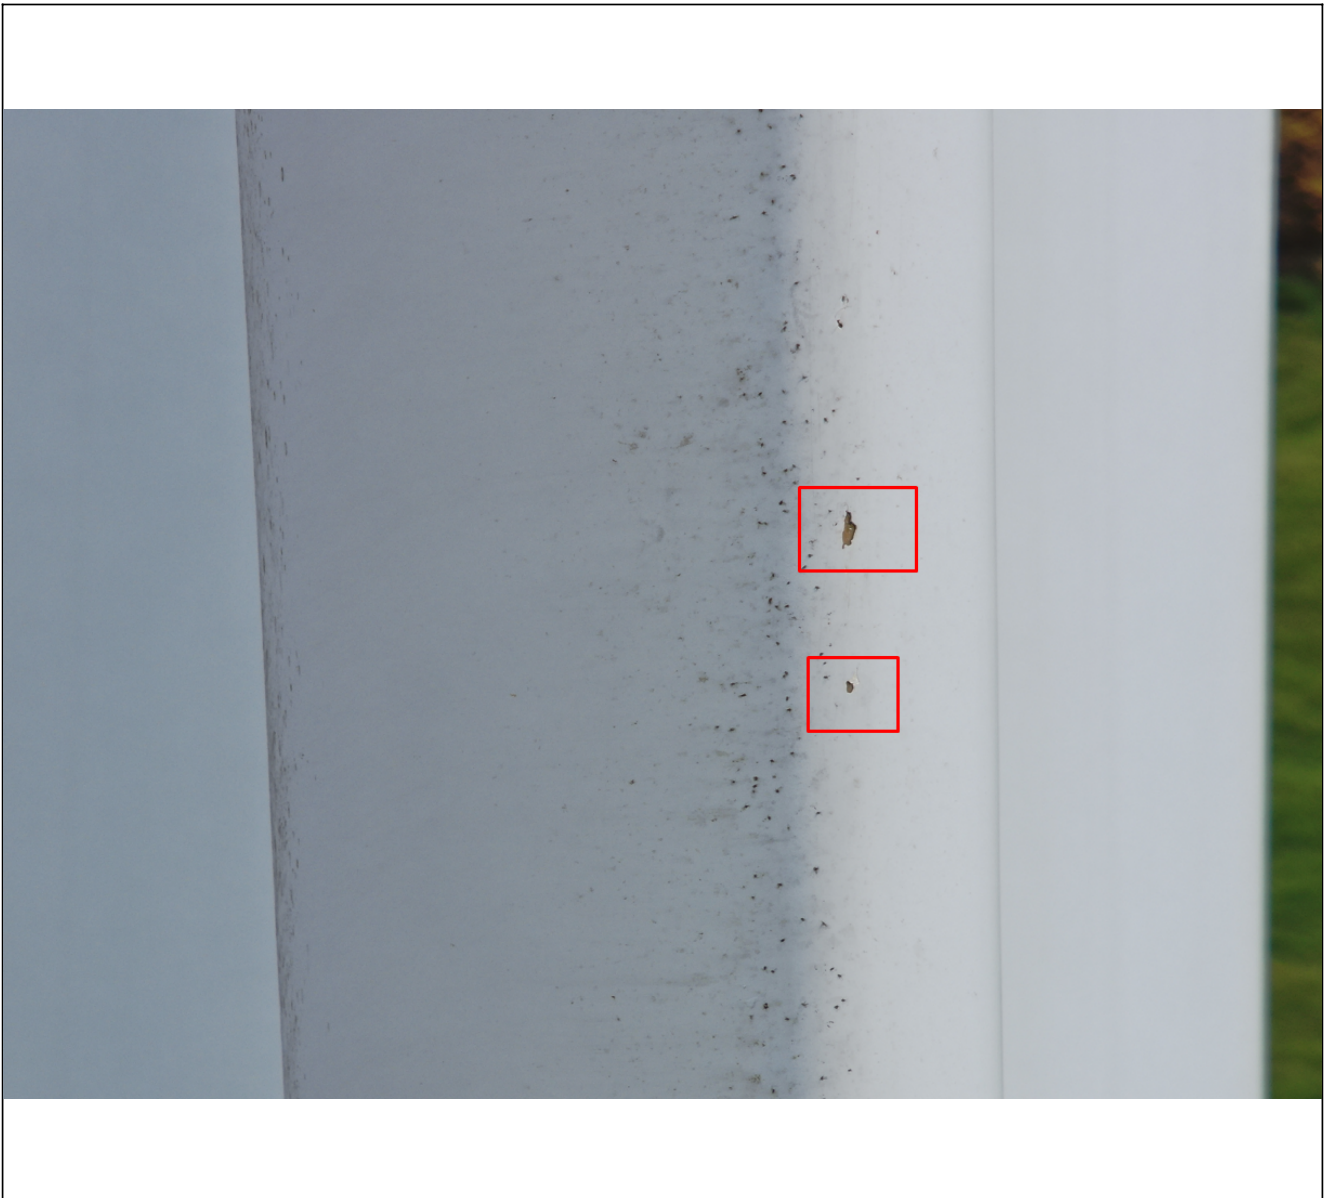
Damage Reference	DN-31	
Damage Category	CAT 2	
Damage Type	Erosion	
Distance From Root (m)	19	
Blade Surface	Leading Edge	
Blade Letter/Number	C	
Blade SN		
Image Ref.		
Description	Chipping to blade exposing laminate.

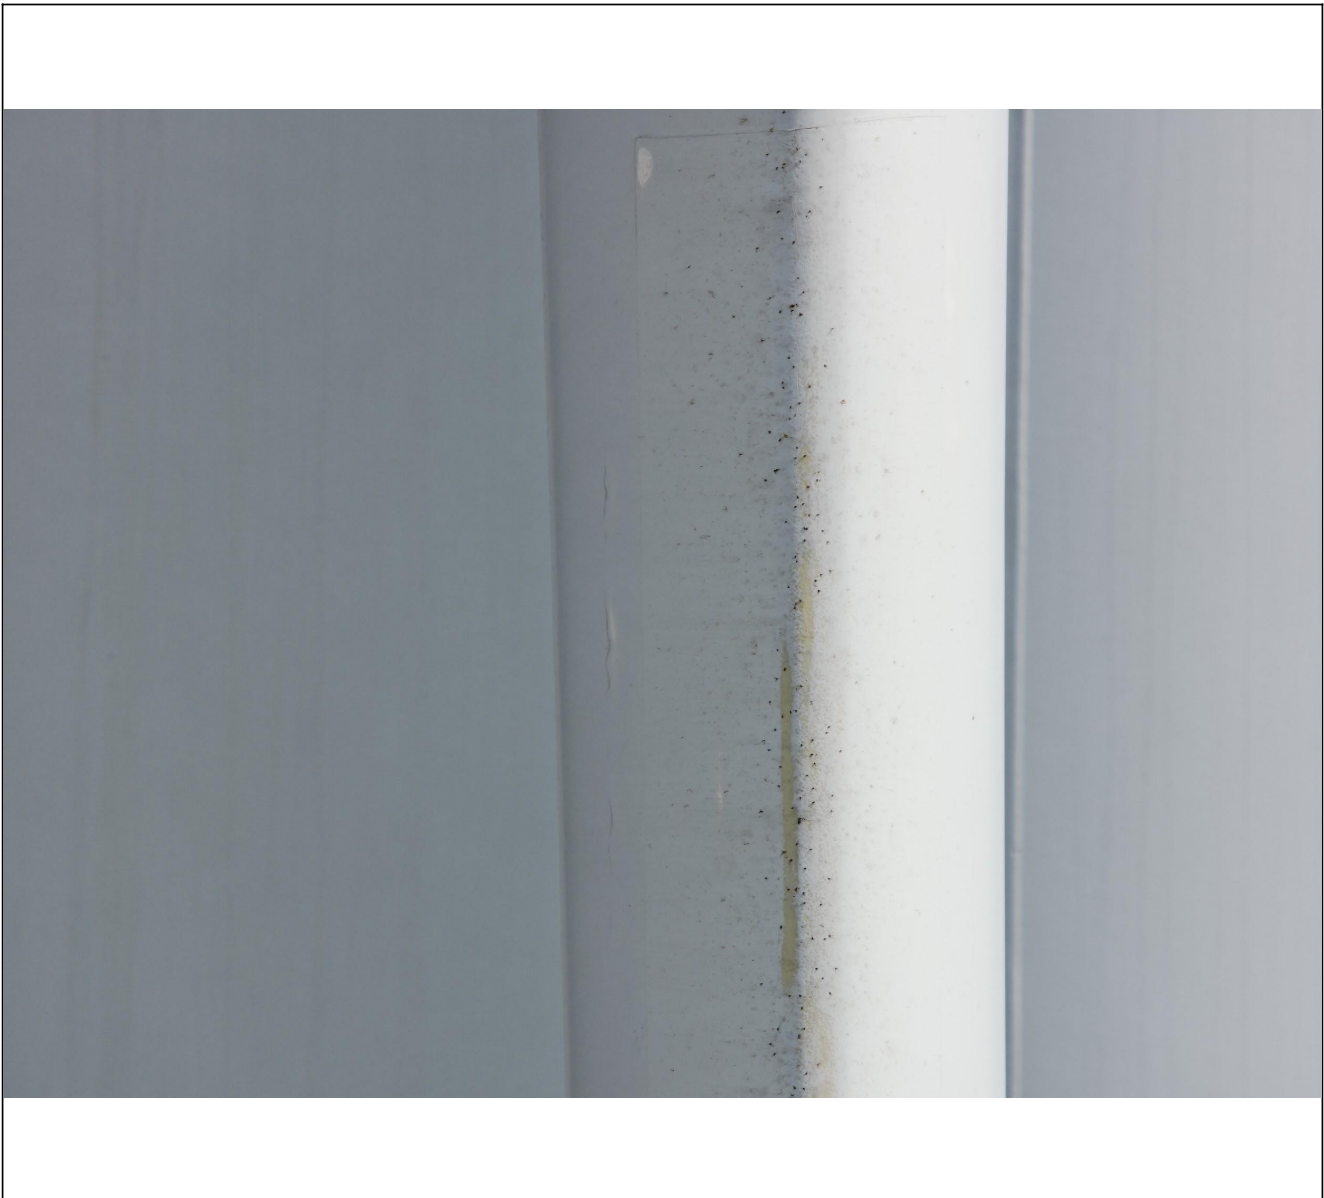
Damage Reference	DN-32	
Damage Category	CAT 2	
Damage Type	Erosion	
Distance From Root (m)	20	
Blade Surface	Leading Edge	
Blade Letter/Number	C	
Blade SN		
Image Ref.		
Description	Topcoat and gelcoat eroded

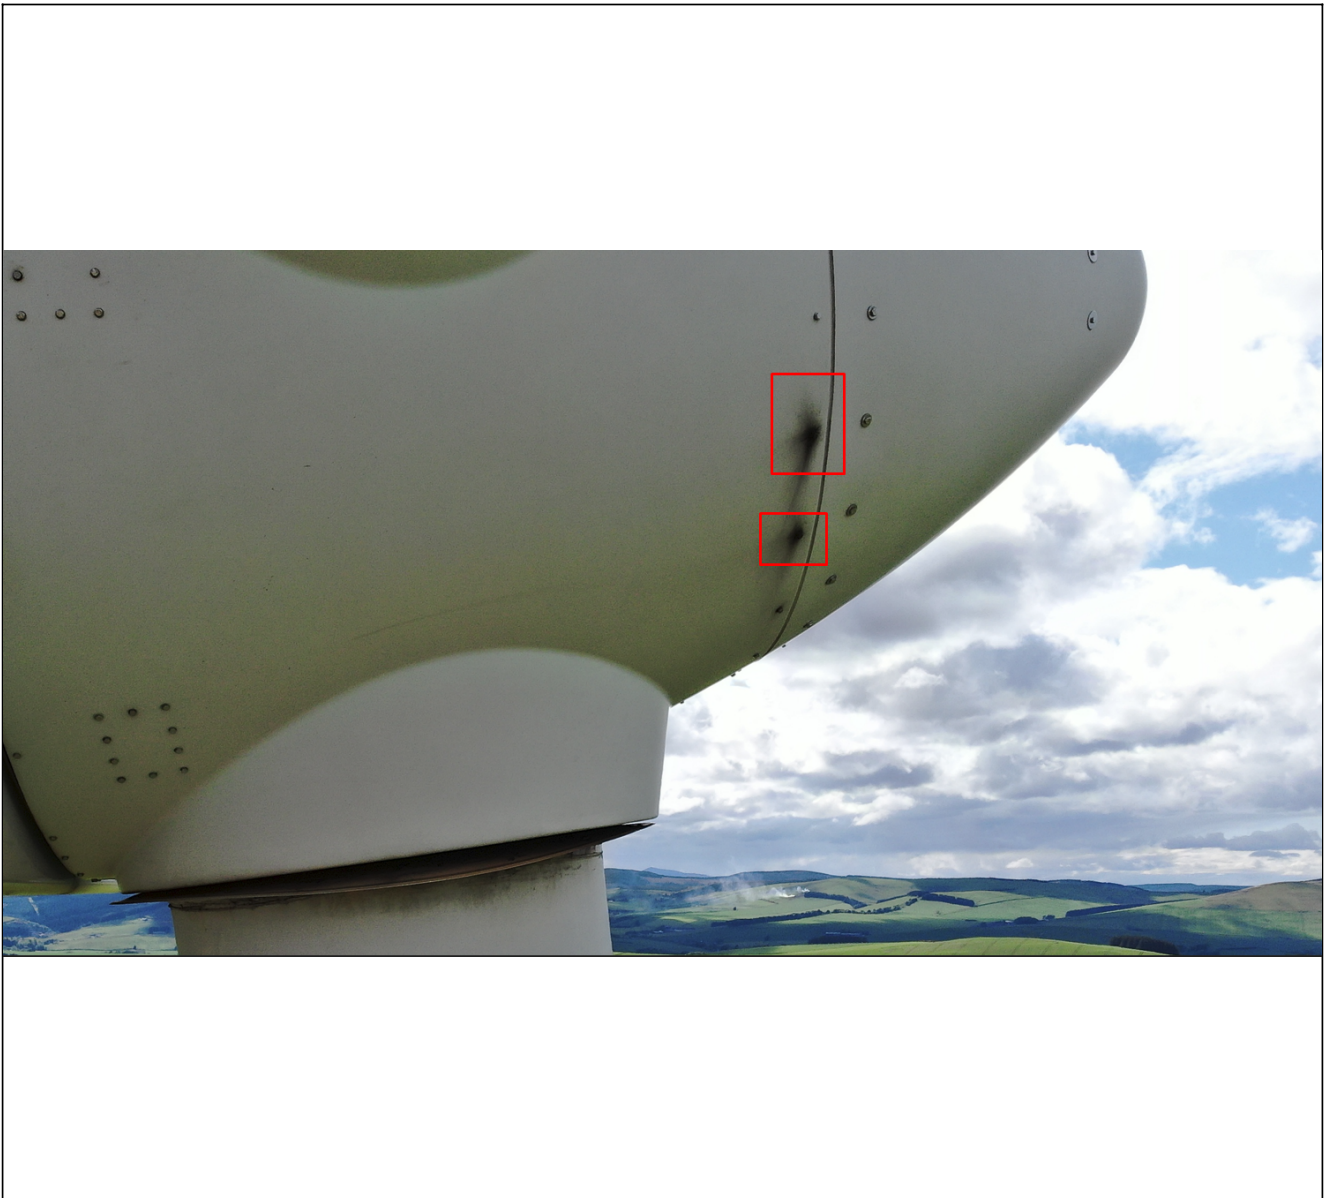
Damage Reference	DN-33	
Damage Category	CAT 3	
Damage Type	Loose Fastener	
Distance From Root (m)	0	
Blade Surface	Suction Side	
Blade Letter/Number	C	
Blade SN		
Image Ref.		
Description	Loose fasteners on hub damaging underlying laminate

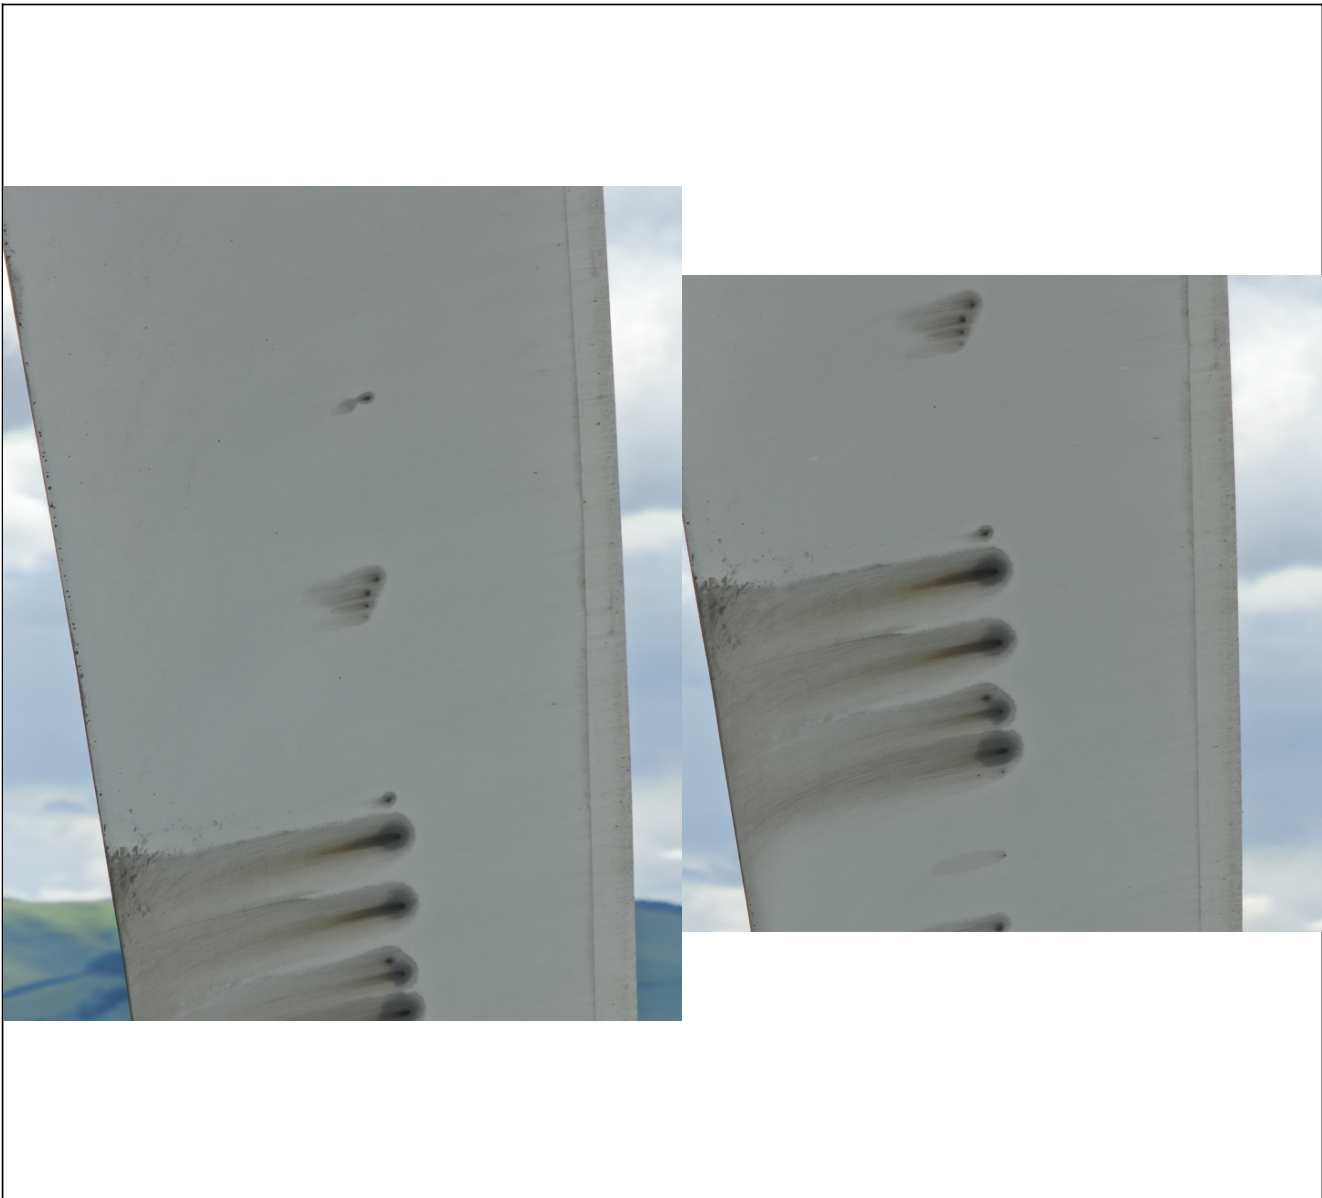
DN-07 / DN-08 / DN-10 / DN-34 / DN-37 / DN-38 : Apparent "drill and fill" repairs along the blade spar line. Noted for information.

Damage Reference	DN-34	
Damage Category	CAT 3	
Damage Type	Contamination	
Distance From Root (m)	31	
Blade Surface	Suction Side	
Blade Letter/Number	C	
Blade SN		
Image Ref.		
Description	Previous repairs along blade spar. Oil leaking through from the inside.

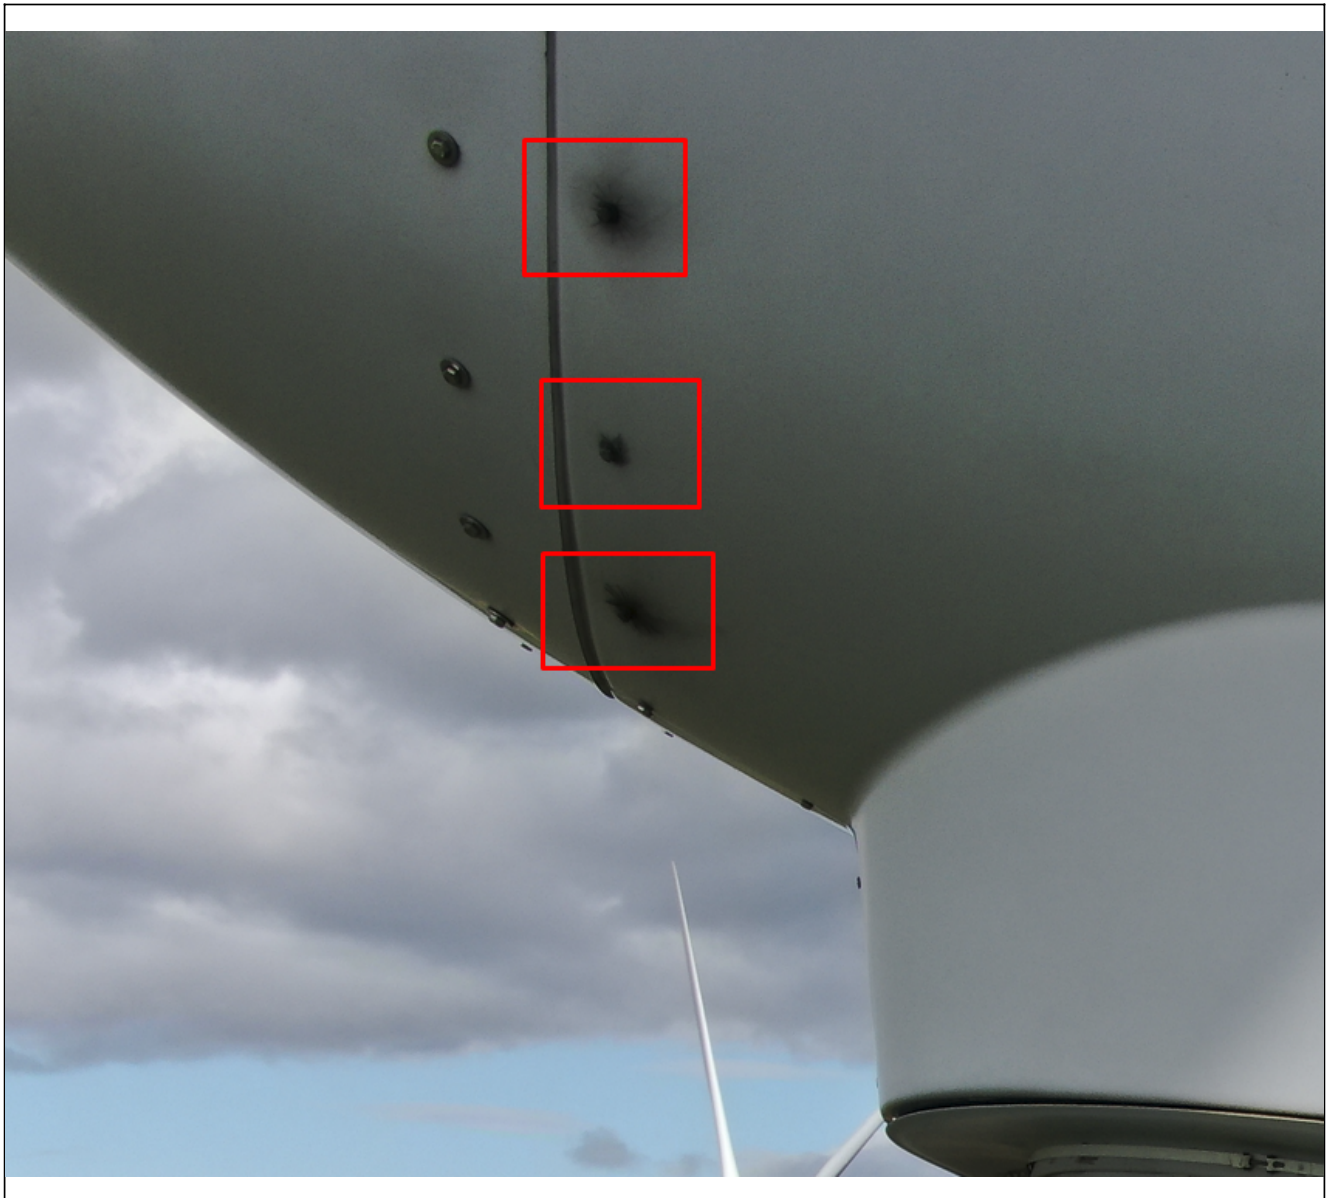
Damage Reference	DN-35	
Damage Category	CAT 3	
Damage Type	Loose Fastener	
Distance From Root (m)	0	
Blade Surface	Pressure Side	
Blade Letter/Number	C	
Blade SN		
Image Ref.		
Description	Loose fasteners on hub damaging underlying laminate

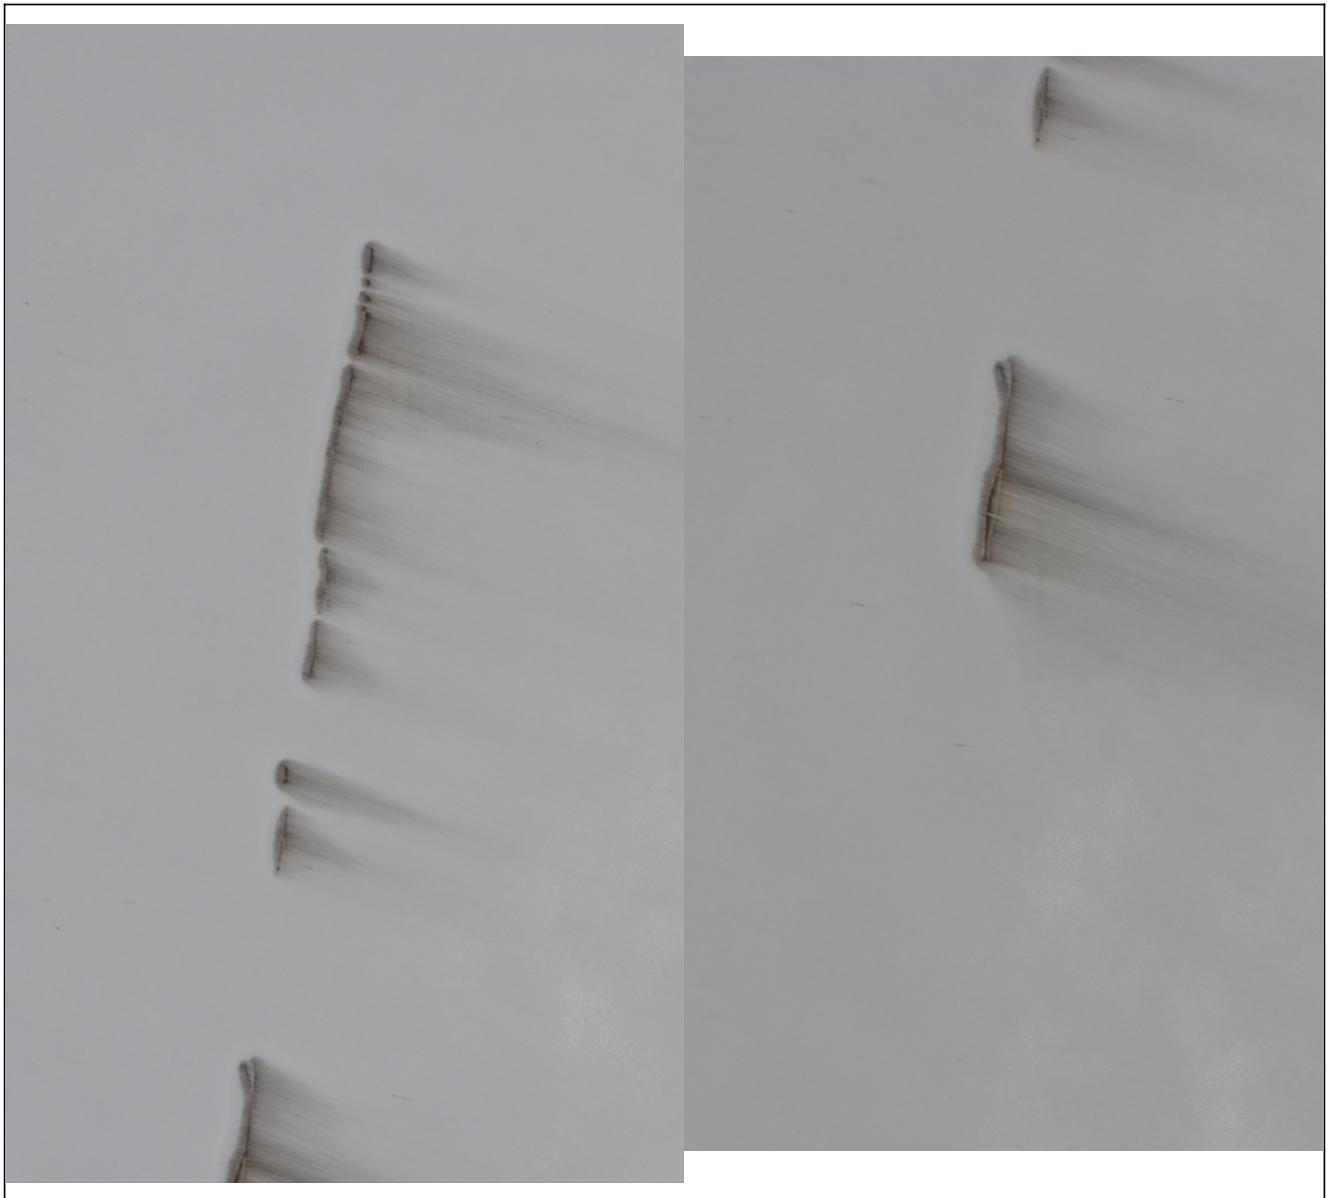
Damage Reference	DN-36	
Damage Category	CAT 2	
Damage Type	Cracking	
Distance From Root (m)	27	
Blade Surface	Pressure Side	
Blade Letter/Number	C	
Blade SN		
Image Ref.		
Description	Cracks in topcoat and gelcoat.

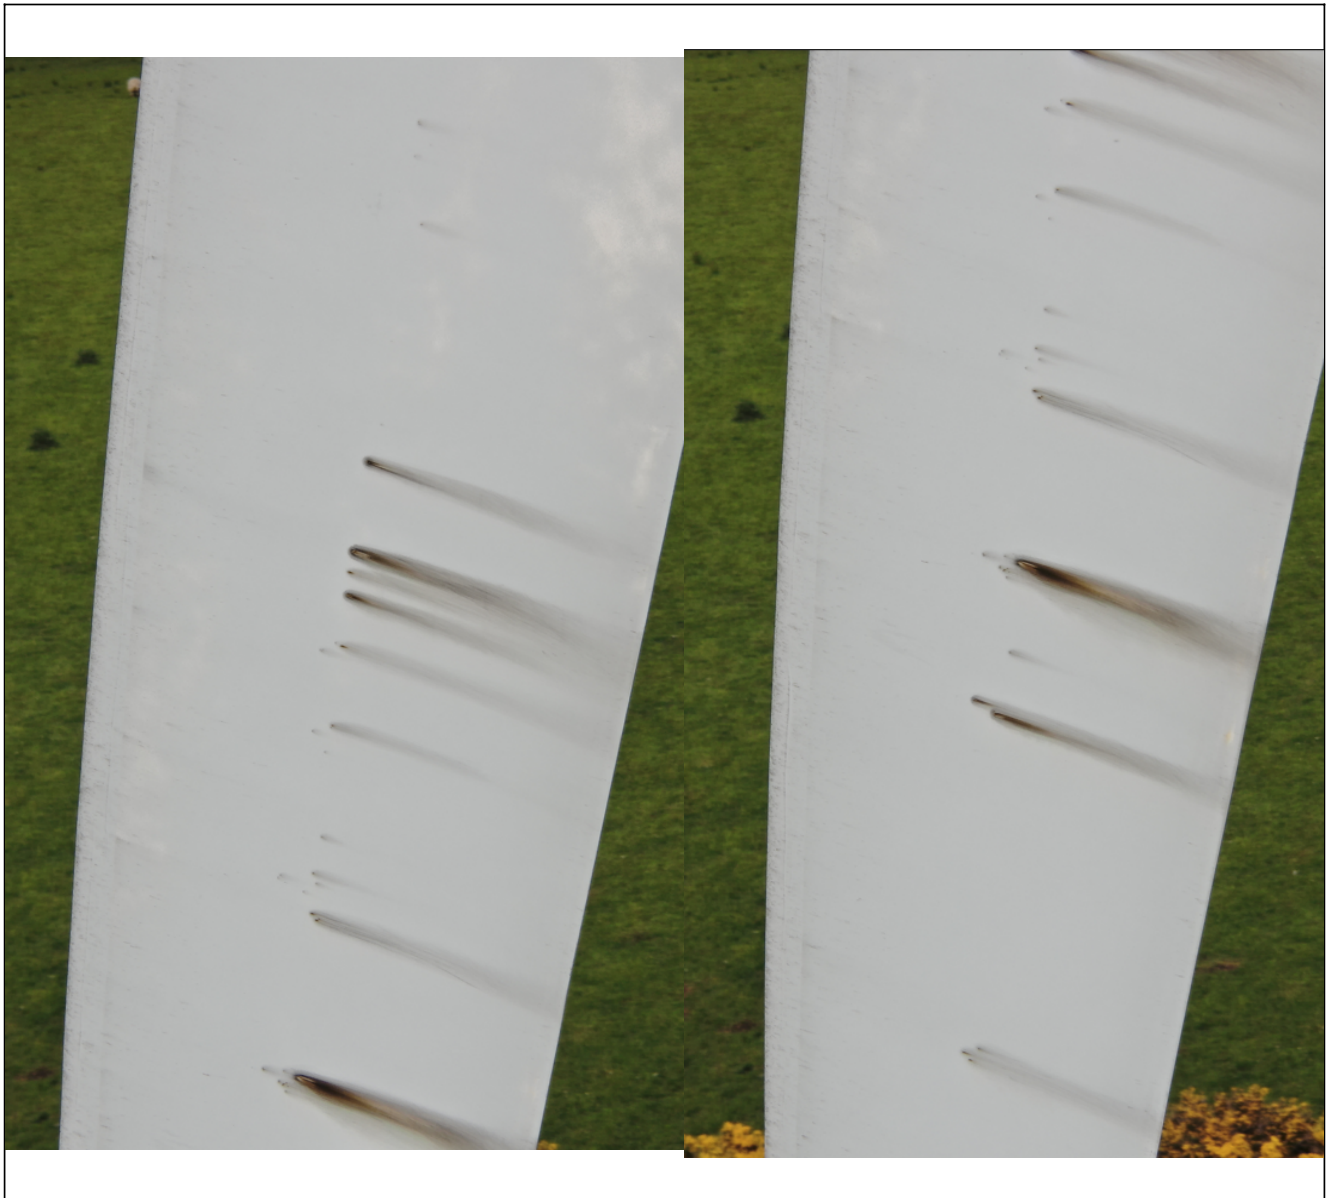
Damage Reference	DN-37	
Damage Category	CAT 2	
Damage Type	Contamination	
Distance From Root (m)	31	
Blade Surface	Pressure Side	
Blade Letter/Number	C	
Blade SN		
Image Ref.		
Description	Previous repairs along blade spar. Oil leaking through from the inside.

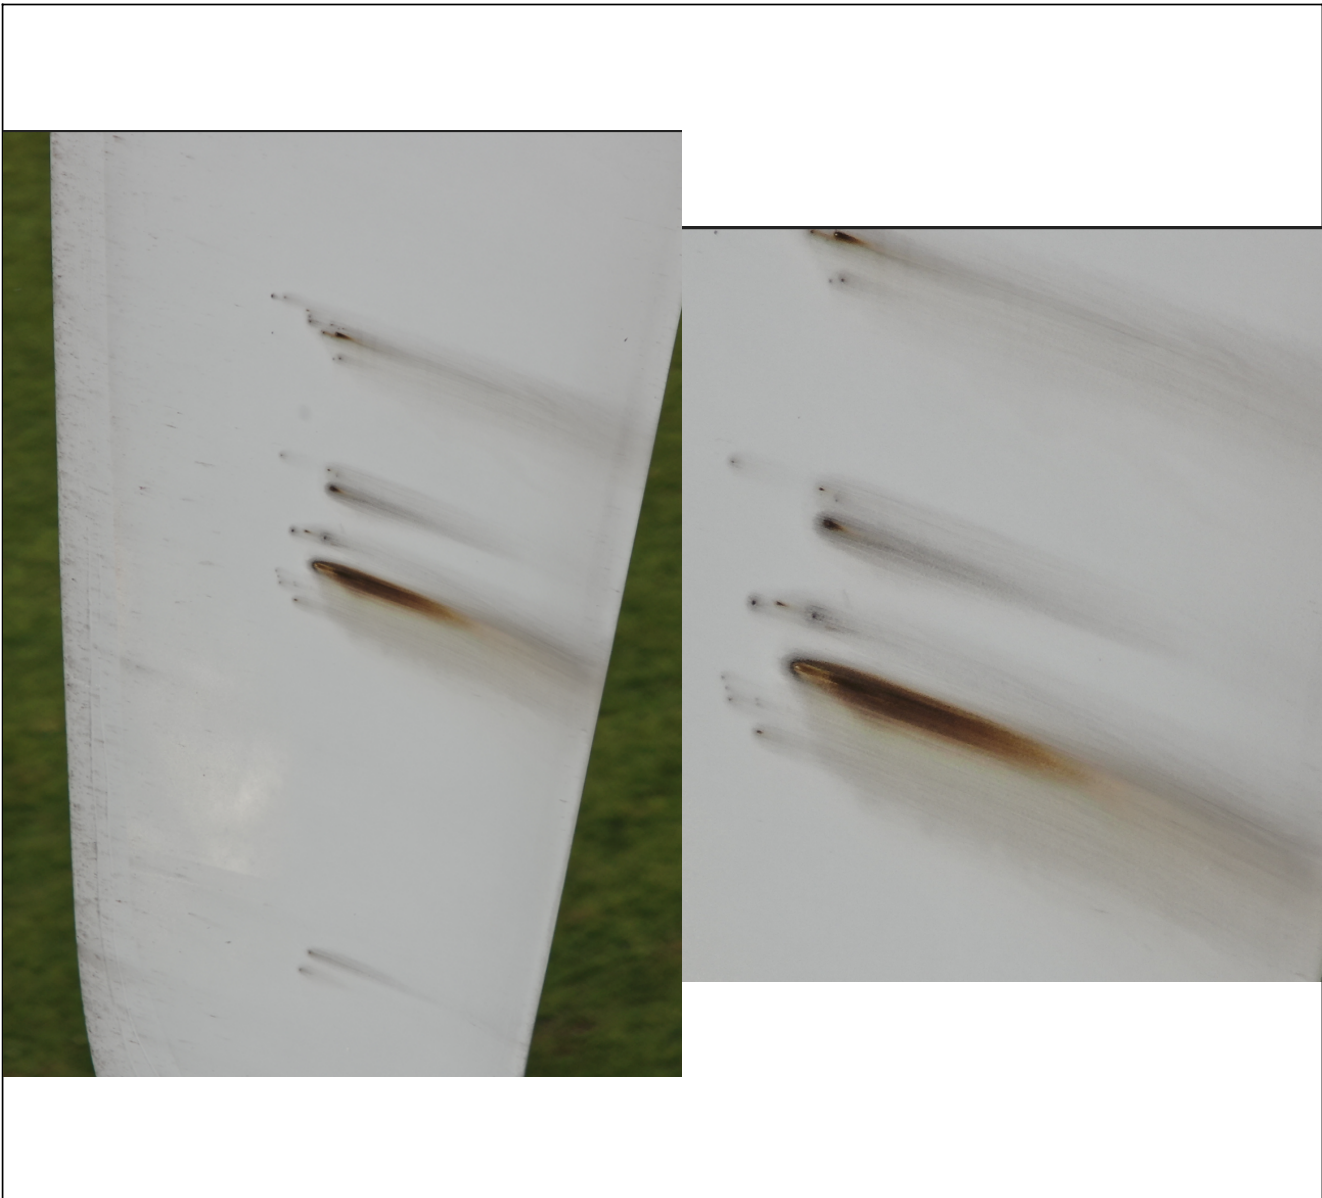
Damage Reference	DN-38	
Damage Category	CAT 2	
Damage Type	Contamination	
Distance From Root (m)	32	
Blade Surface	Pressure Side	
Blade Letter/Number	C	
Blade SN		
Image Ref.		
Description	Previous repairs along blade spar. Oil leaking through from the inside.

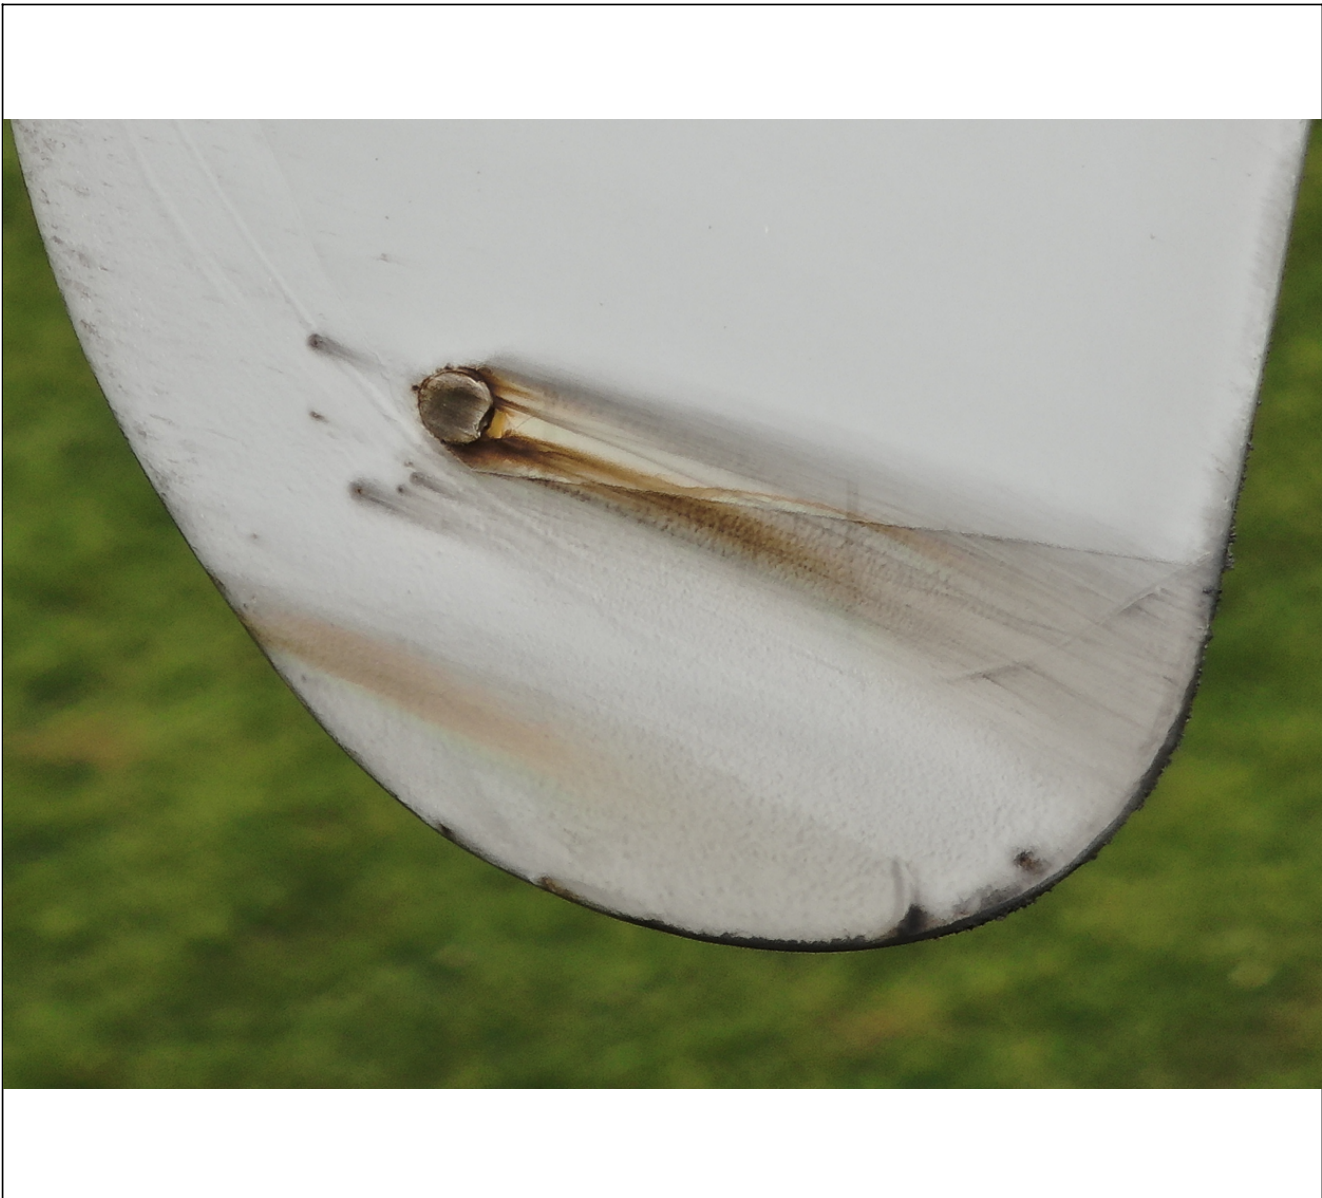
Damage Reference	DN-39	
Damage Category	CAT 2	
Damage Type	Lightning damage	
Distance From Root (m)	32	
Blade Surface	Pressure Side	
Blade Letter/Number	C	
Blade SN		
Image Ref.		
Description	Lightning receptor hit by lightning and slightly melted
