Wind Turbine Blade Inspection Report

UAV/SUA Aerial Inspection

Report Number: MECHV_REP-200-672-1

Client: DJN Renewables
Location: Curraghderrig Wind Farm, Co. Kerry
Asset: Turbine T02 - Enercon E70 E4 2300 - Serial# 156345

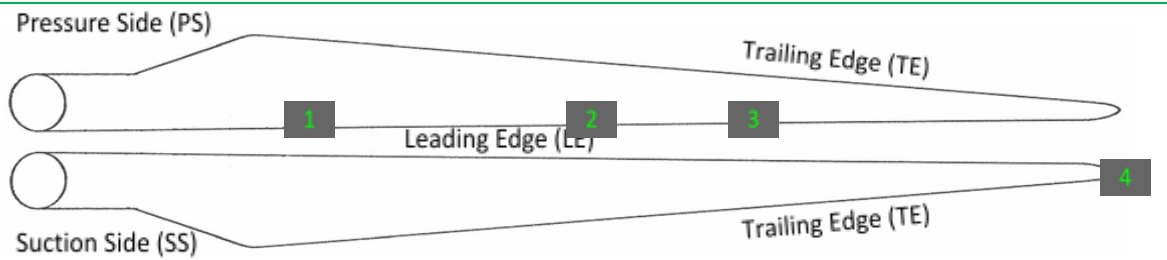
Blade A
Serial# 5267

REF	Description	CAT
1	Small scratch in paint on LE	2
2	LE Erosion	2
3	Gouge in gelcoat. Construction/transport damage	3
4	Oil contamination at tip seeping from drain hole.	2
5		
6		
7

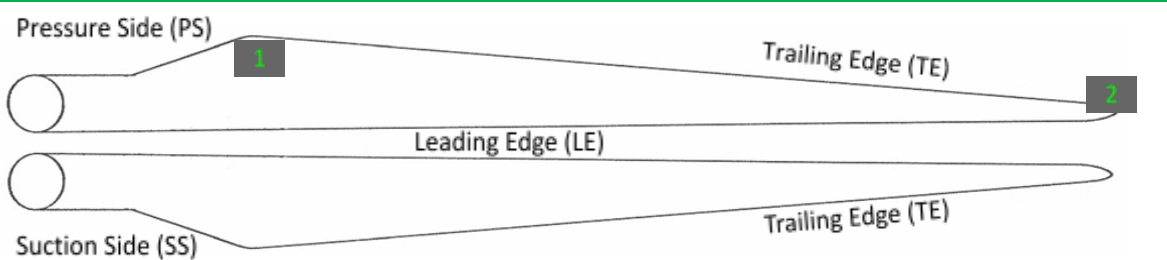
Blade B
Serial# 5268

REF	Description	CAT
1	Gel coat cracking	2
2	Small chip in gel coat at TE near tip	2
3		
4		
5		
6		
7

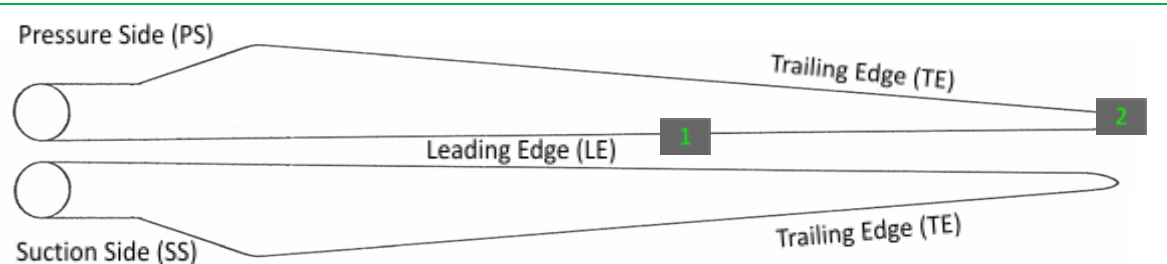
Blade C
Serial# 5266

REF	Description	CAT
1	Minor LE Erosion. Isolated small patch.	2
2	LE Erosion at tip.	2
3		
4		
5		
6		
7

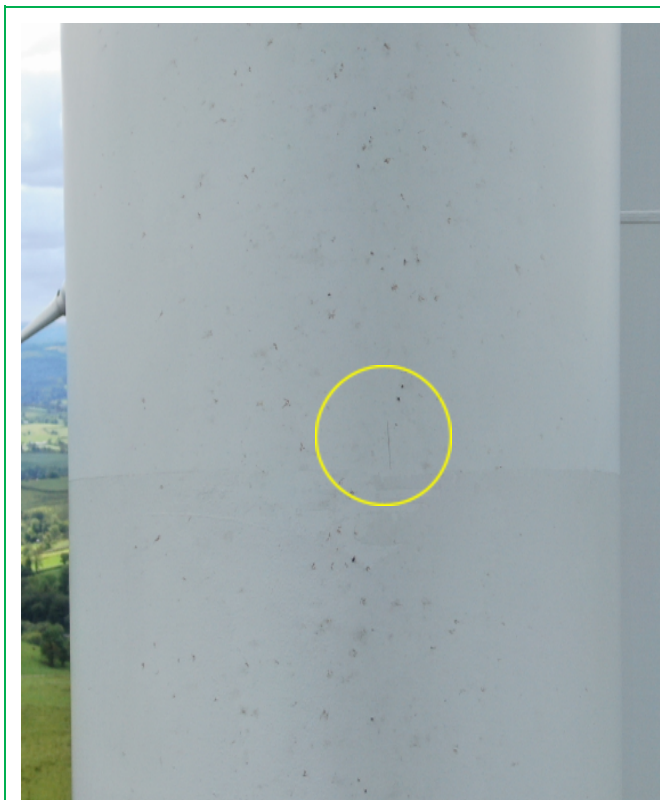
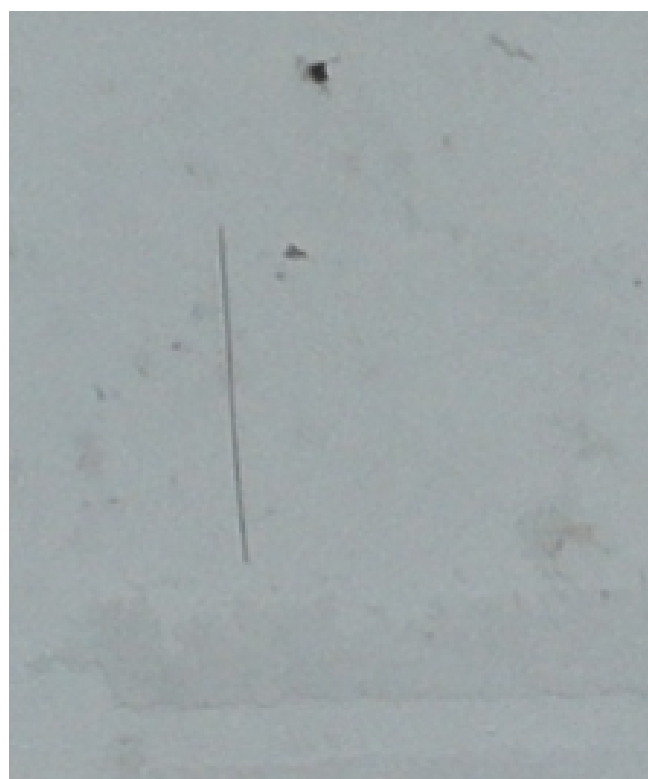
REF #	1
		Damage Class - CAT	1
		Damage - Type	Handling
		Distance from Root	8m
		<input checked="" type="checkbox"/> LE <input type="checkbox"/> TE <input type="checkbox"/> PS <input type="checkbox"/> SS	
Comment	Small scratch in paint on LE	Blade	A
Recommendation	n/a	Serial#	5267
		Image Ref	DJI_0489

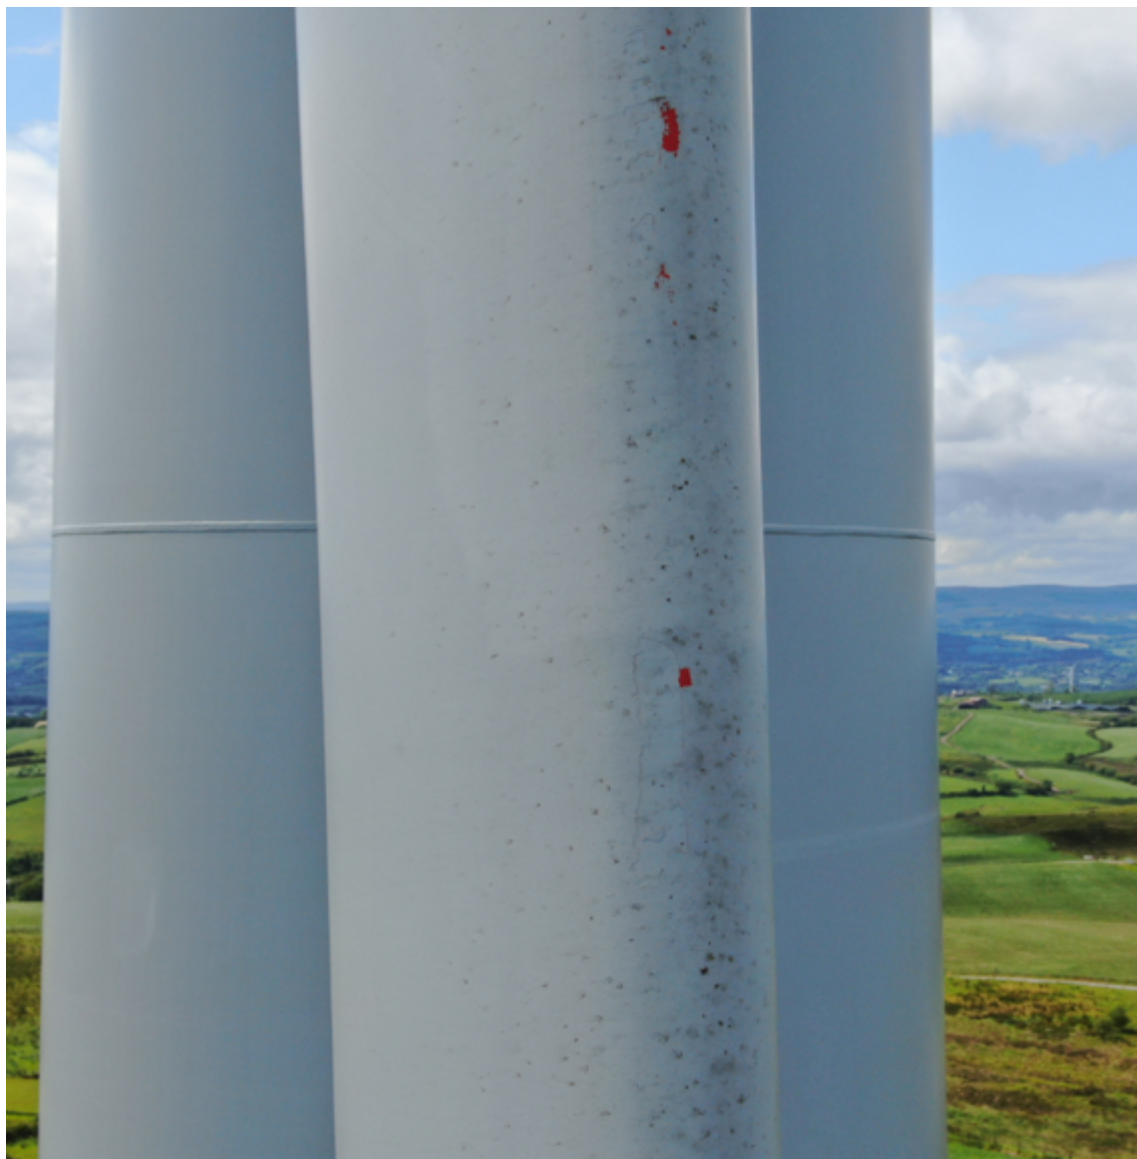
IMAGE 1

REF #		2	
		Damage Class - CAT		2	
		Damage - Type		Wear	
		Distance from Root		21m	
		<input checked="" type="checkbox"/> LE <input type="checkbox"/> TE <input type="checkbox"/> PS <input type="checkbox"/> SS			
Comment	LE Erosion	Blade	A	Serial#	5267
Recommendation	n/a	Image Ref		DJI_0512

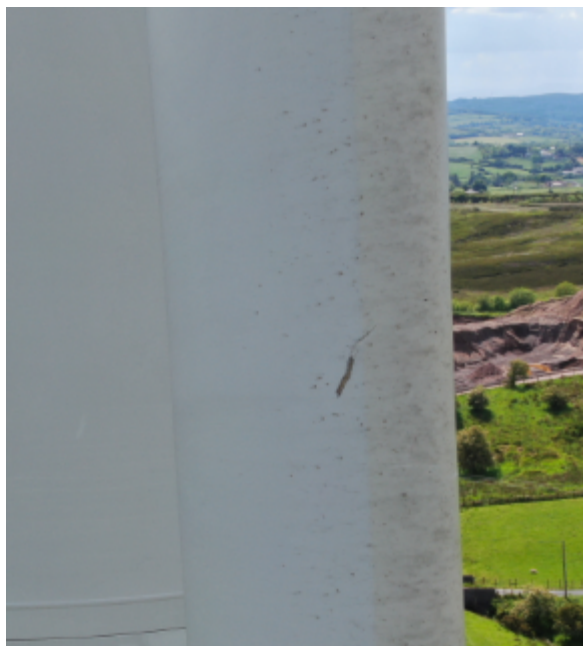
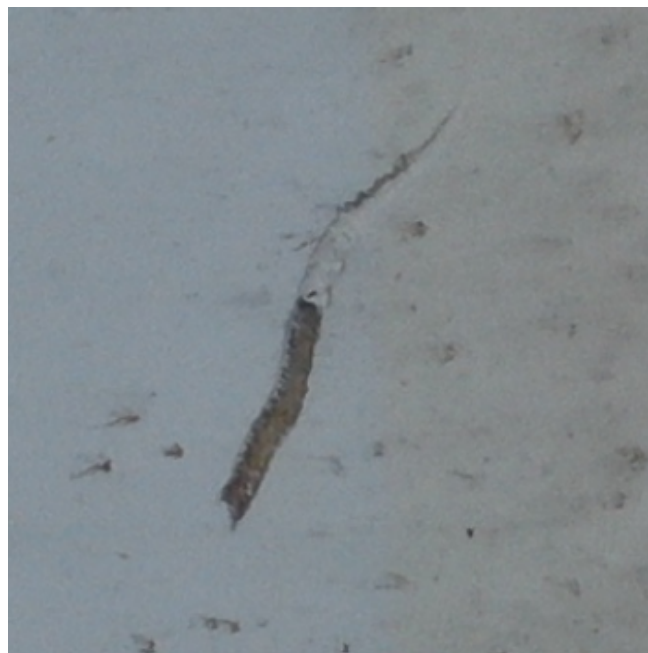
REF #		3	
		Damage Class - CAT		3	
		Damage - Type		Handling	
		Distance from Root		30m	
		<input checked="" type="checkbox"/> LE <input type="checkbox"/> TE <input type="checkbox"/> PS <input type="checkbox"/> SS			
Comment	Gouge in gelcoat. Construction/transport damage	Blade	A	Serial#	5267
Recommendation	n/a	Image Ref		DJI_0467

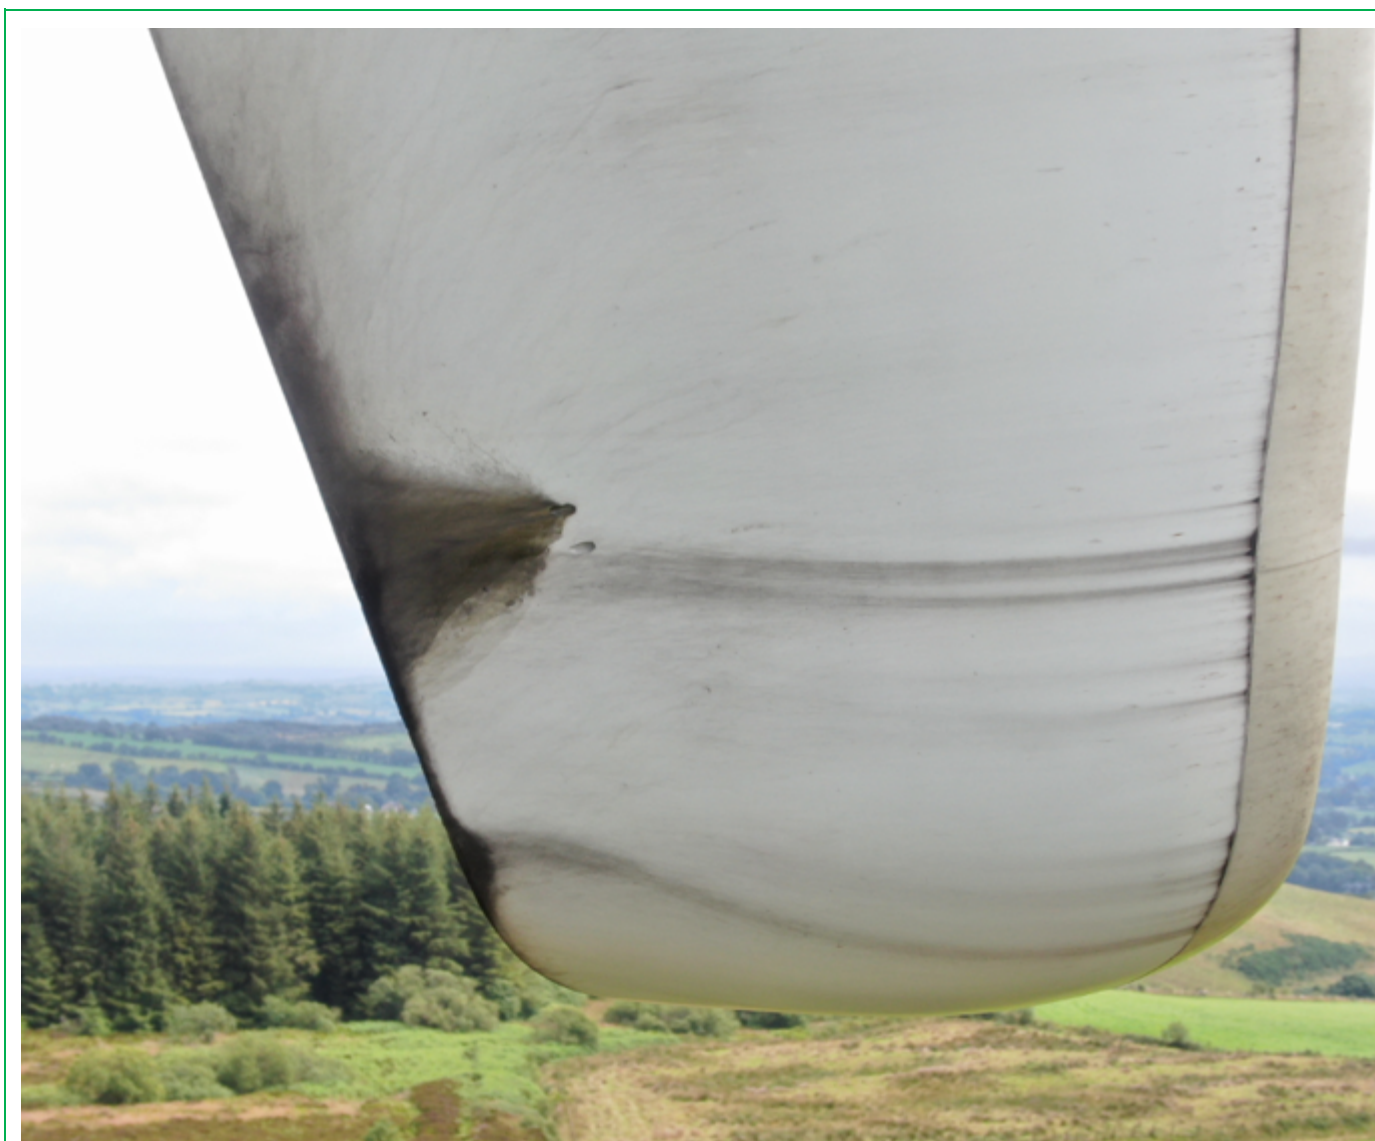
IMAGE 1

REF #		4	
		Damage Class - CAT		2	
		Damage - Type		Contamination	
		Distance from Root		40m	
		<input type="checkbox"/> LE <input type="checkbox"/> TE <input type="checkbox"/> PS <input checked="" type="checkbox"/> SS			
Comment	Oil contamination at tip seeping from drain hole.	Blade	A	Serial#	5267
Recommendation	n/a	Image Ref		DJI_0558

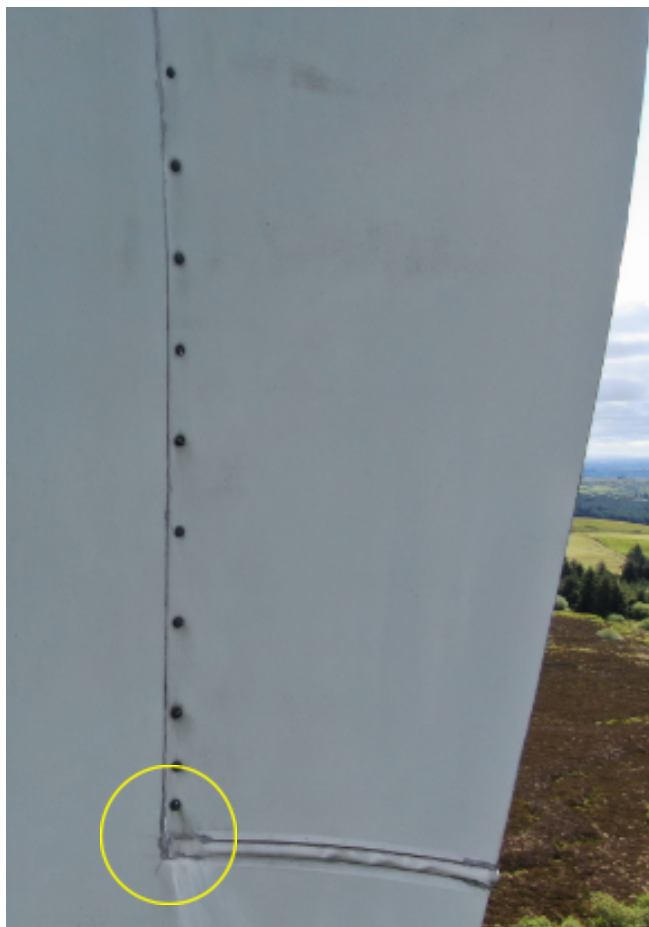
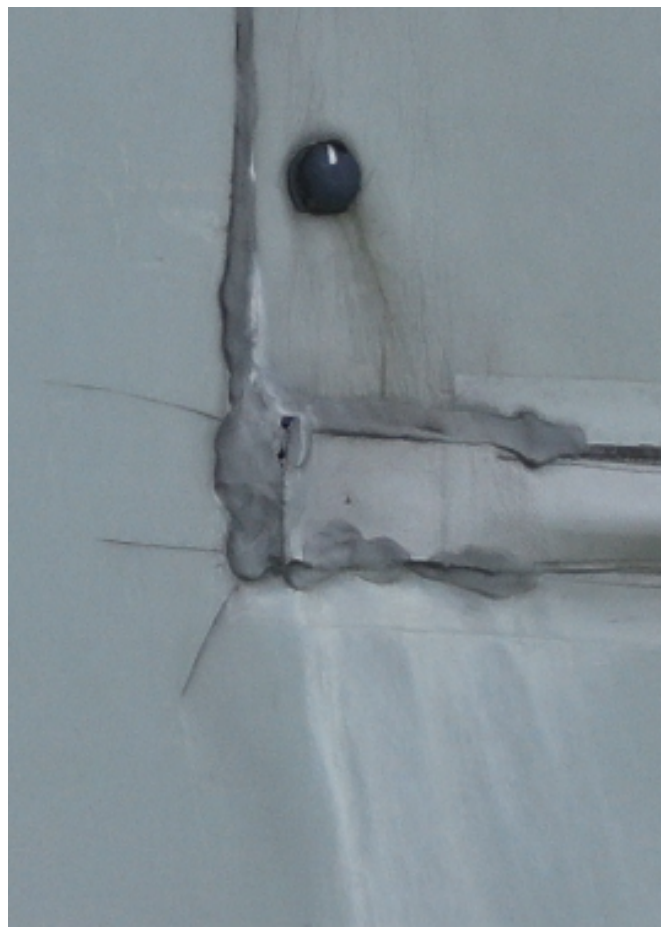
REF #		1	
		Damage Class - CAT		2	
		Damage - Type		Damage	
		Distance from Root		4m	
		<input type="checkbox"/> LE <input type="checkbox"/> TE <input checked="" type="checkbox"/> PS <input type="checkbox"/> SS			
Comment	Gel coat cracking	Blade	B	Serial#	5268
Recommendation	Monitor at next inspection	Image Ref		DJI_0582

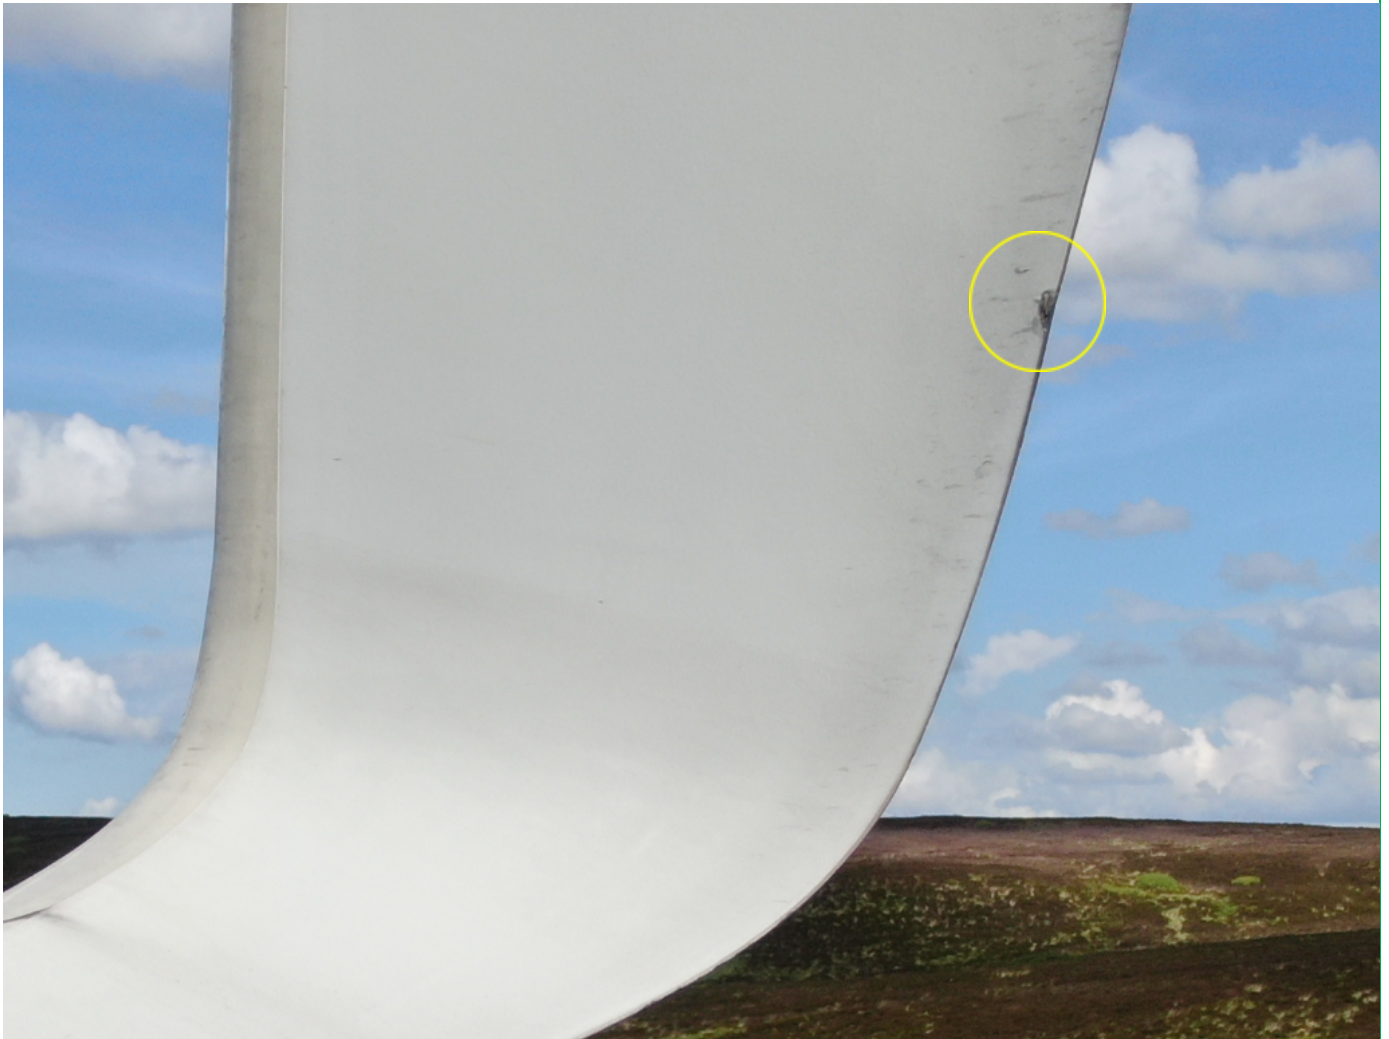
IMAGE 1

REF #	2		
		Damage Class - CAT	2		
		Damage - Type	Damage		
		Distance from Root	40m		
		<input type="checkbox"/> LE <input checked="" type="checkbox"/> TE <input type="checkbox"/> PS <input type="checkbox"/> SS			
Comment	Small chip in gel coat at TE near tip	Blade	B	Serial#	5268
Recommendation	n/a	Image Ref		DJI_0641

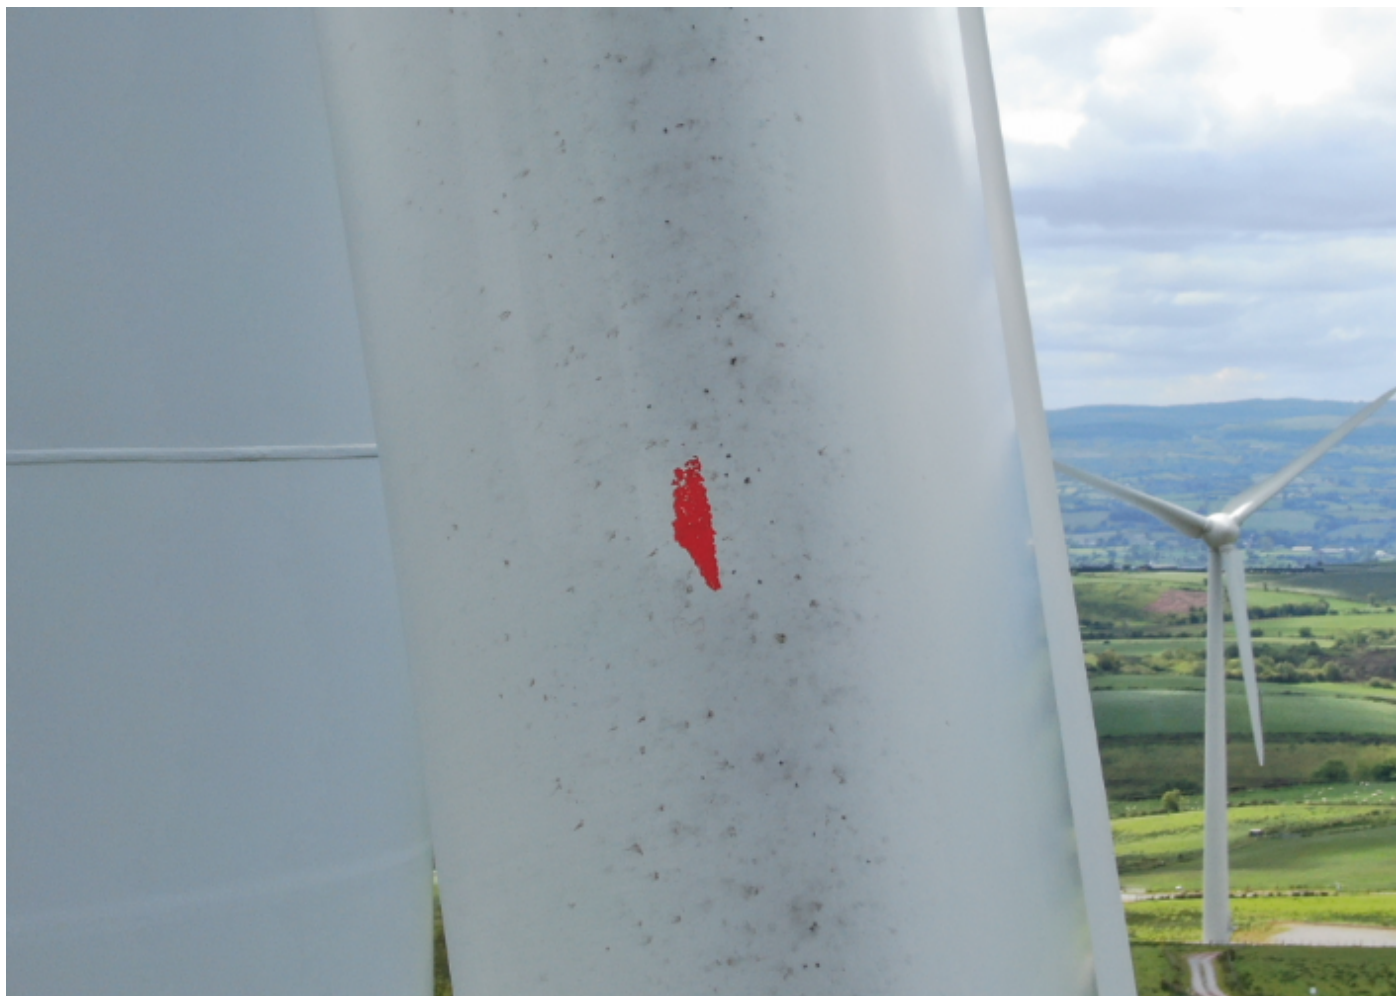
IMAGE 1

REF #		1	
		Damage Class - CAT		2	
		Damage - Type		Wear	
		Distance from Root		25m	
		<input checked="" type="checkbox"/> LE <input type="checkbox"/> TE <input type="checkbox"/> PS <input type="checkbox"/> SS			
Comment	Minor LE Erosion. Isolated small patch.	Blade	C	Serial#	5266
Recommendation	n/a	Image Ref		DJI_0745

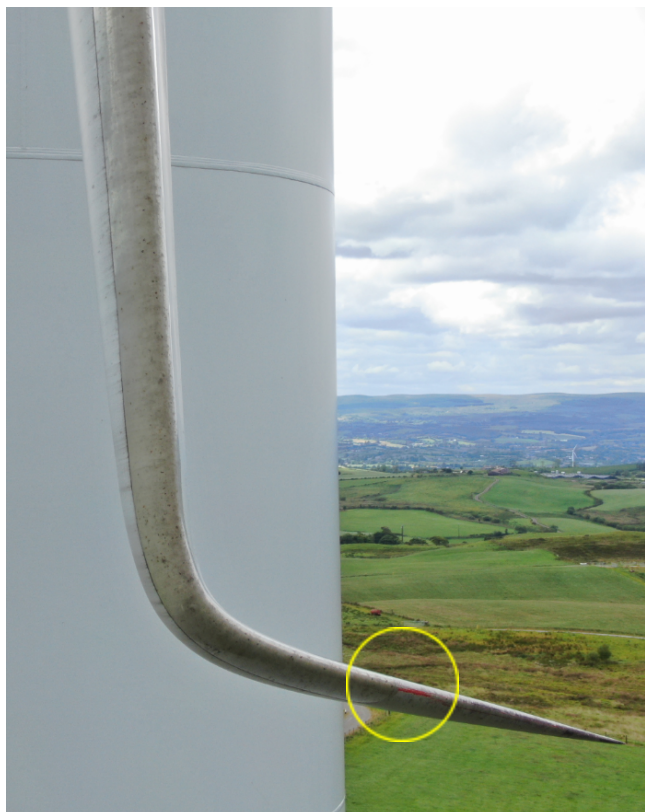
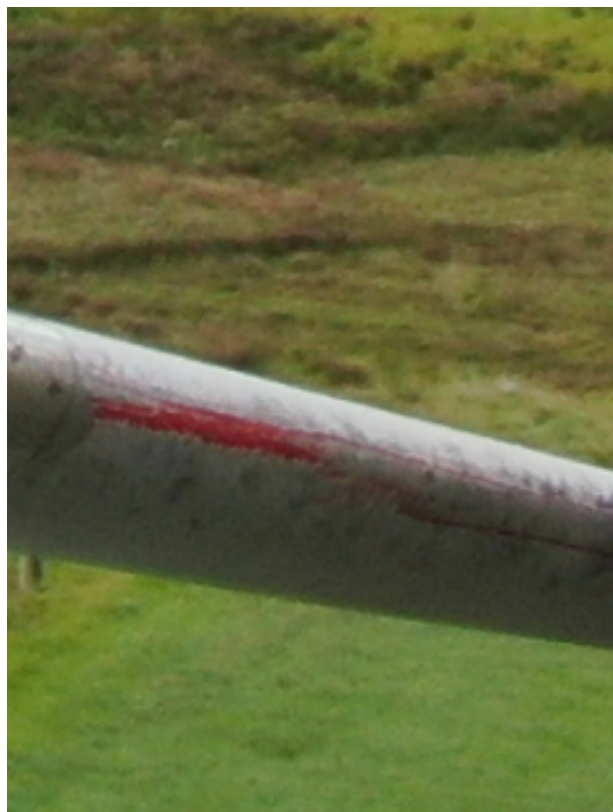
REF #		2	
		Damage Class - CAT		2	
		Damage - Type		Wear	
		Distance from Root		40.8m	
		<input checked="" type="checkbox"/> LE		<input type="checkbox"/> TE	<input type="checkbox"/> PS
Comment	LE Erosion at tip.	Blade	C	Serial#	5266
Recommendation	n/a	Image Ref		DJI_0798

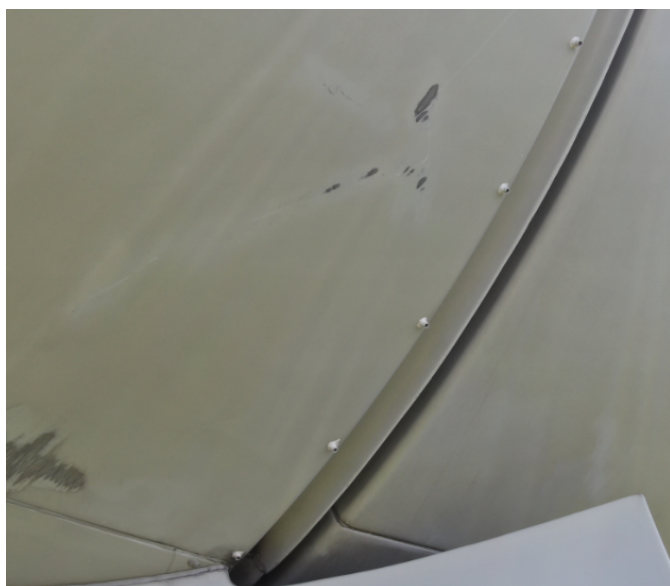
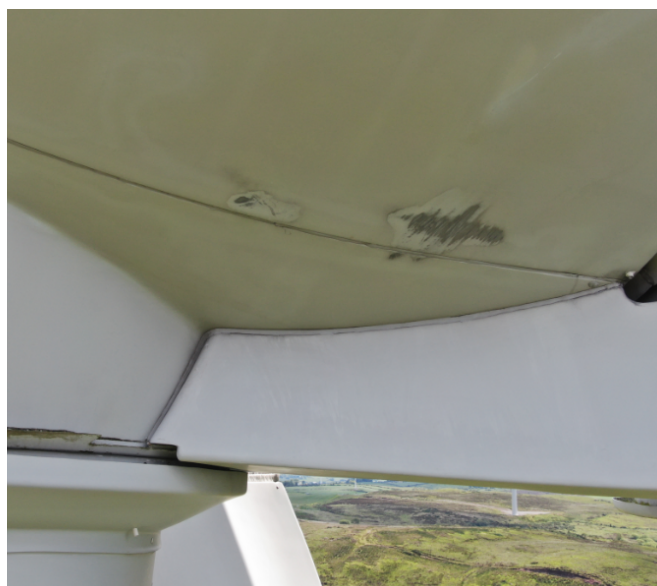
REF #	1
		Damage Class - CAT	2
		Damage - Type	Cosmetic
		Distance from Root	n/a
Comment	Paint damage on hub exterior	Location	Hub
Recommendation	n/a	Image Ref	n/a

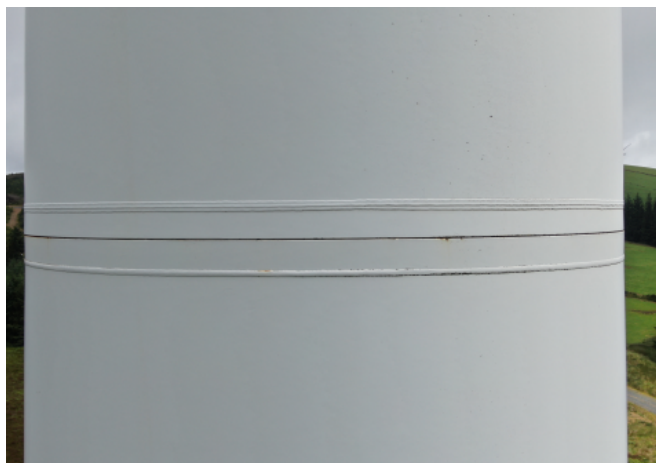
IMAGE 1 – General Condition

REF #	1
		Damage Class - CAT	2
		Damage - Type	Cosmetic
		Distance from Root	n/a
Comment	Minor corrosion on tower joint	Location	Tower
Recommendation	No structural risk. Corrosion is coming from an area of flaked paintwork.	Image Ref	n/a

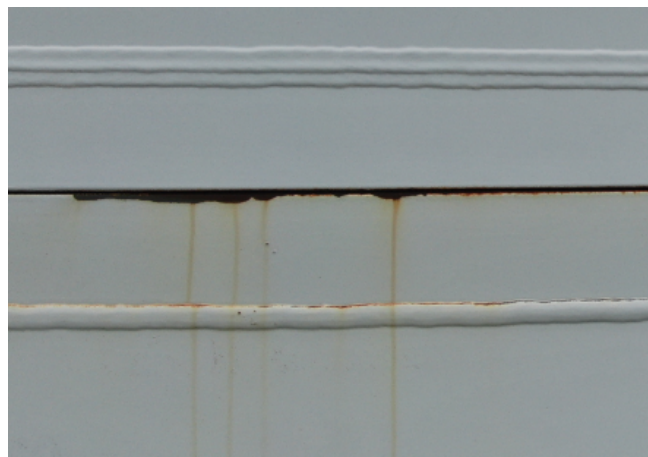
IMAGE 2 – Close up of yellow marked area
