# Wind Turbine Inspection Report

## End of Warranty

**Report Number:** MECHV\_REP-100-854

**Client:** Oriel Wind Farm Ltd.  
**Location:** Oriel Wind Farm, Creggan, Co. Tyrone  
**Asset:** Turbine T12 - Nordex N90 2500 HS Gamma  
**Serial #:** 84752

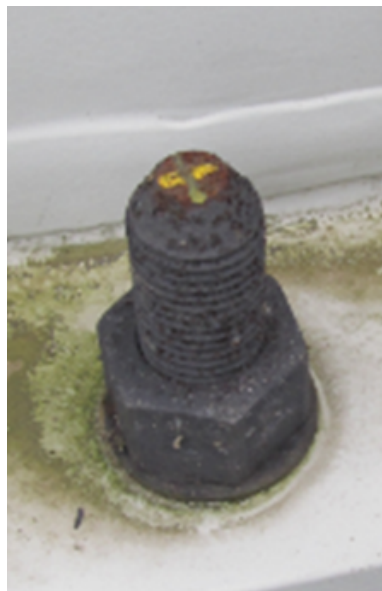
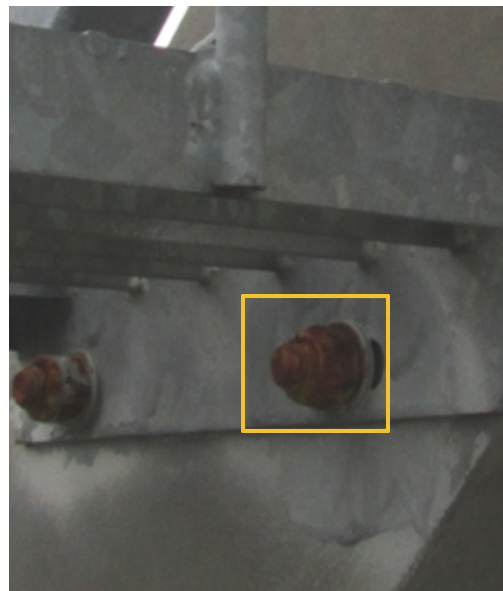
ID#:	1	
Defect Severity:	Low	P4
Defect Class:	Operational	O

Minor surface corrosion on bolts at external stairs. Foundation anchor bolts also require additional anti-corrosion measures to be applied.

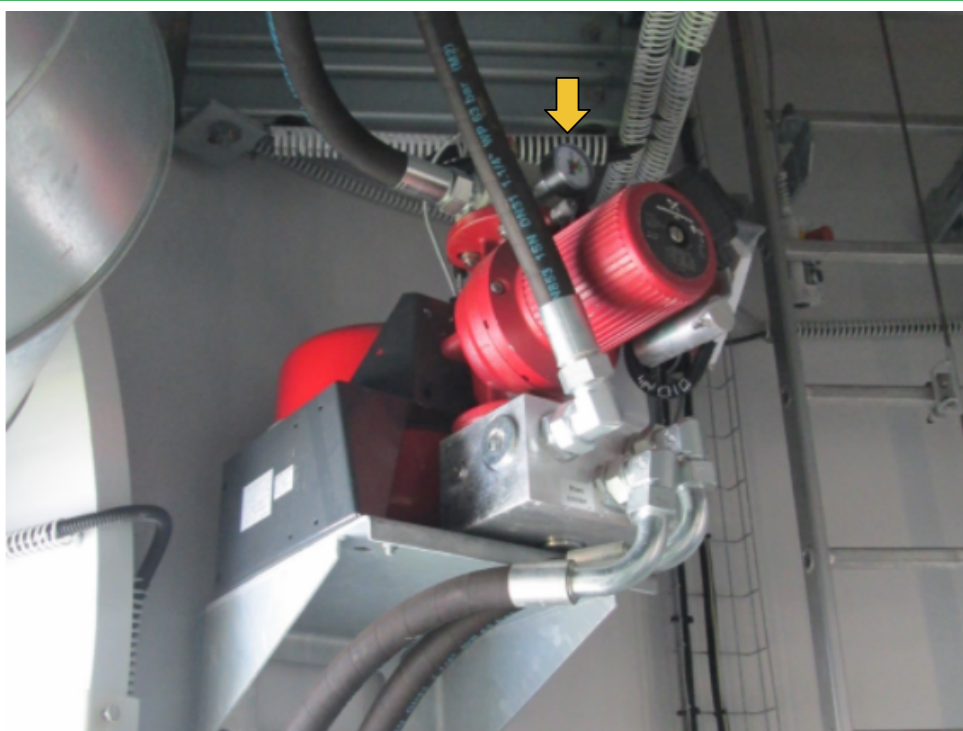
ID#:	2	
Defect Severity:	Low	P4
Defect Class:	Operational	O

Converter cooling system pressure low. Maintenance attention required or WTG may potentially fault.

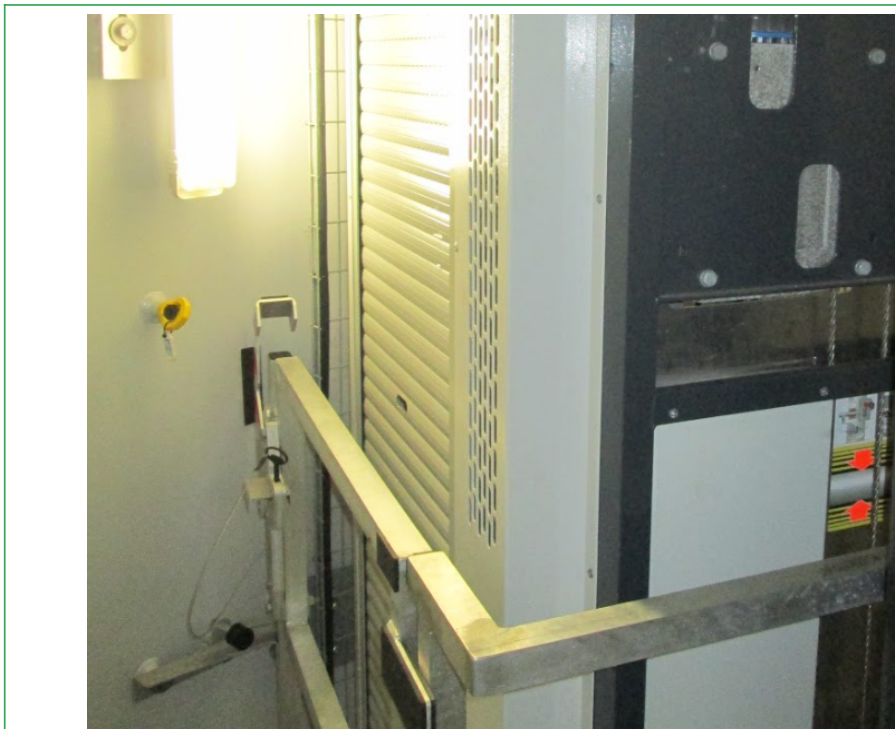
ID#:	3	
Defect Severity:	Medium	P3
Defect Class:	Safety	S

There is no record of lift certification. Previous record is out of date. All other WTG's inspected at this site had valid lift certification records from Mar-2020. Confirm with service provider that this has also been inspected.

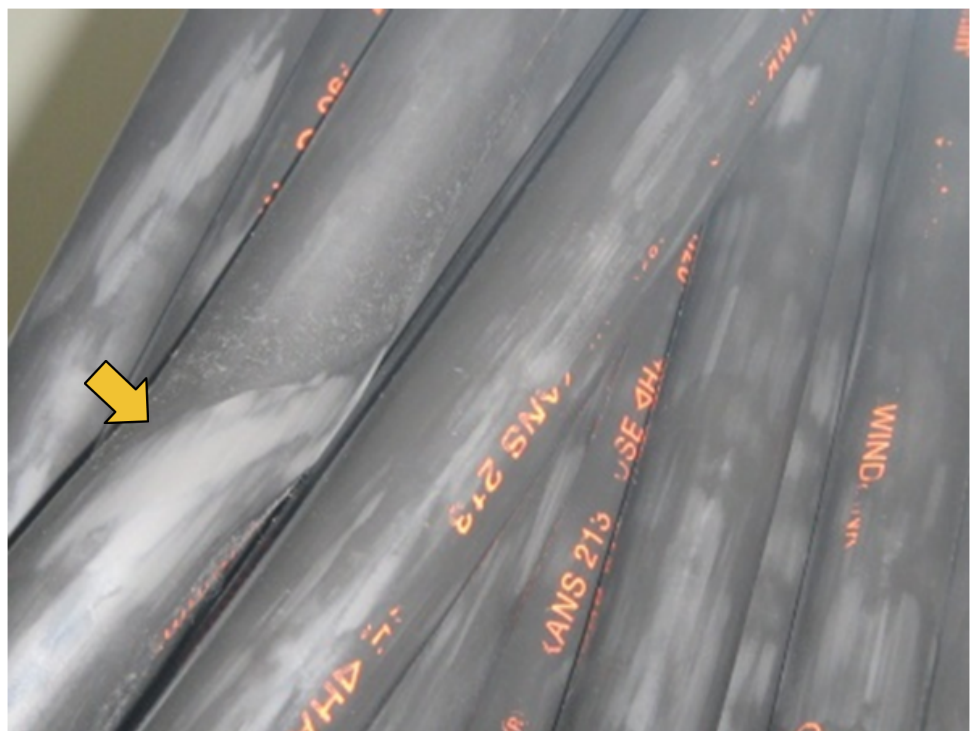
ID#:	4	
Defect Severity:	Low	P4
Defect Class:	Operational	O

Power cables are rubbing at the cable loop and the insulation is being rubbed into a powder. This is generally to be expected. Observation only. Monitor any further wear.

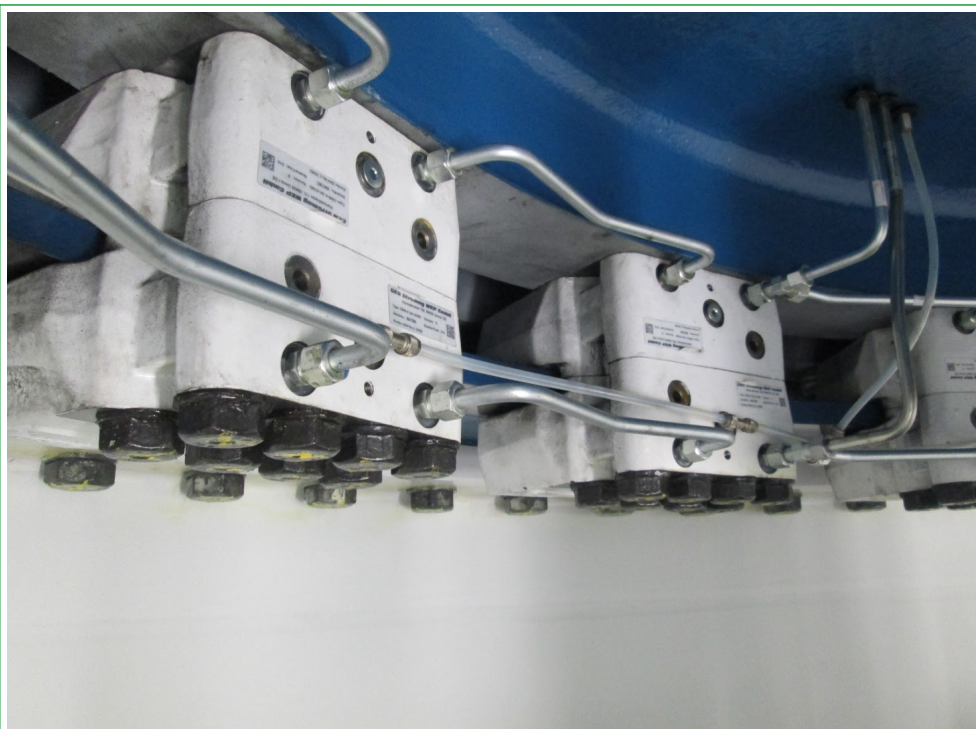
ID#:	5	
Defect Severity:	Low	P4
Defect Class:	Operational	O

One of the yaw brake calipers appears to be sticking. Screeching noise could be observed from the exterior of the WTG. Unknown which exact caliper is not releasing fully. Does not affect yaw function but is an audible nuisance.

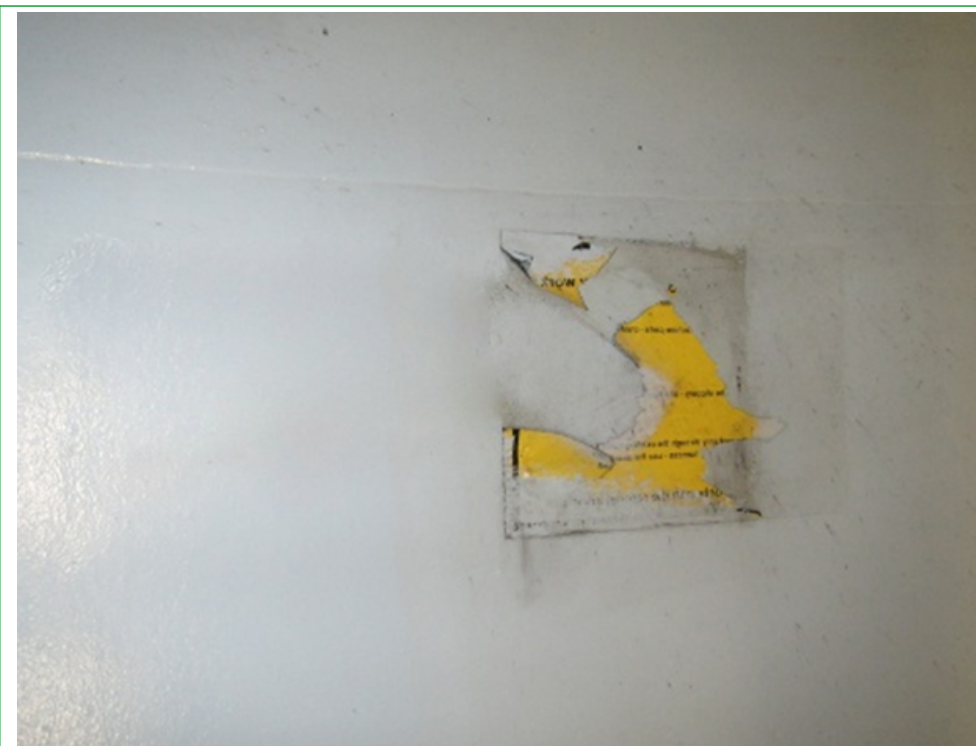
ID#:	6	
Defect Severity:	Low	P4
Defect Class:	Safety	S

Damaged safety signage at yaw deck. Recommend replacement.

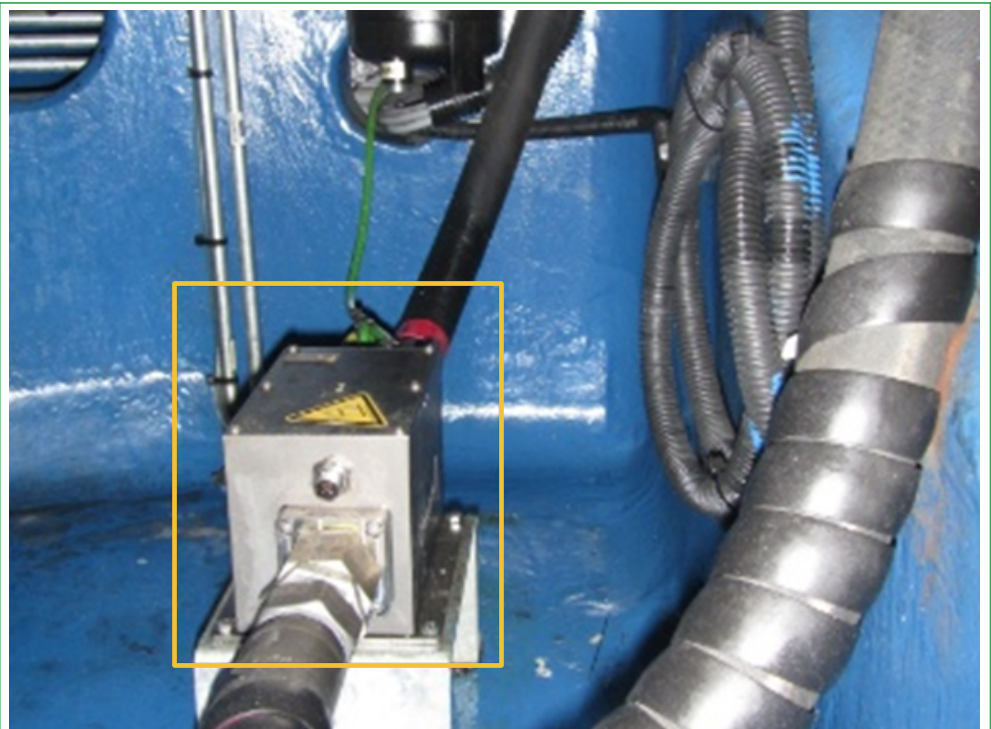
ID#:	7	
Defect Severity:	Medium	P3
Defect Class:	Operational	O

Gear oil particle counter not commissioned. No active data recording. This device provides a protective condition monitoring function for the gearbox and should be active at all times.

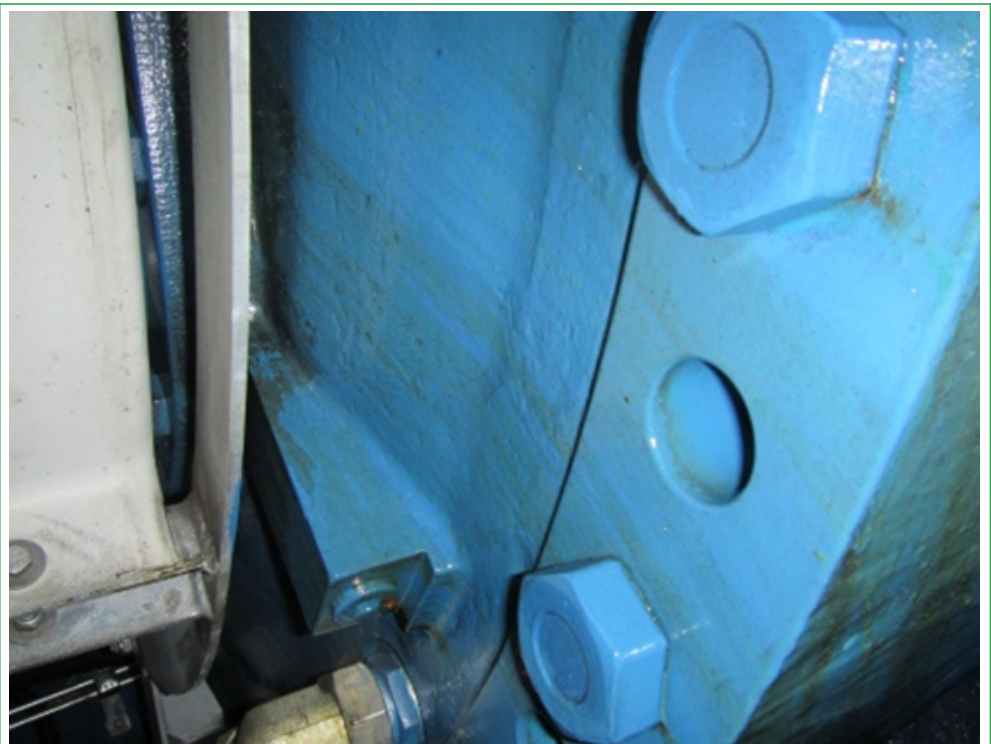
ID#:	8	
Defect Severity:	Medium	P3
Defect Class:	Environmental	E

Oil leaking from gearbox seal on planetary stage 1 rotor side housing cover. Leak is slow and long-term.

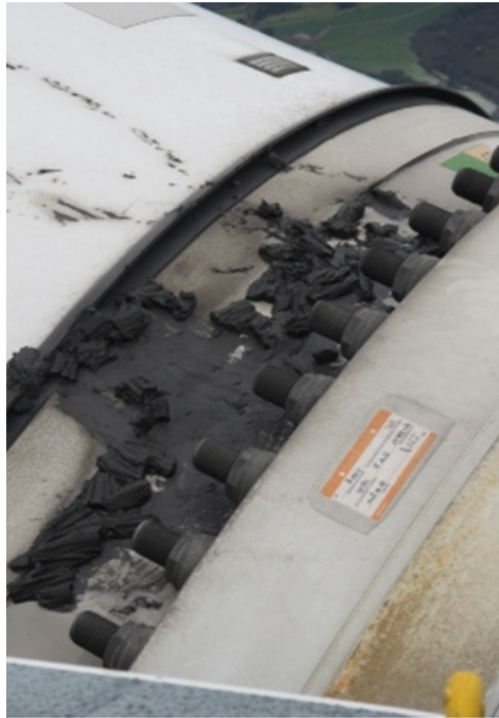
ID#:	9	
Defect Severity:	Medium	P3
Defect Class:	Environmental	E

All blade bearings are losing excessive grease through their outer seals. This has been observed on other WTG's inspected at this site.

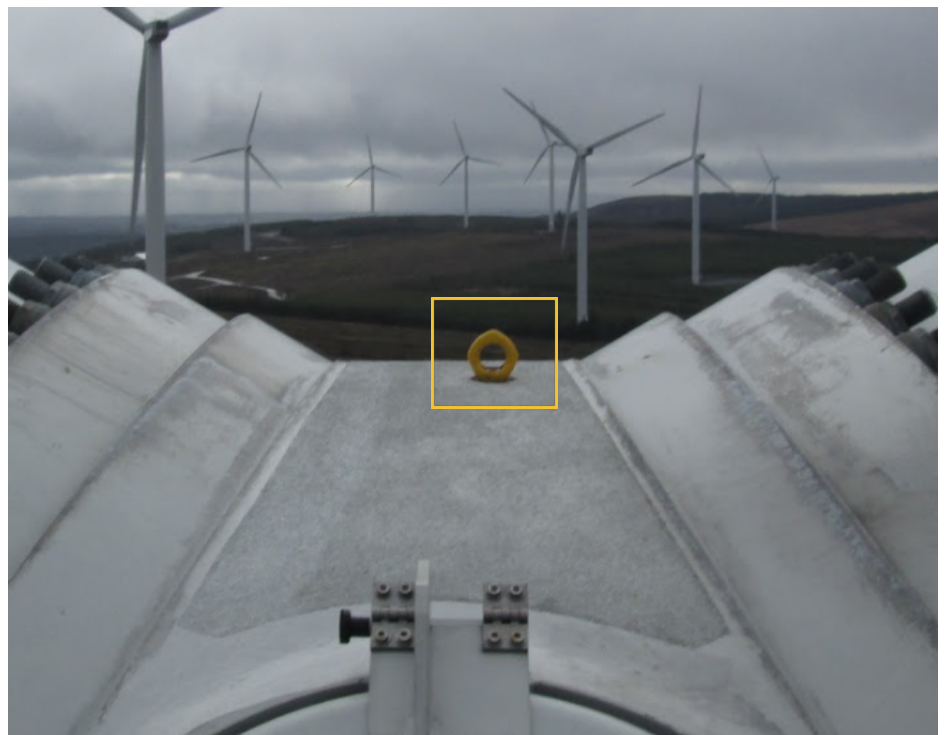
ID#:	10	
Defect Severity:	Low	P4
Defect Class:	Safety	S

Missing certification tag on hub fall arrest anchor point. Note all other anchor points have tags attached and are in date. This must have just fallen off due to weathering.

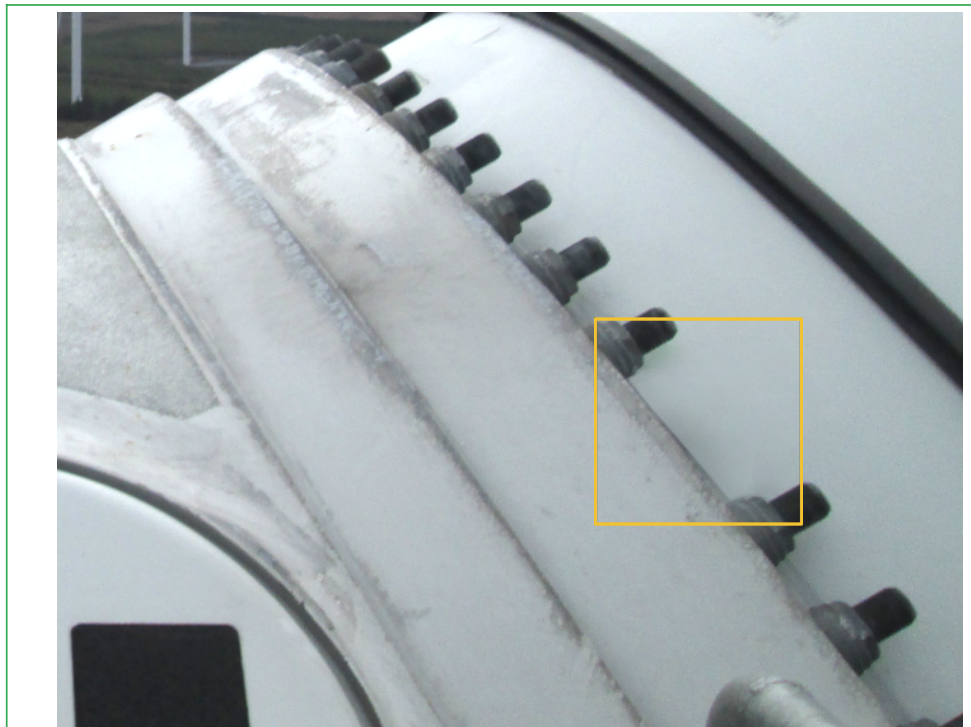
ID#:	11	
Defect Severity:	High	P2
Defect Class:	Operational	O

With the exception of the defects noted in the table below the WTG appears to be well maintained and in good working order. The primary finding of note is the failed blade bolt on Blade A. There are also some items which require maintenance attention therefore it is recommended that these be discussed with the O&M service provider.

Failed blade bolt on Blade A. Recommend follow up with the O&M service provider to determine root cause and if there are any other cases. All other visible blade bolts were checked and they are present. Drone survey can be used to check other WTG blade bolts if desired.

P1	• None to report
P2	• Failed blade bolt. Recommend immediate follow up with O&M service provider to investigate (ID#11).
P3	<ul style="list-style-type: none"> <li>• Missing record of lift certification (ID#3)</li> <li>• Gear oil particle counter not operational (ID#7)</li> <li>• Slow gear oil leak from gearbox (ID#8)</li> <li>• Grease escaping from blade bearings (ID#9)</li> </ul>
P4	• See individual entries.

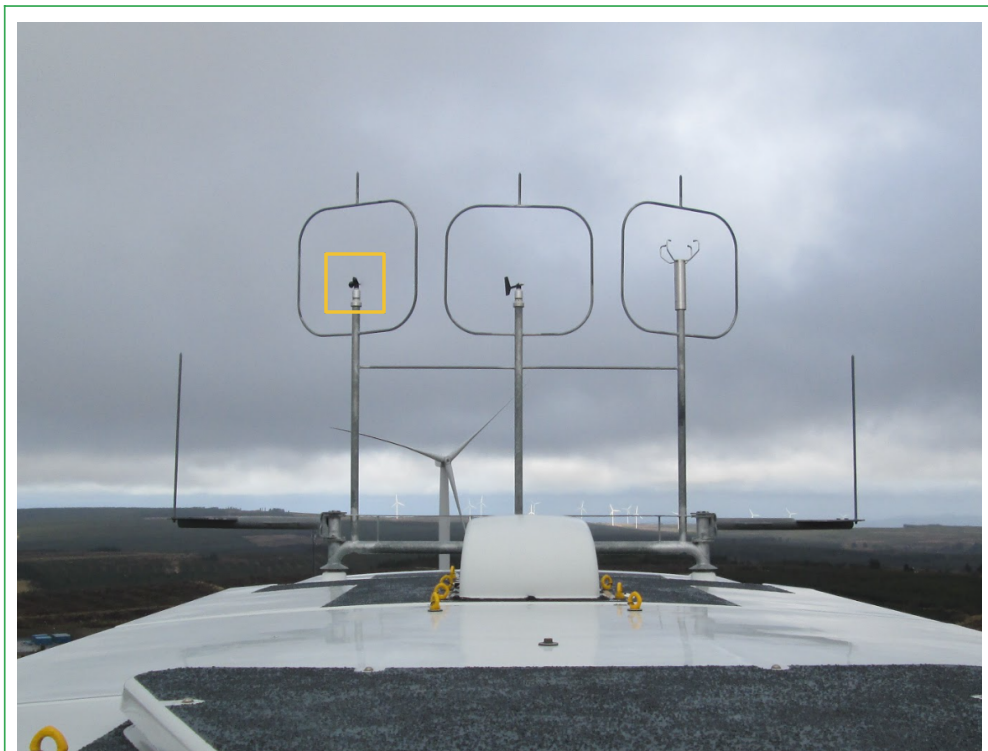
ID#:	12	
Defect Severity:	Low	P4
Defect Class:	Operational	O

Cup anemometer is missing one of its cups. This may affect data logging and WTG operation if this anemometer is being used. The default should be the ultrasonic anemometer which appears to be in good order.
