Wind Turbine Blade Inspection Report

UAV/SUA Aerial Inspection

Report Number: MECHV_REP-200-672-1

Client: DJN Renewables
Location: Curraghderrig Wind Farm, Co. Kerry
Asset: Turbine T02 - Enercon E70 E4 2300 - Serial# 156345

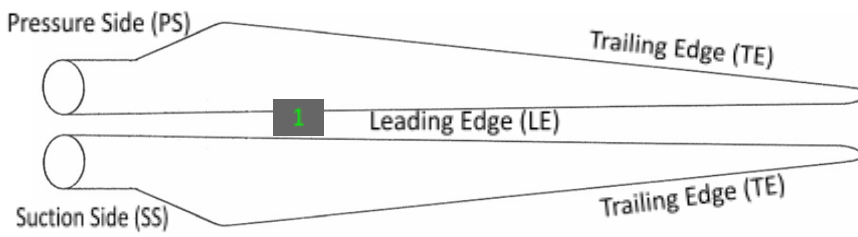
REF #	1
		Damage Class - CAT	1
		Damage - Type	Handling
		Distance from Root	8m
		<input checked="" type="checkbox"/> LE <input type="checkbox"/> TE <input type="checkbox"/> PS <input type="checkbox"/> SS	
Comment	Small scratch in paint on LE	Blade	A
Recommendation	n/a	Serial#	5267
		Image Ref	DJI_0489

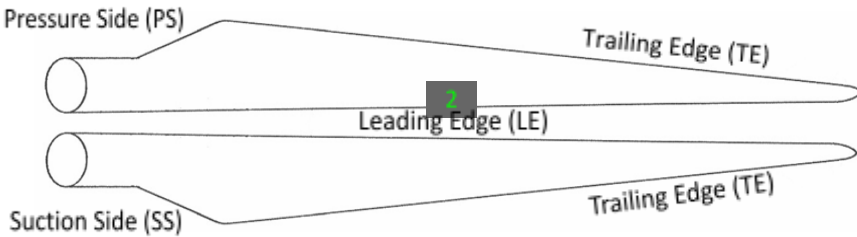
REF #		2	
		Damage Class - CAT		2	
		Damage - Type		Wear	
		Distance from Root		21m	
		<input checked="" type="checkbox"/> LE <input type="checkbox"/> TE <input type="checkbox"/> PS <input type="checkbox"/> SS			
Comment	LE Erosion	Blade	A	Serial#	5267
Recommendation	n/a	Image Ref		DJI_0512

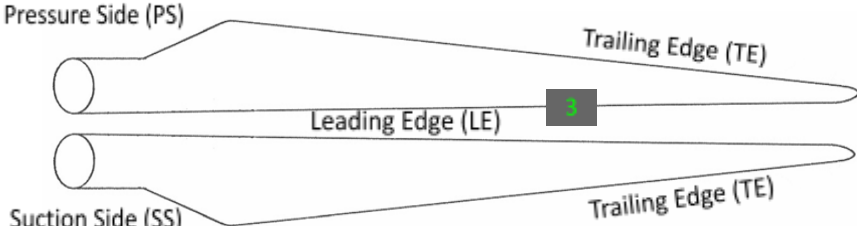
REF #		3	
		Damage Class - CAT		3	
		Damage - Type		Handling	
		Distance from Root		30m	
		<input checked="" type="checkbox"/> LE <input type="checkbox"/> TE <input type="checkbox"/> PS <input type="checkbox"/> SS			
Comment	Gouge in gelcoat. Construction/transport damage	Blade	A	Serial#	5267
Recommendation	n/a	Image Ref		DJI_0467

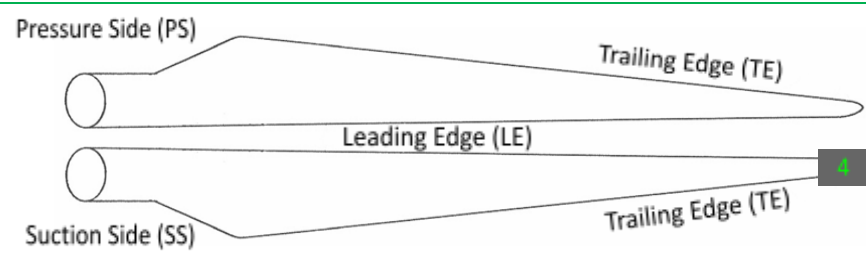
REF #		4	
		Damage Class - CAT		2	
		Damage - Type		Contamination	
		Distance from Root		40m	
		<input type="checkbox"/> LE <input type="checkbox"/> TE <input type="checkbox"/> PS <input checked="" type="checkbox"/> SS			
Comment	Oil contamination at tip seeping from drain hole.	Blade	A	Serial#	5267
Recommendation	n/a	Image Ref		DJI_0558

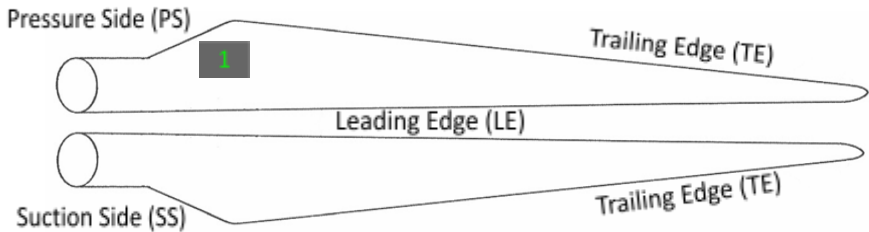
REF #		1	
		Damage Class - CAT		2	
		Damage - Type		Damage	
		Distance from Root		4m	
		<input type="checkbox"/> LE <input type="checkbox"/> TE <input checked="" type="checkbox"/> PS <input type="checkbox"/> SS			
Comment	Gel coat cracking	Blade	B	Serial#	5268
Recommendation	Monitor at next inspection	Image Ref		DJI_0582

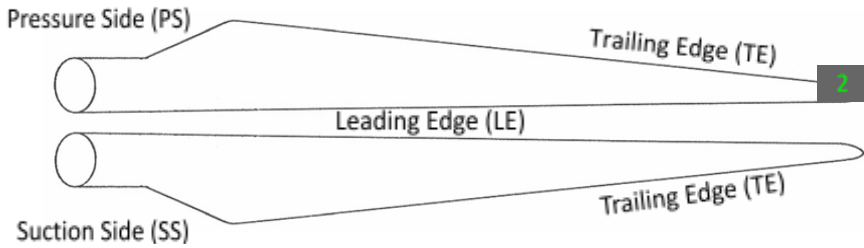
REF #	2		
		Damage Class - CAT	2		
		Damage - Type	Damage		
		Distance from Root	40m		
		<input type="checkbox"/> LE <input checked="" type="checkbox"/> TE <input type="checkbox"/> PS <input type="checkbox"/> SS			
Comment	Small chip in gel coat at TE near tip	Blade	B	Serial#	5268
Recommendation	n/a	Image Ref		DJI_0641

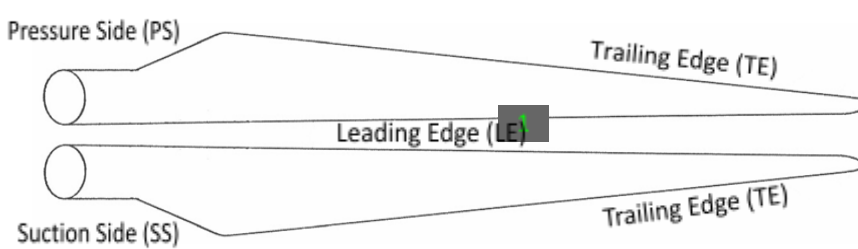
REF #		1	
		Damage Class - CAT		2	
		Damage - Type		Wear	
		Distance from Root		25m	
		<input checked="" type="checkbox"/> LE <input type="checkbox"/> TE <input type="checkbox"/> PS <input type="checkbox"/> SS			
Comment	Minor LE Erosion. Isolated small patch.	Blade	C	Serial#	5266
Recommendation	n/a	Image Ref		DJI_0745

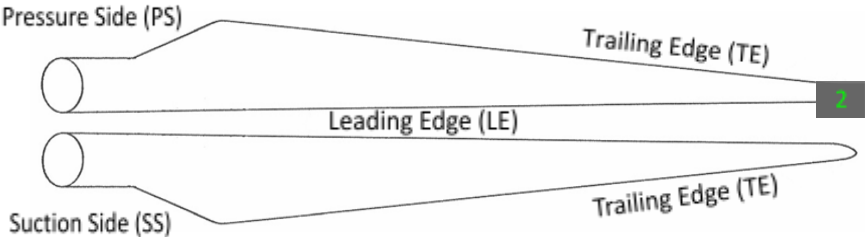
REF #		2	
		Damage Class - CAT		2	
		Damage - Type		Wear	
		Distance from Root		40.8m	
		<input checked="" type="checkbox"/> LE		<input type="checkbox"/> TE	<input type="checkbox"/> PS
Comment	LE Erosion at tip.	Blade	C	Serial#	5266
Recommendation	n/a	Image Ref		DJI_0798

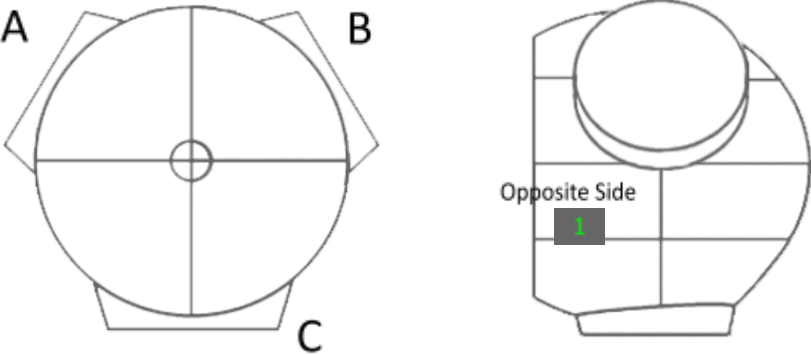
REF #	1
		Damage Class - CAT	2
		Damage - Type	Cosmetic
		Distance from Root	n/a
Comment	Paint damage on hub exterior	Location	Hub
Recommendation	n/a	Image Ref	n/a
